# Lessons Learned in the Design Analysis & Modification of an Early 1900's Dam Lauderdale Lakes, Elkhorn, WI

Brian Valleskey

Cowhey Gudmundson Leder, Ltd.

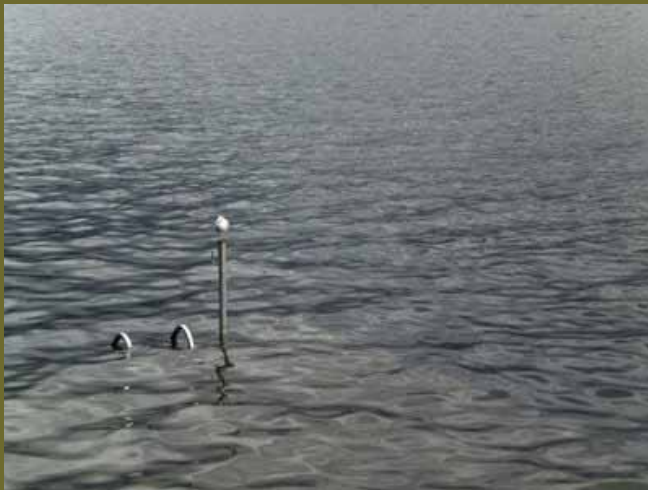
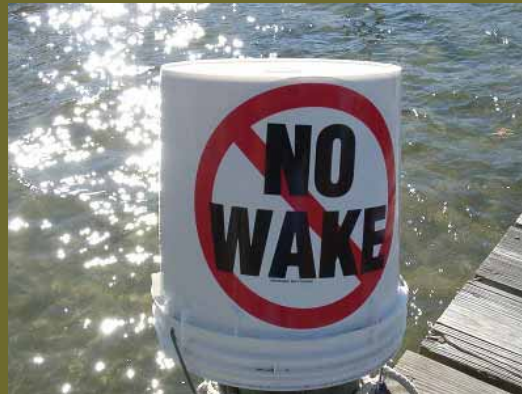
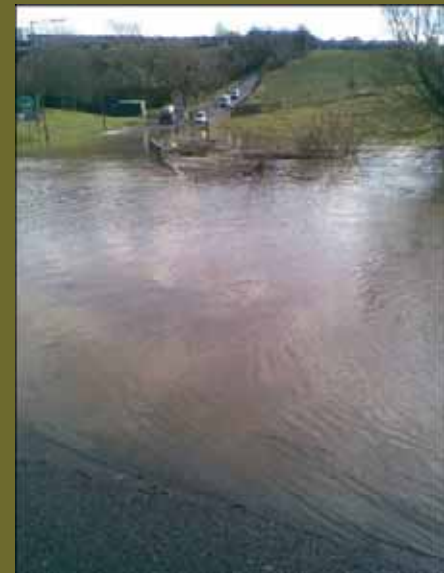
- Increasing periods of “No Wake”
- Localized flooding more frequent
- Unknown effectiveness of lake outfall

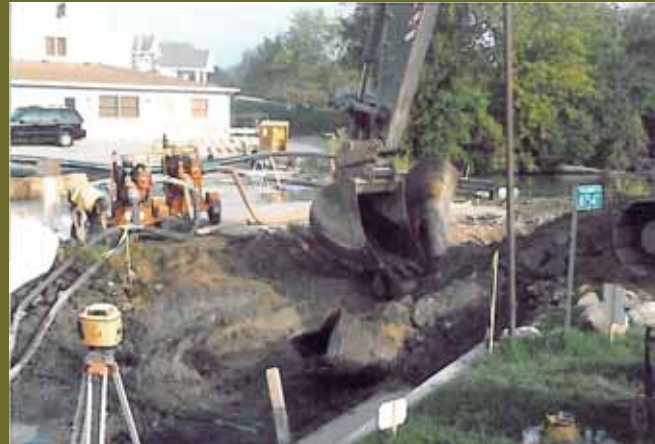
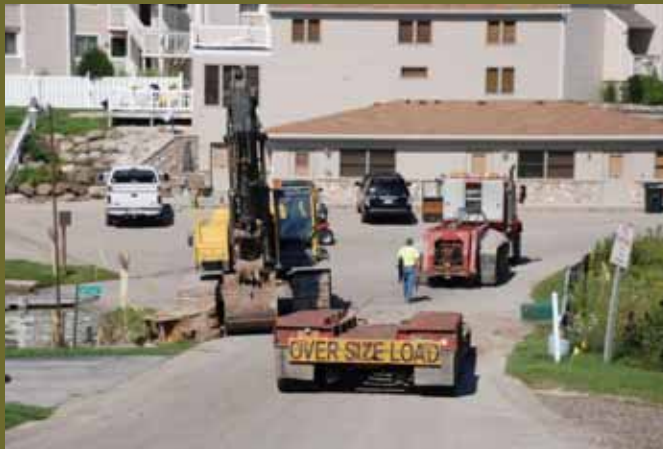
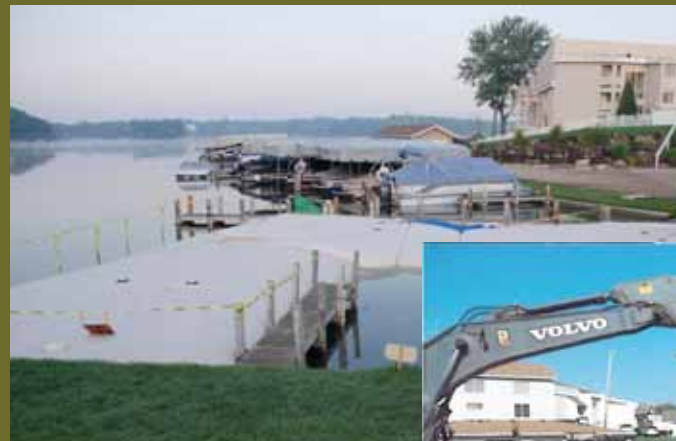
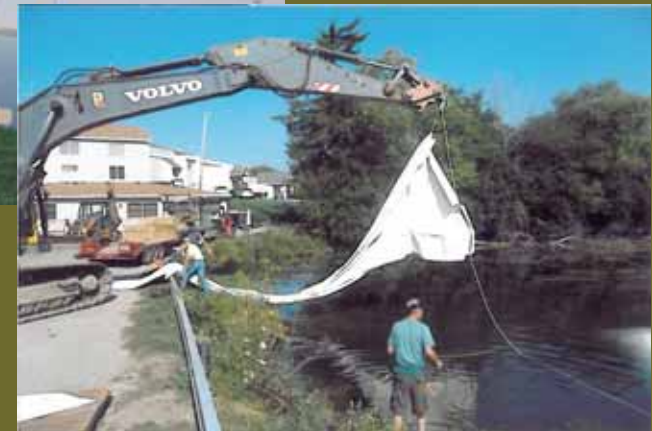
- Staging
- Demolition
- Dewatering

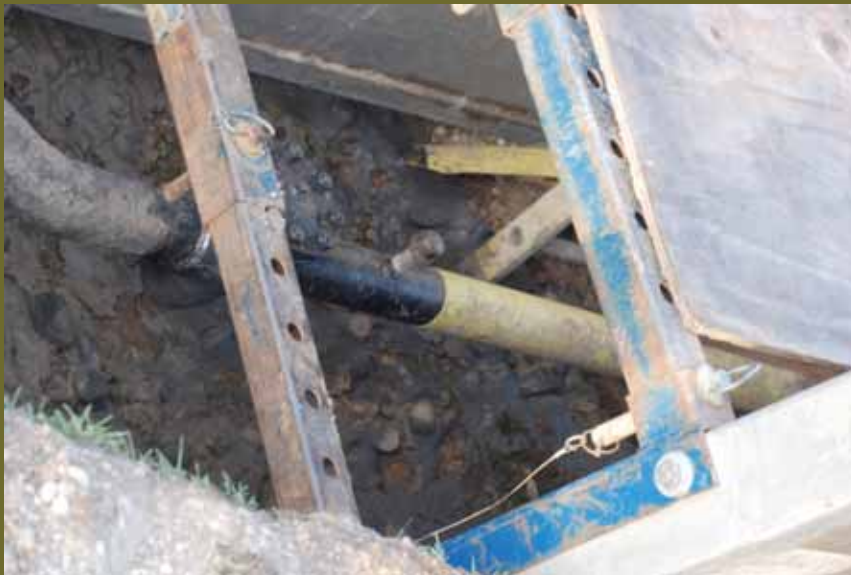
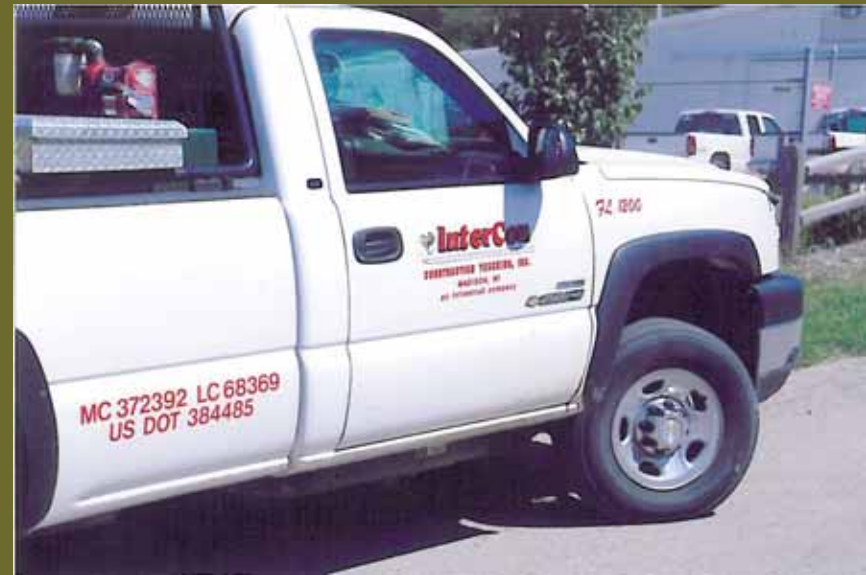
- Contractor Locates Gas Main
- Emergency Coordination
- Emergency Removal

- *We Energies* handles everything within days
- Dewatering completed
- Culvert installation completed

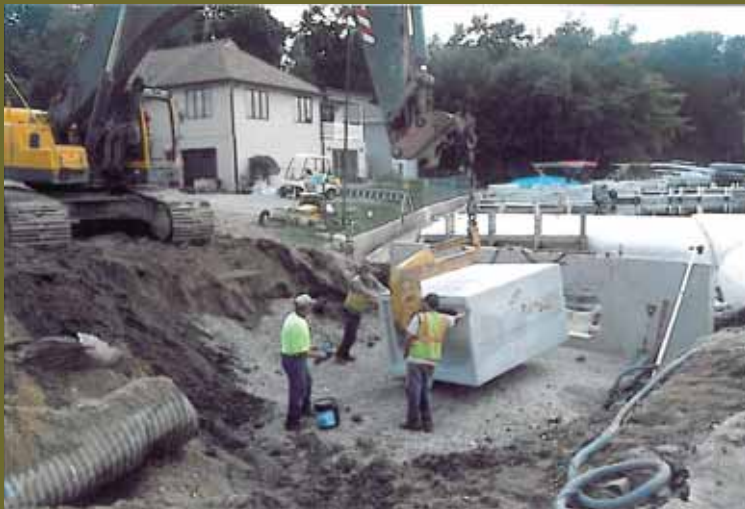
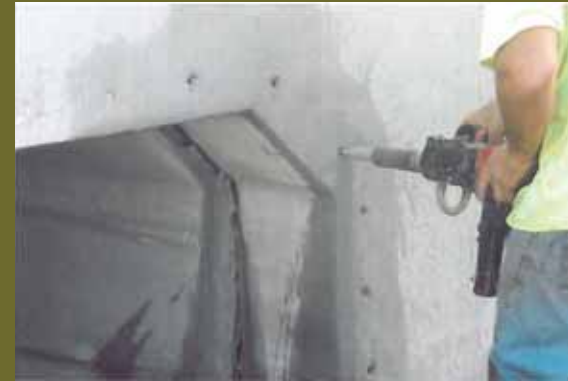
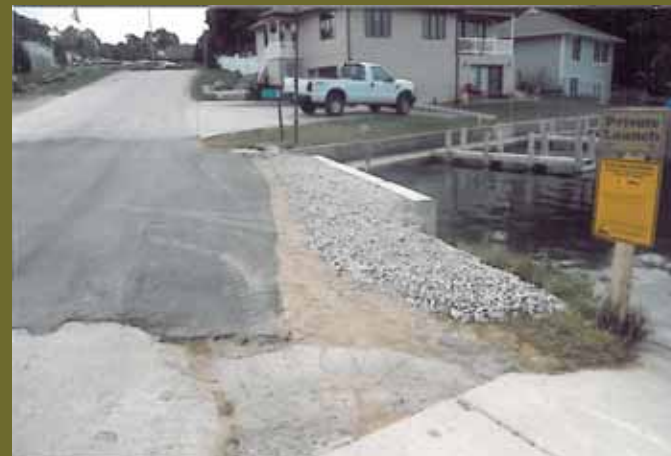
- Staged box culvert installation
- Dewatering reversal
- Restoration
