Lake Rip Rap, Inc.

2010 Illinois Lake Management Convention

“Erosion Control for Residential Shorelines”

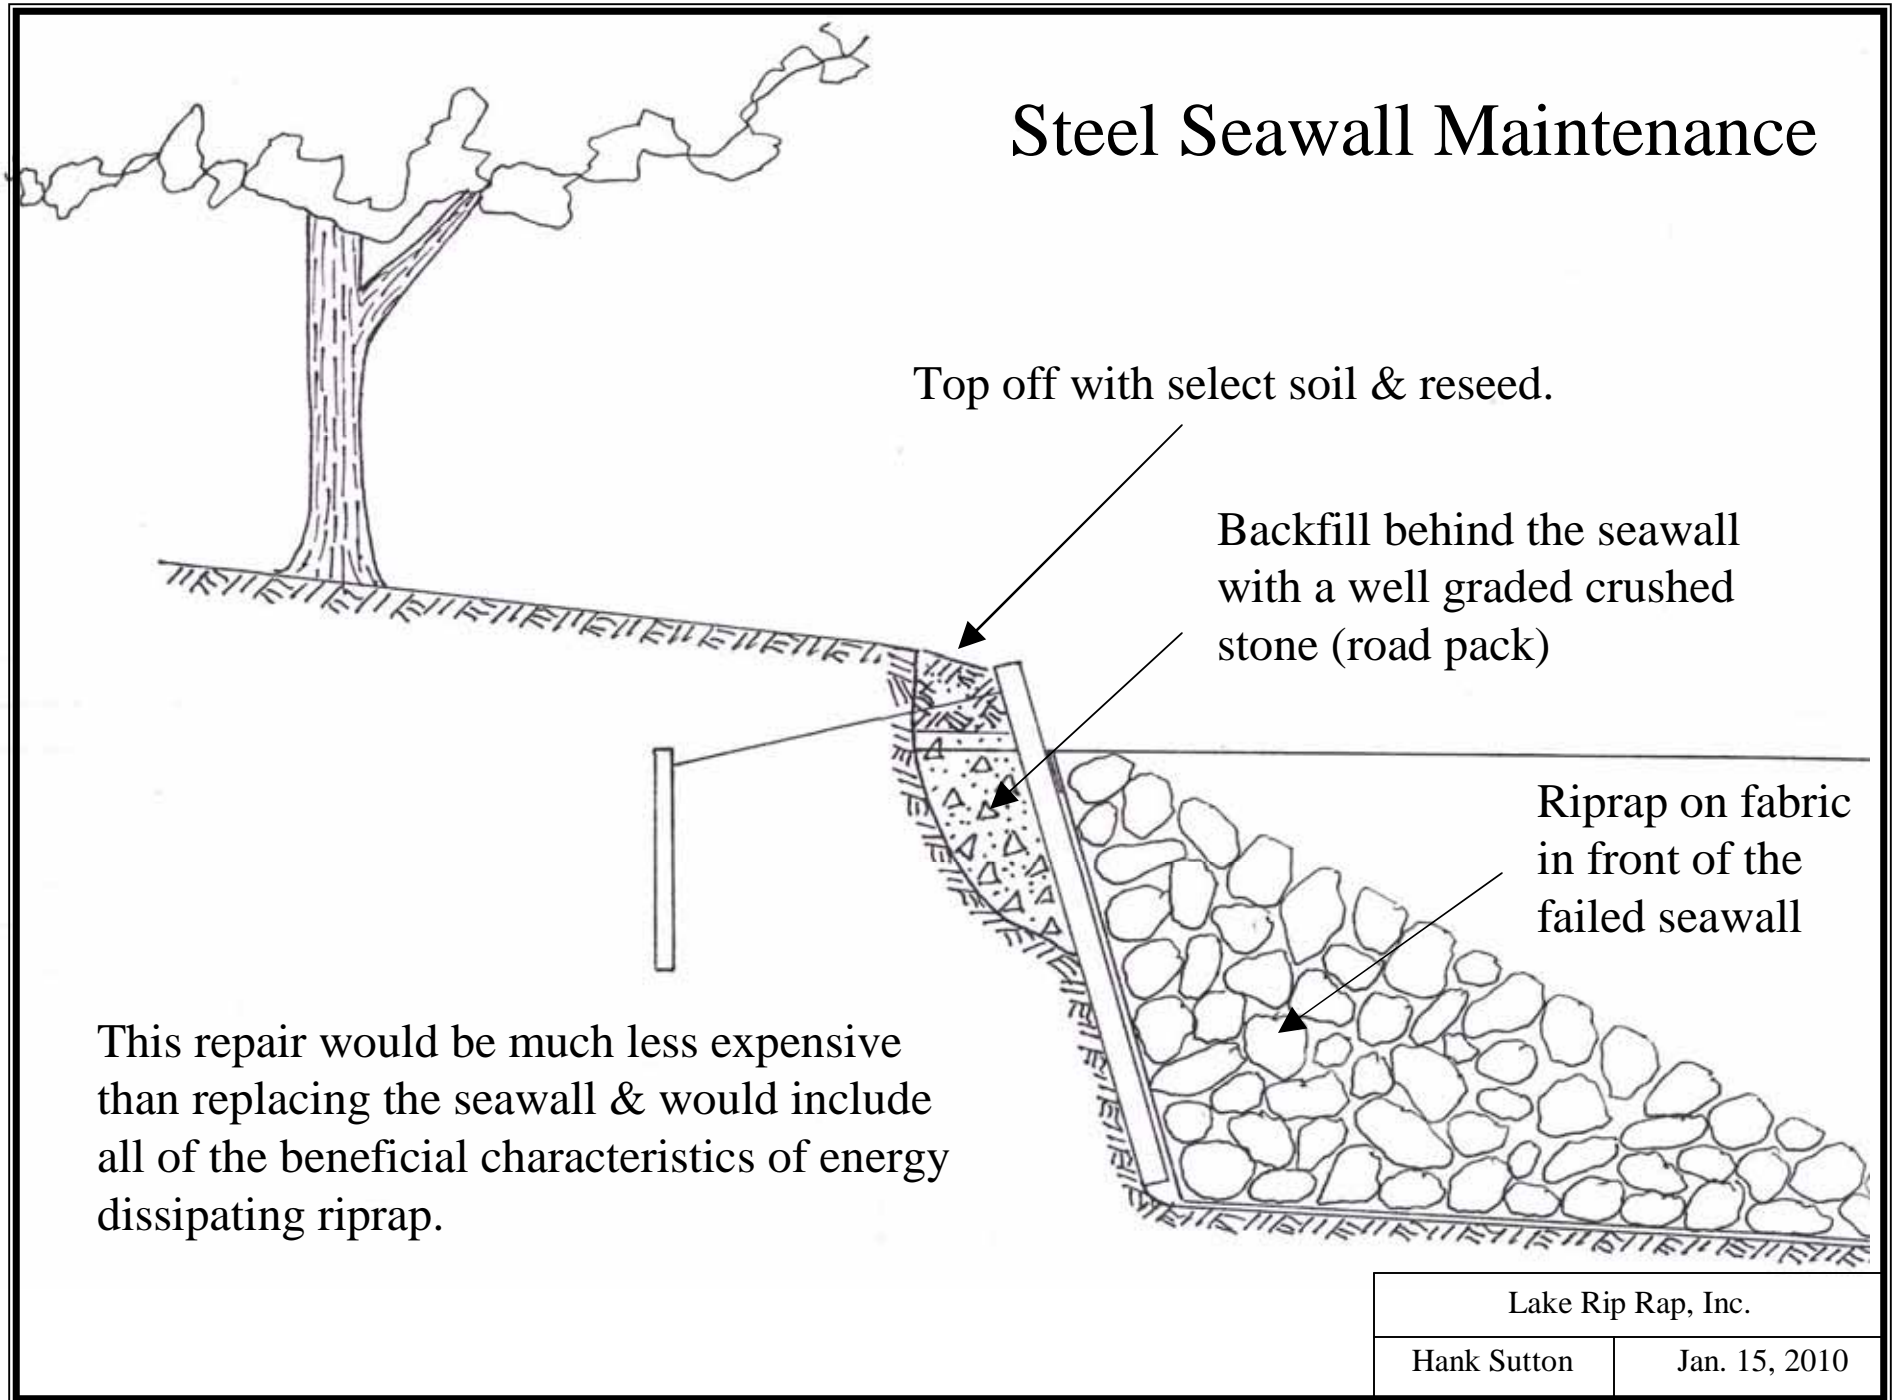
Steel Seawall Maintenance

Top off with select soil & reseed.

Backfill behind the seawall with a well graded crushed stone (road pack)

Riprap on fabric in front of the failed seawall

This repair would be much less expensive than replacing the seawall & would include all of the beneficial characteristics of energy dissipating riprap.

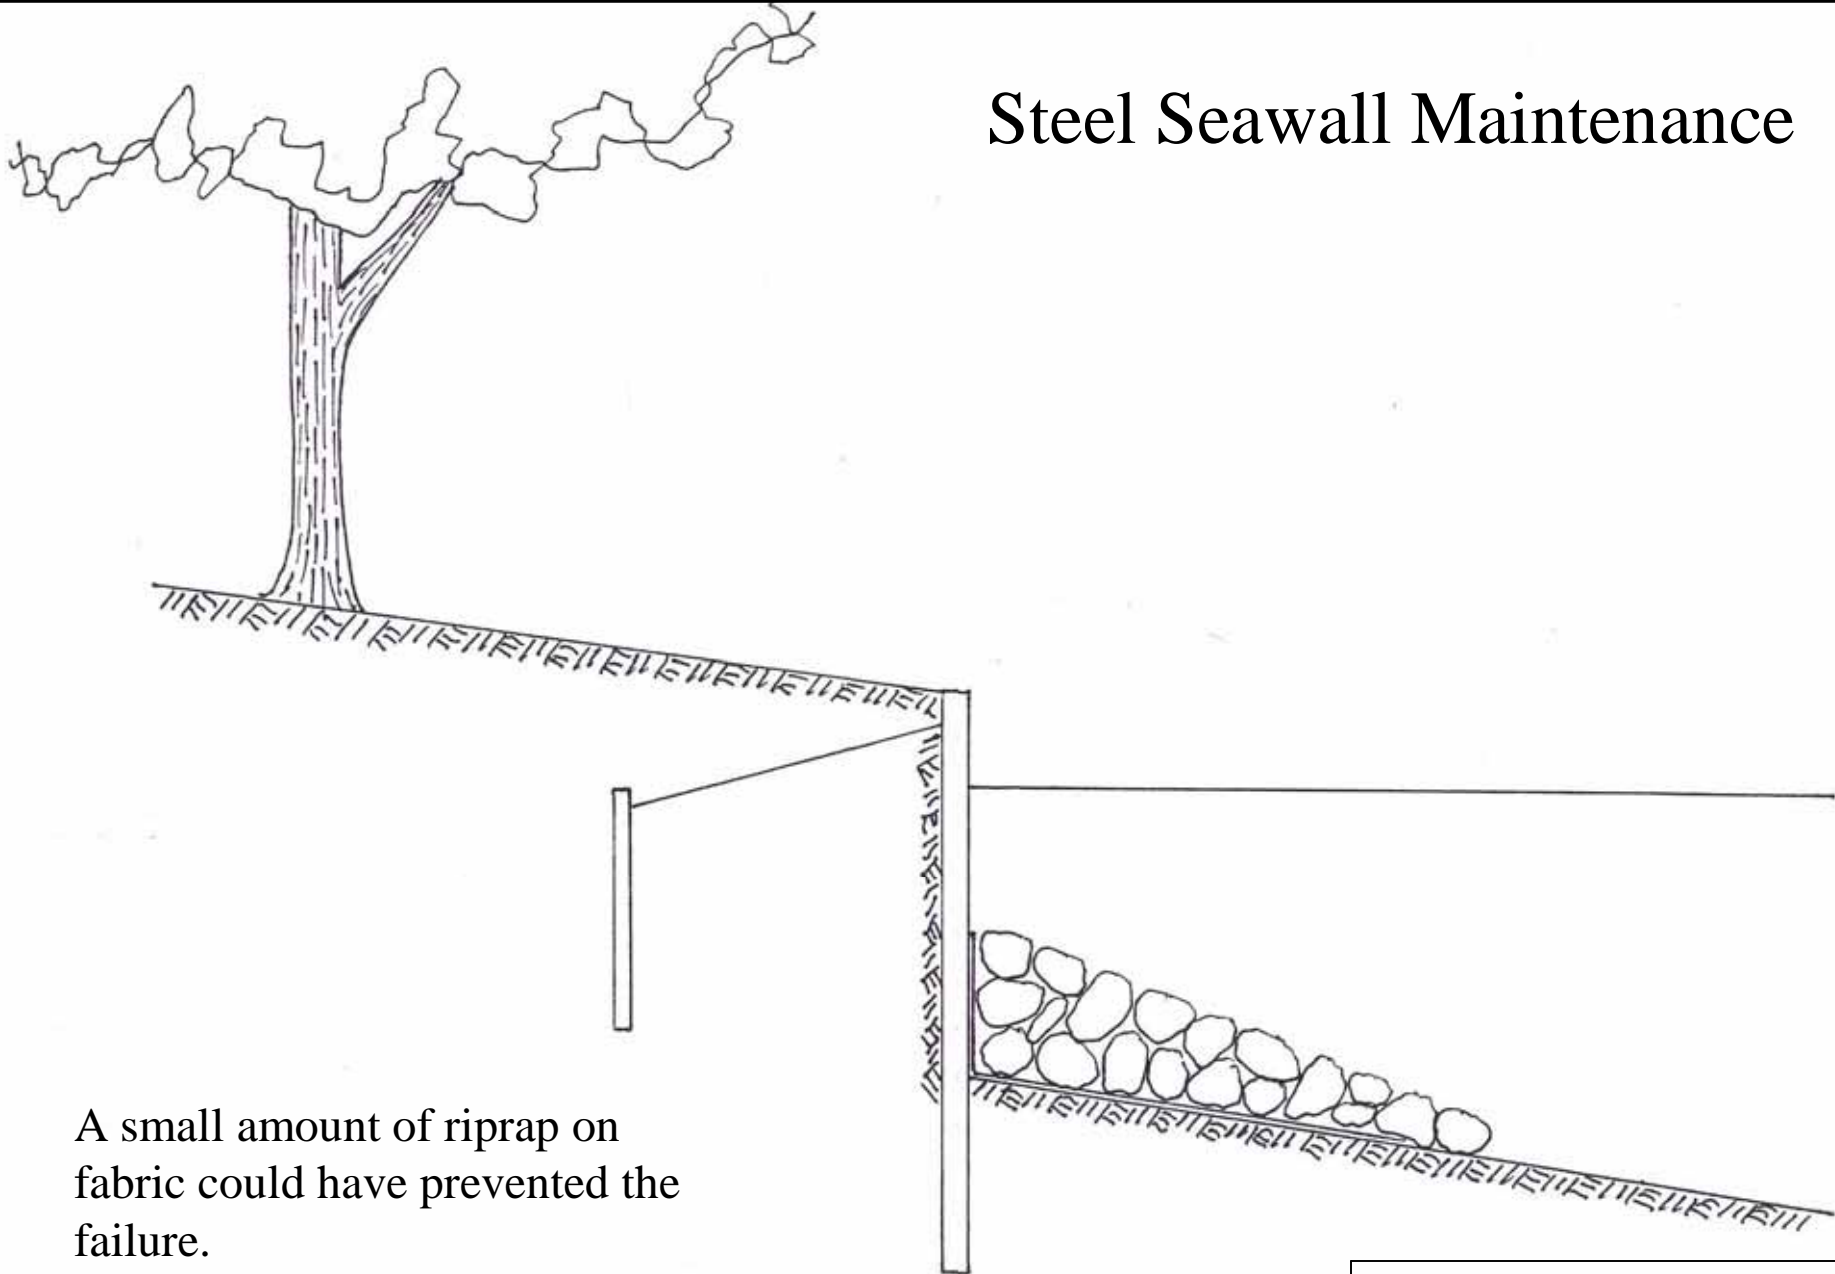
Steel Seawall Maintenance

A small amount of riprap on fabric could have prevented the failure.

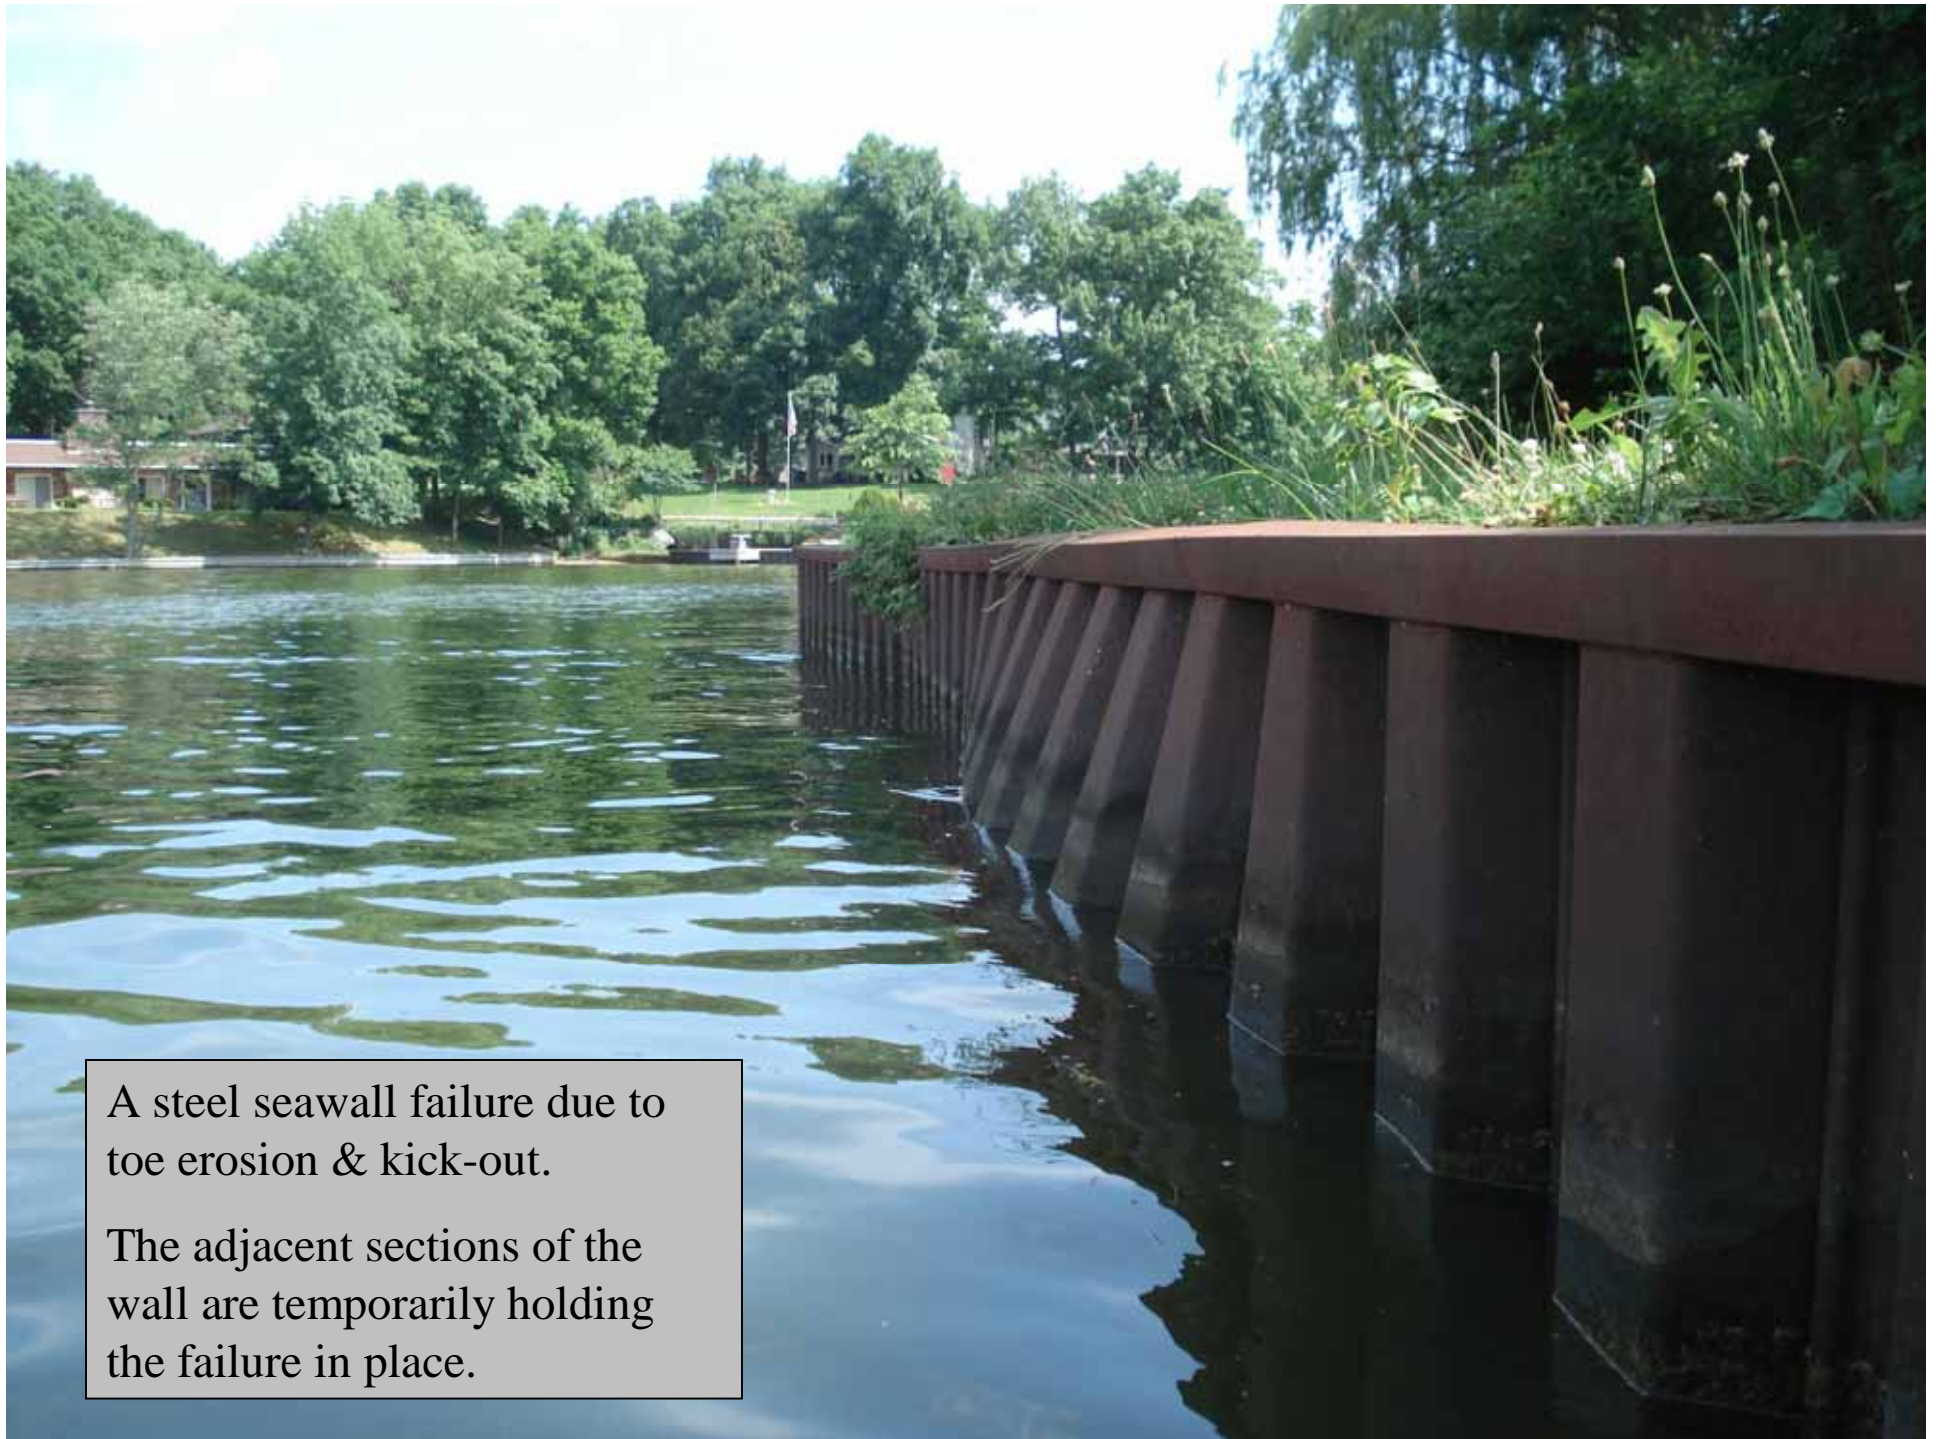
A steel seawall failure due to toe erosion & kick-out.

The adjacent sections of the wall are temporarily holding the failure in place.

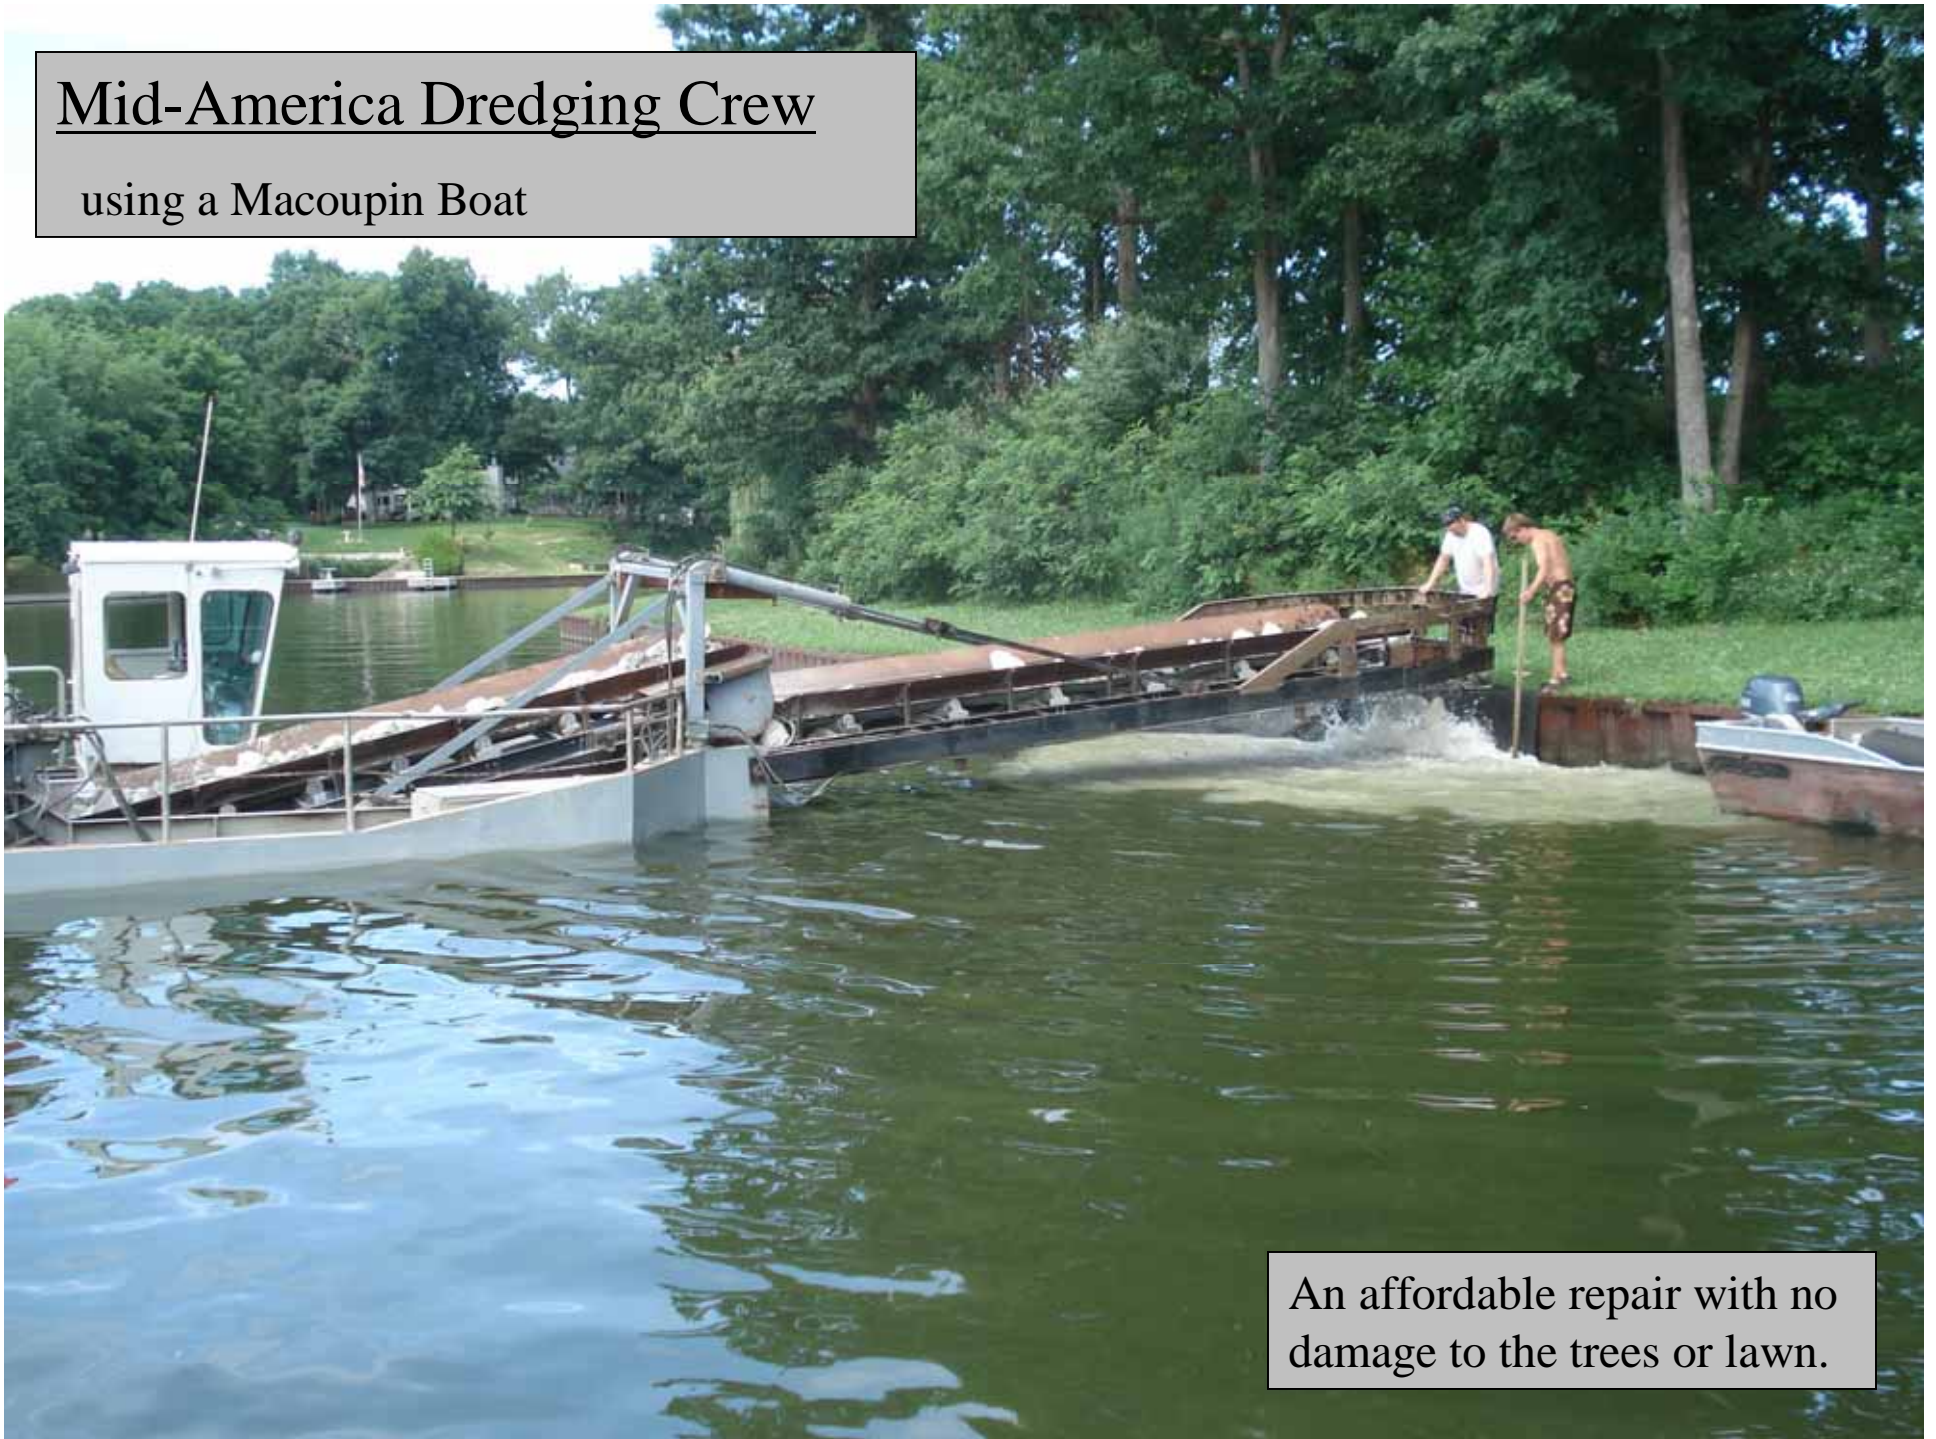
An affordable repair with no damage to the trees or lawn.

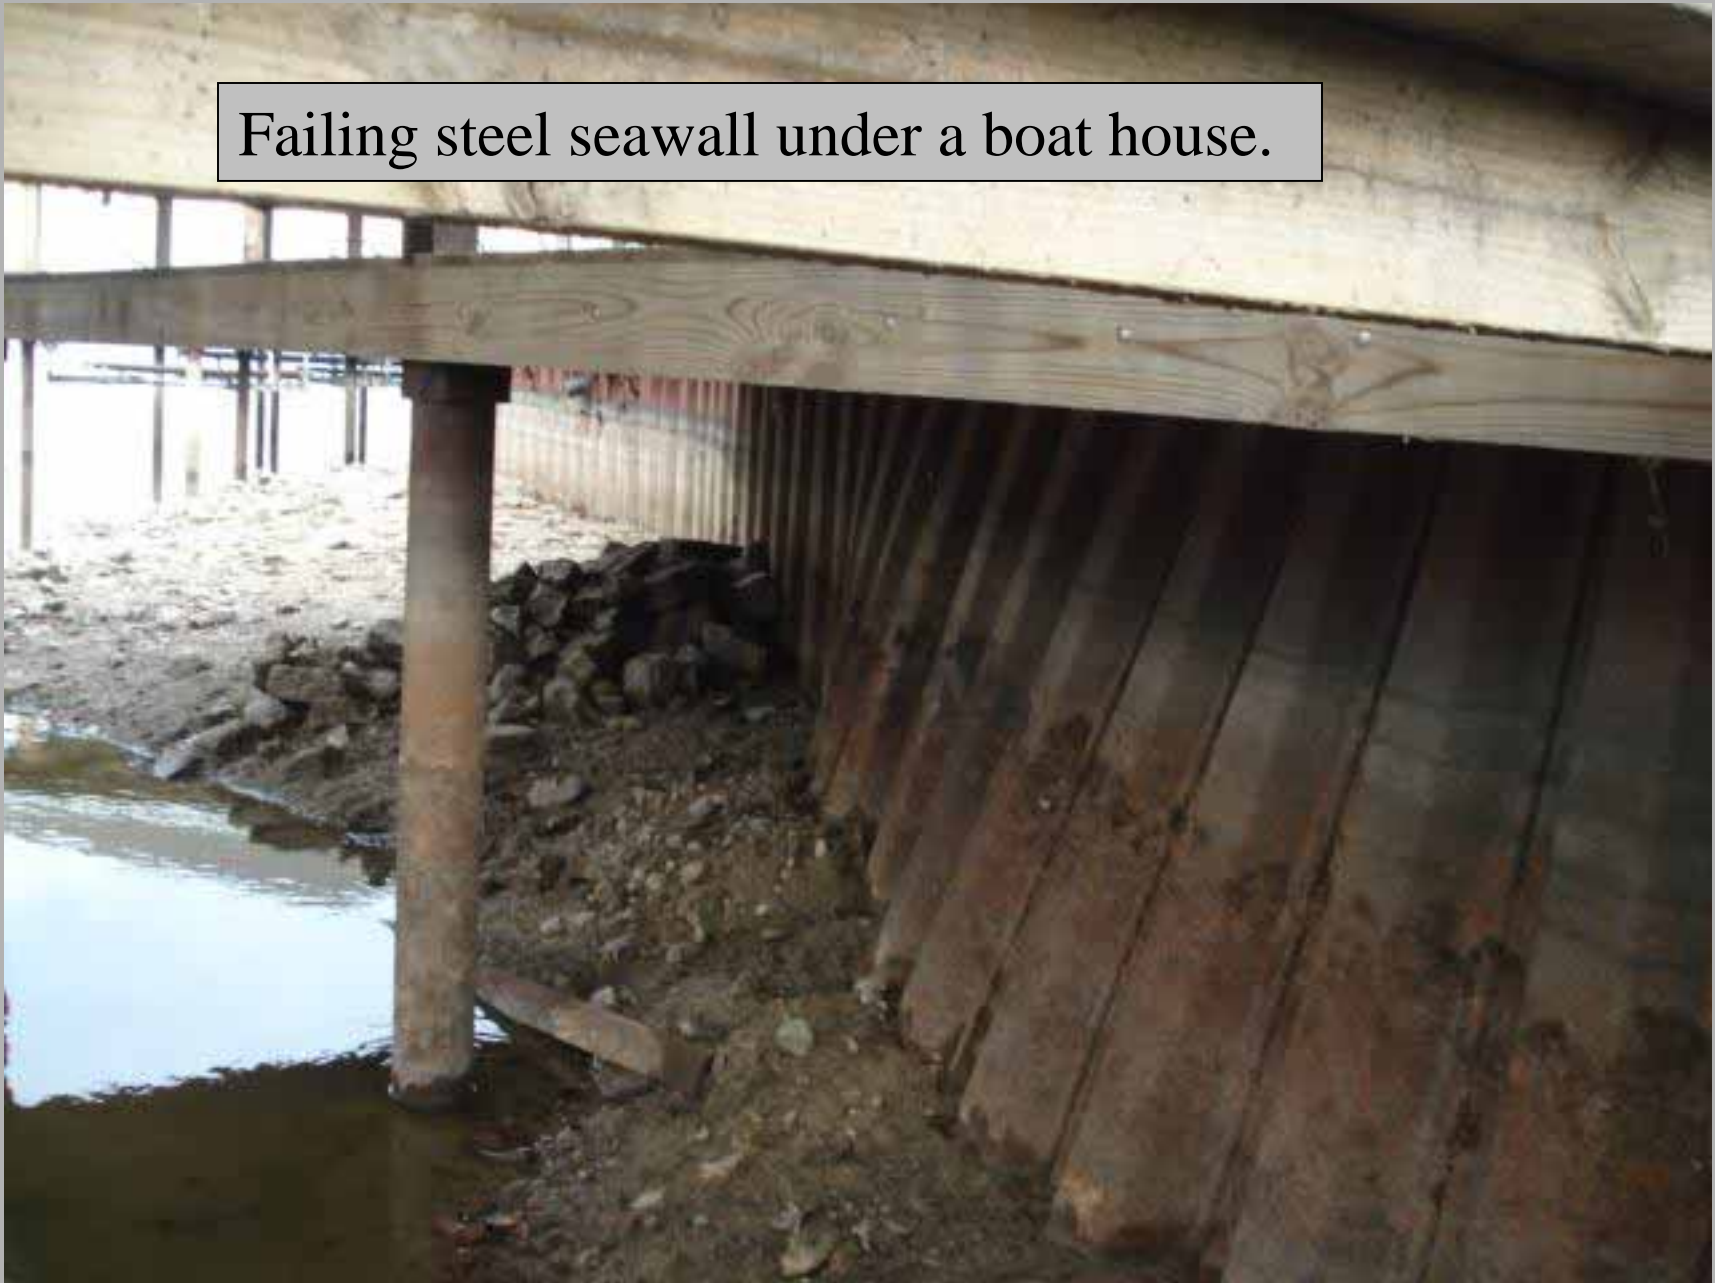
Failing steel seawall under a boat house.

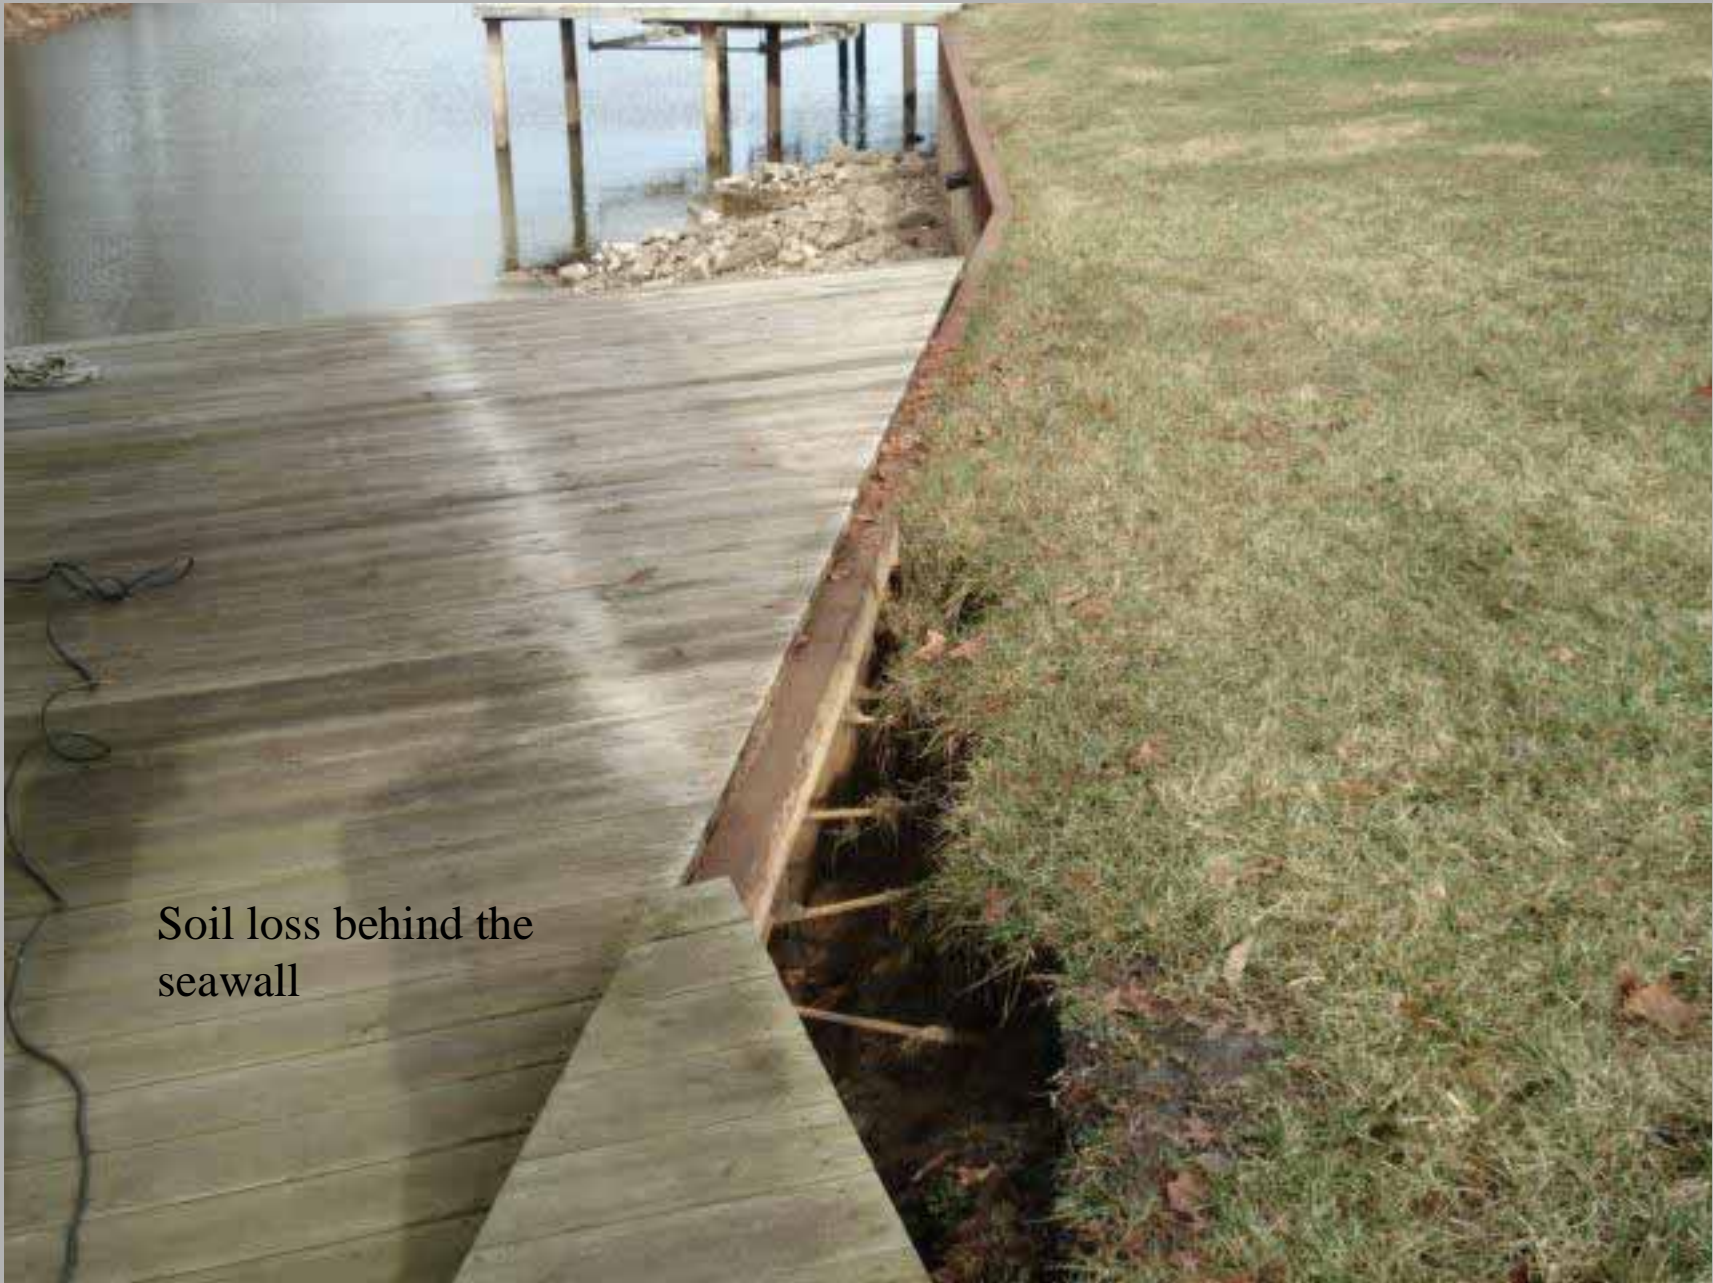
Soil loss behind the seawall

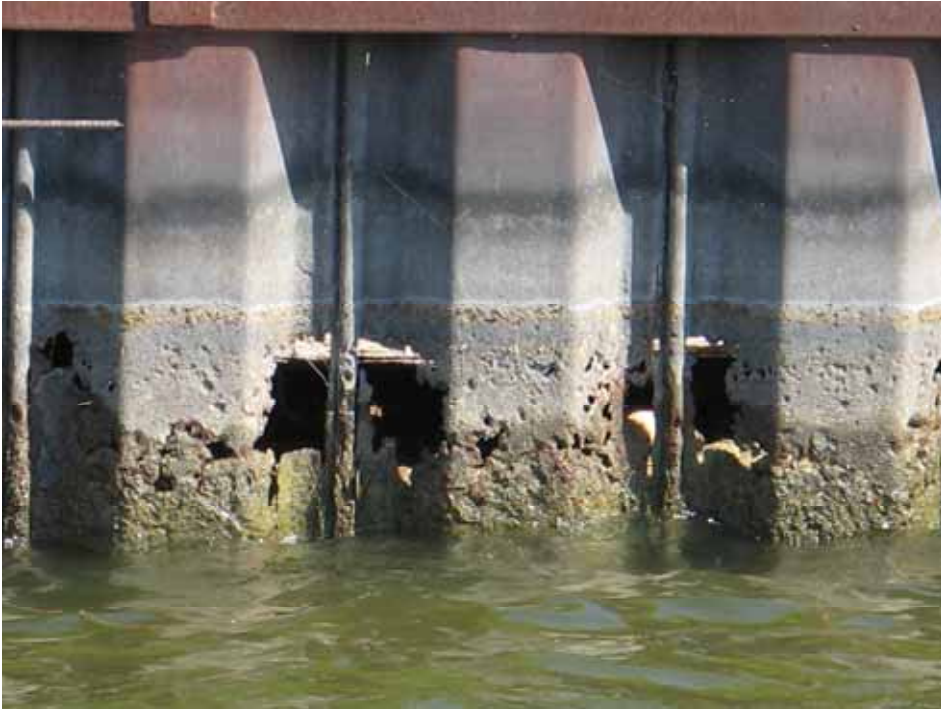
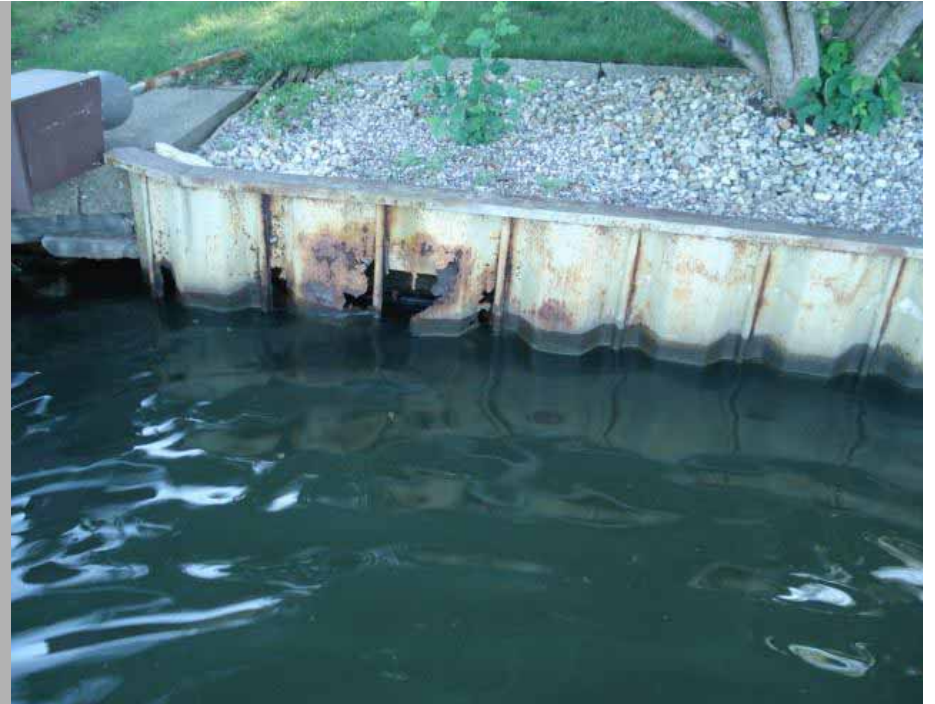
Rusted steel seawalls can be restored by an application of riprap in front of the wall.

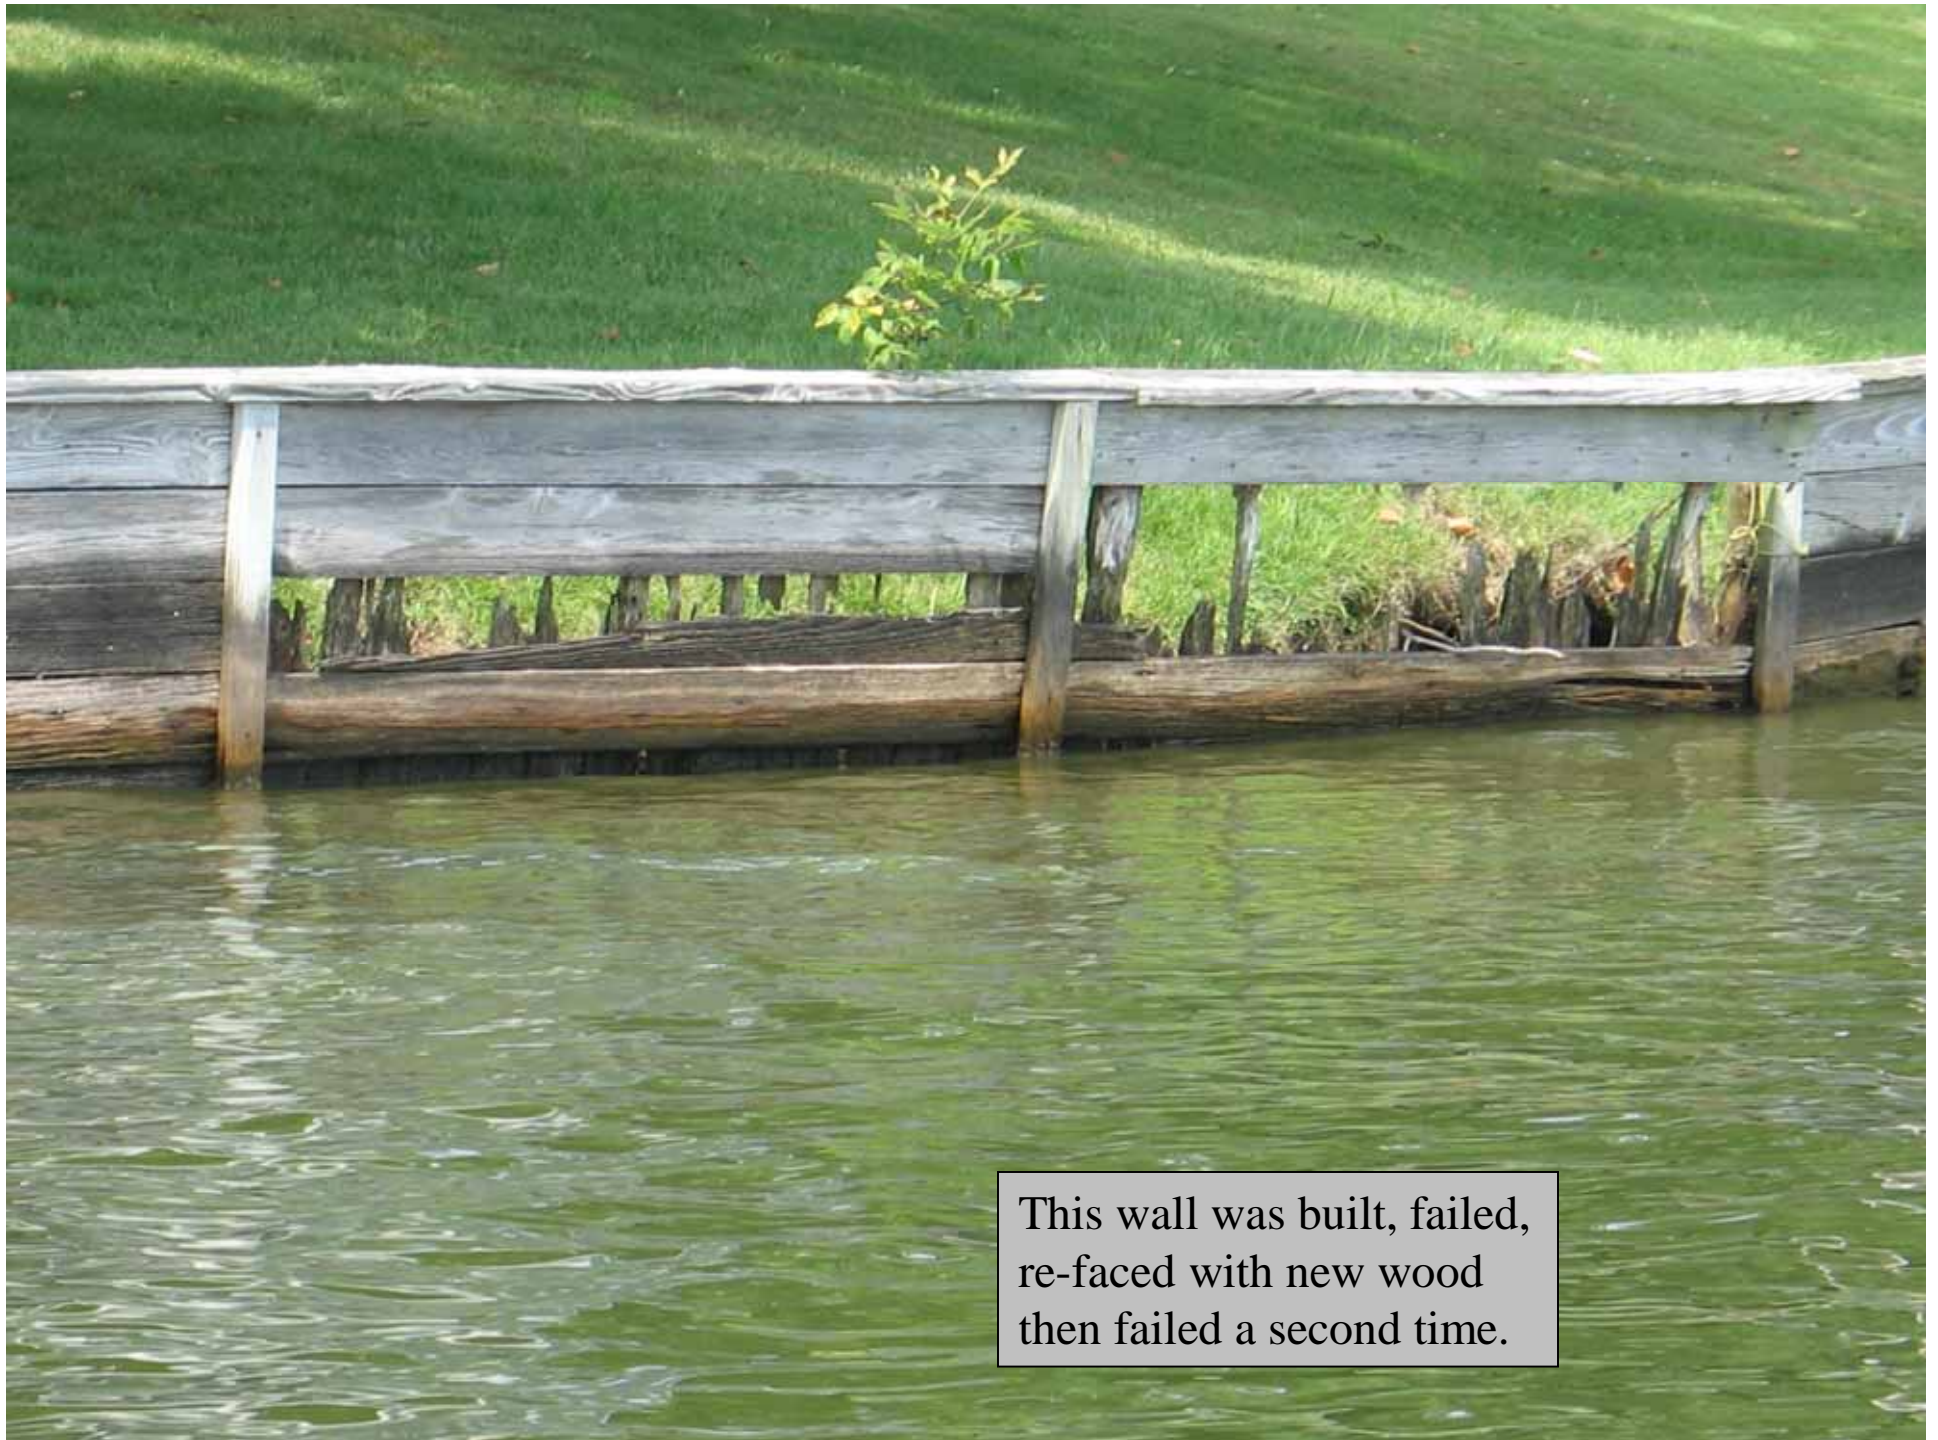
This wall was built, failed, re-faced with new wood then failed a second time.

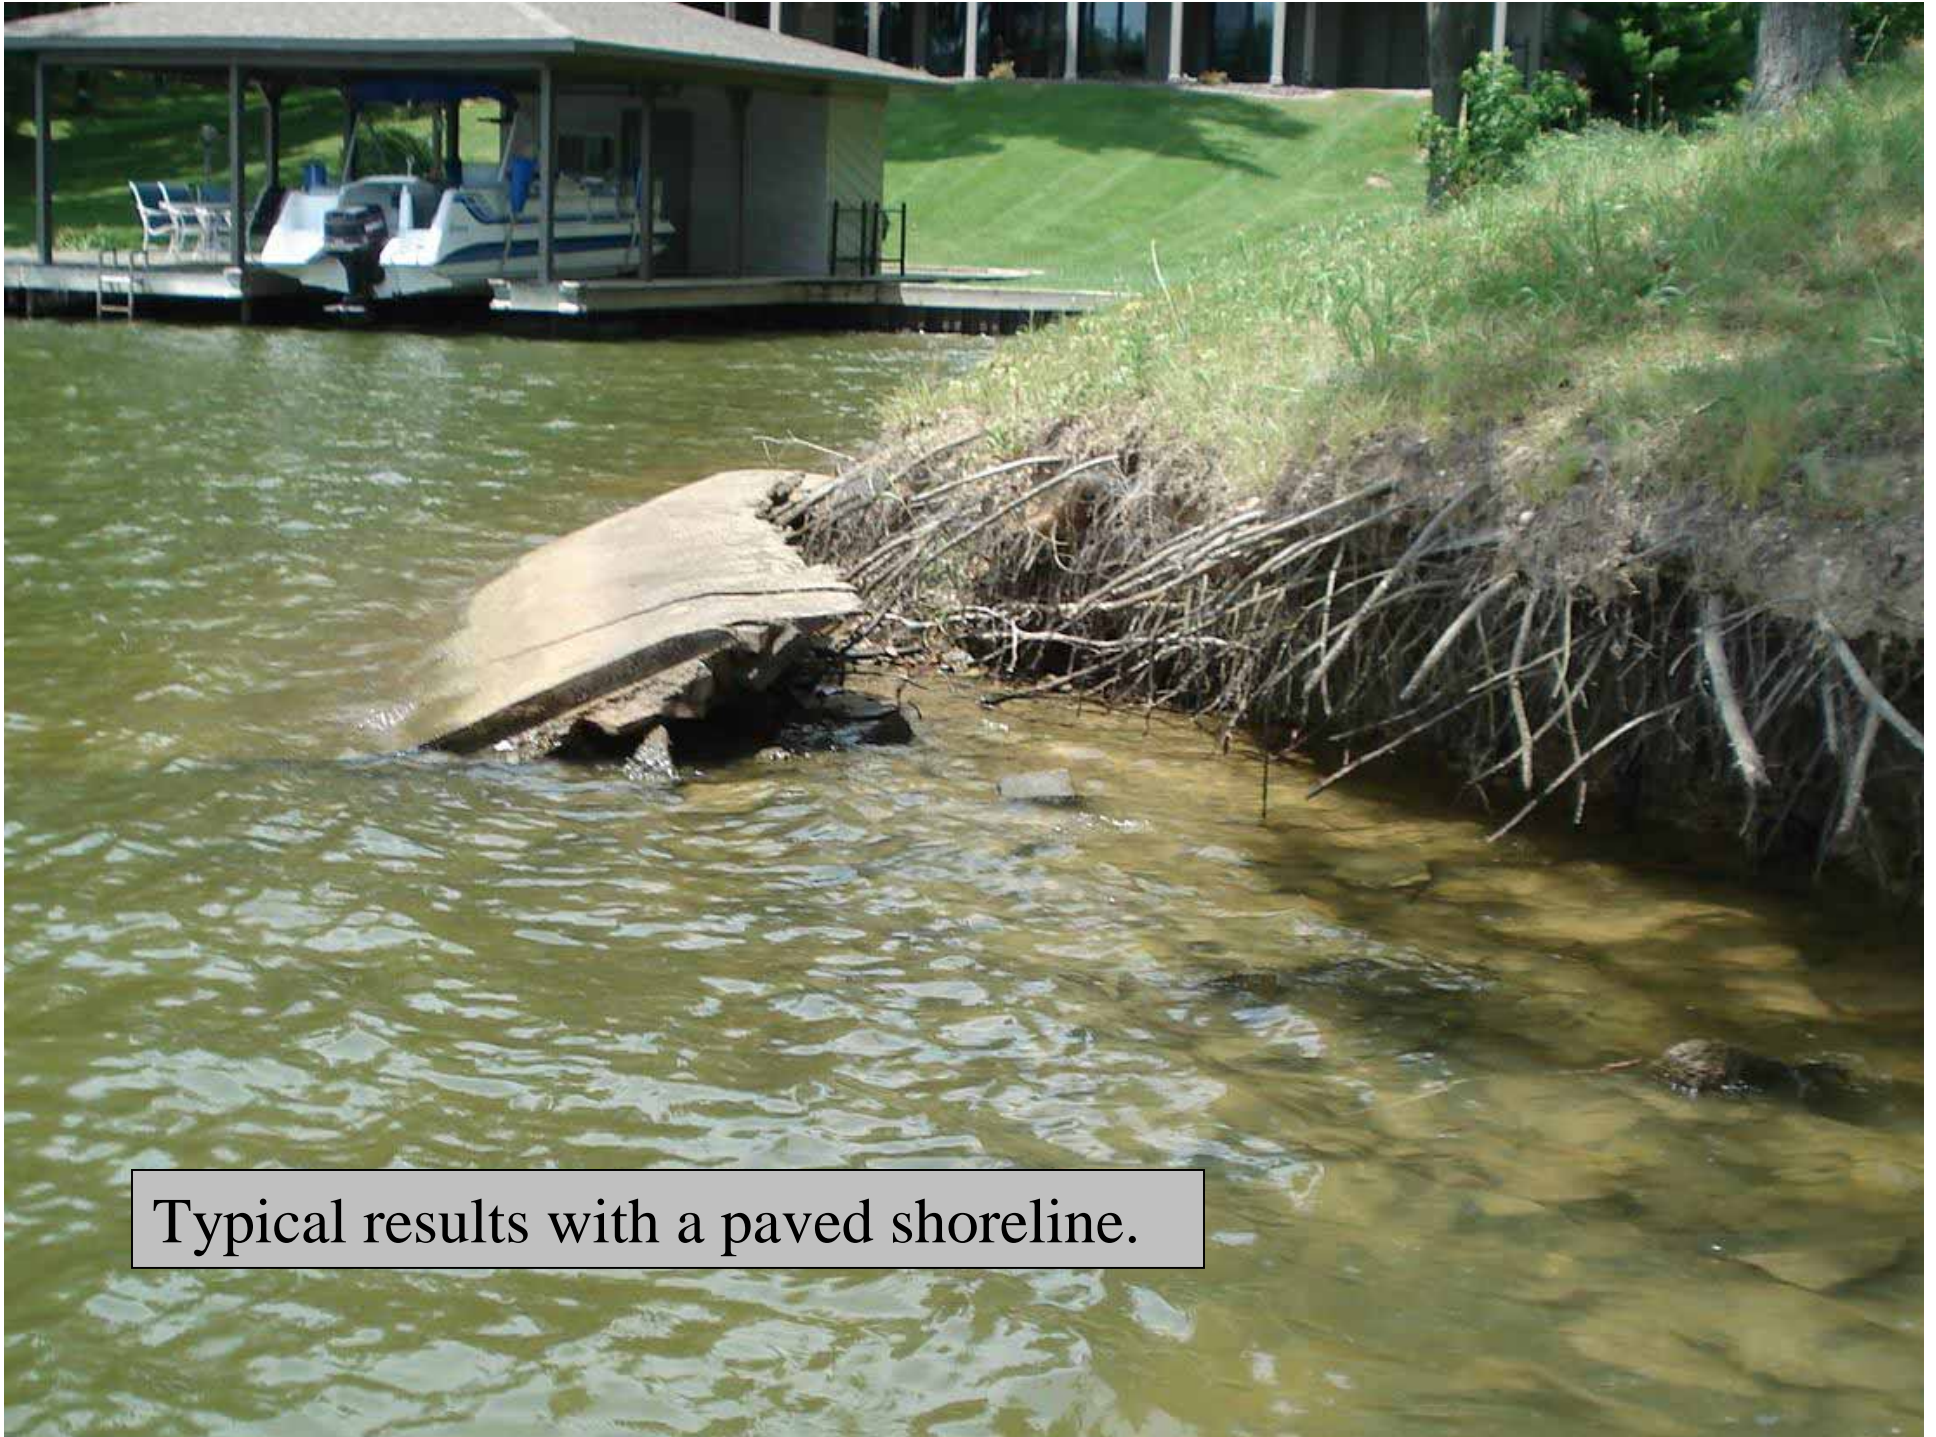
Typical results with a paved shoreline.
