Lake Rip Rap, Inc.

2010 Illinois Lake Management Convention

“Erosion Control for Residential Shorelines”

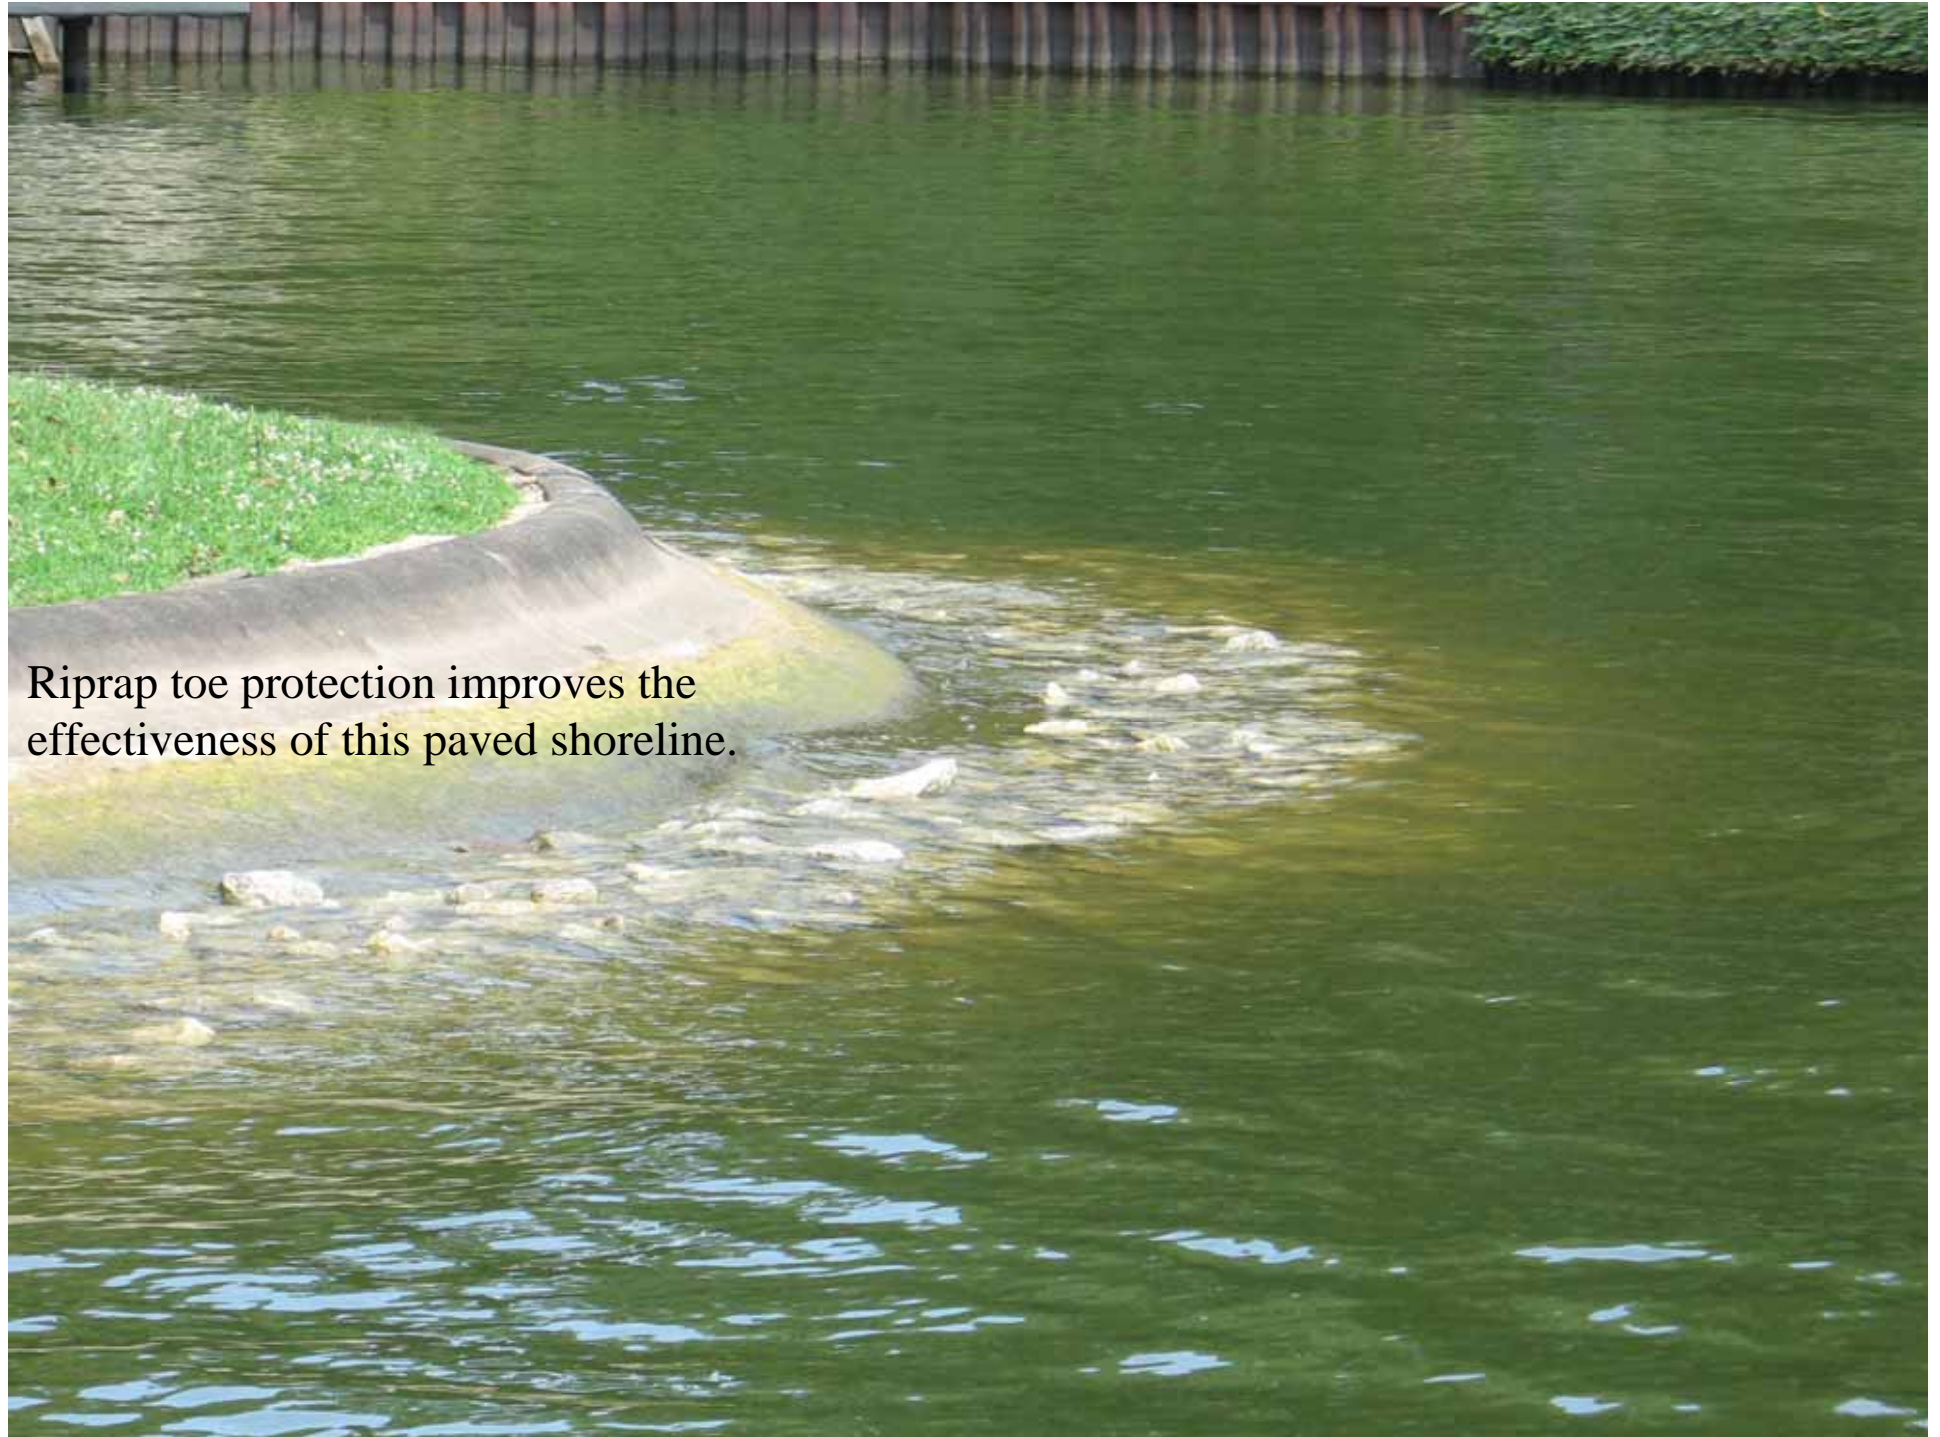
Riprap toe protection improves the effectiveness of this paved shoreline.

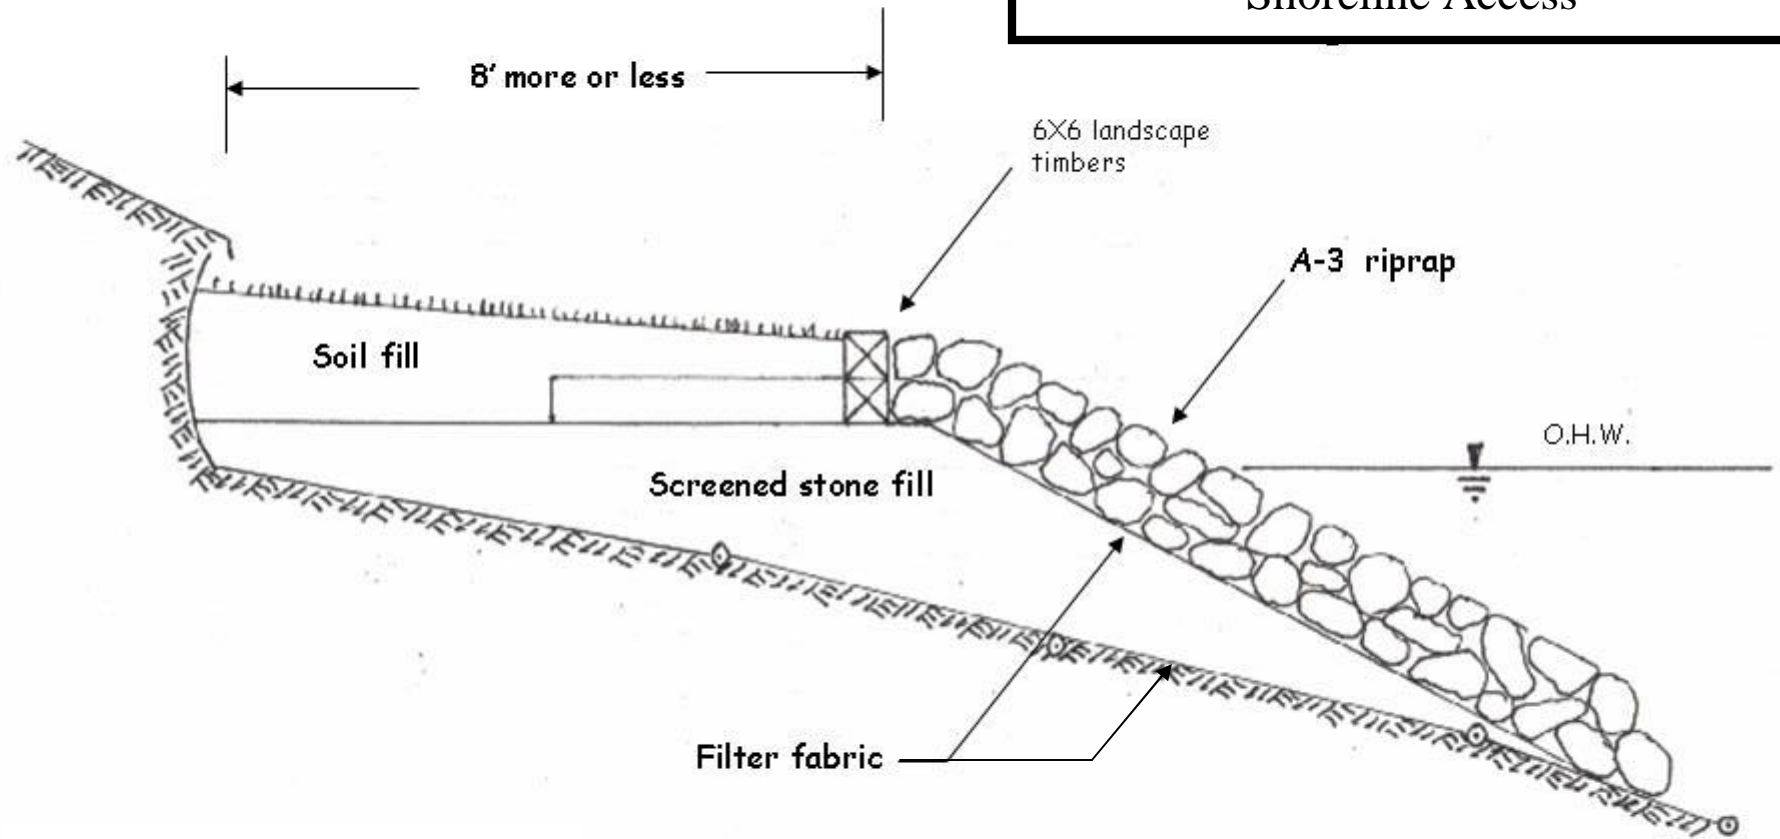
Typical Section

A Seawall Alternative

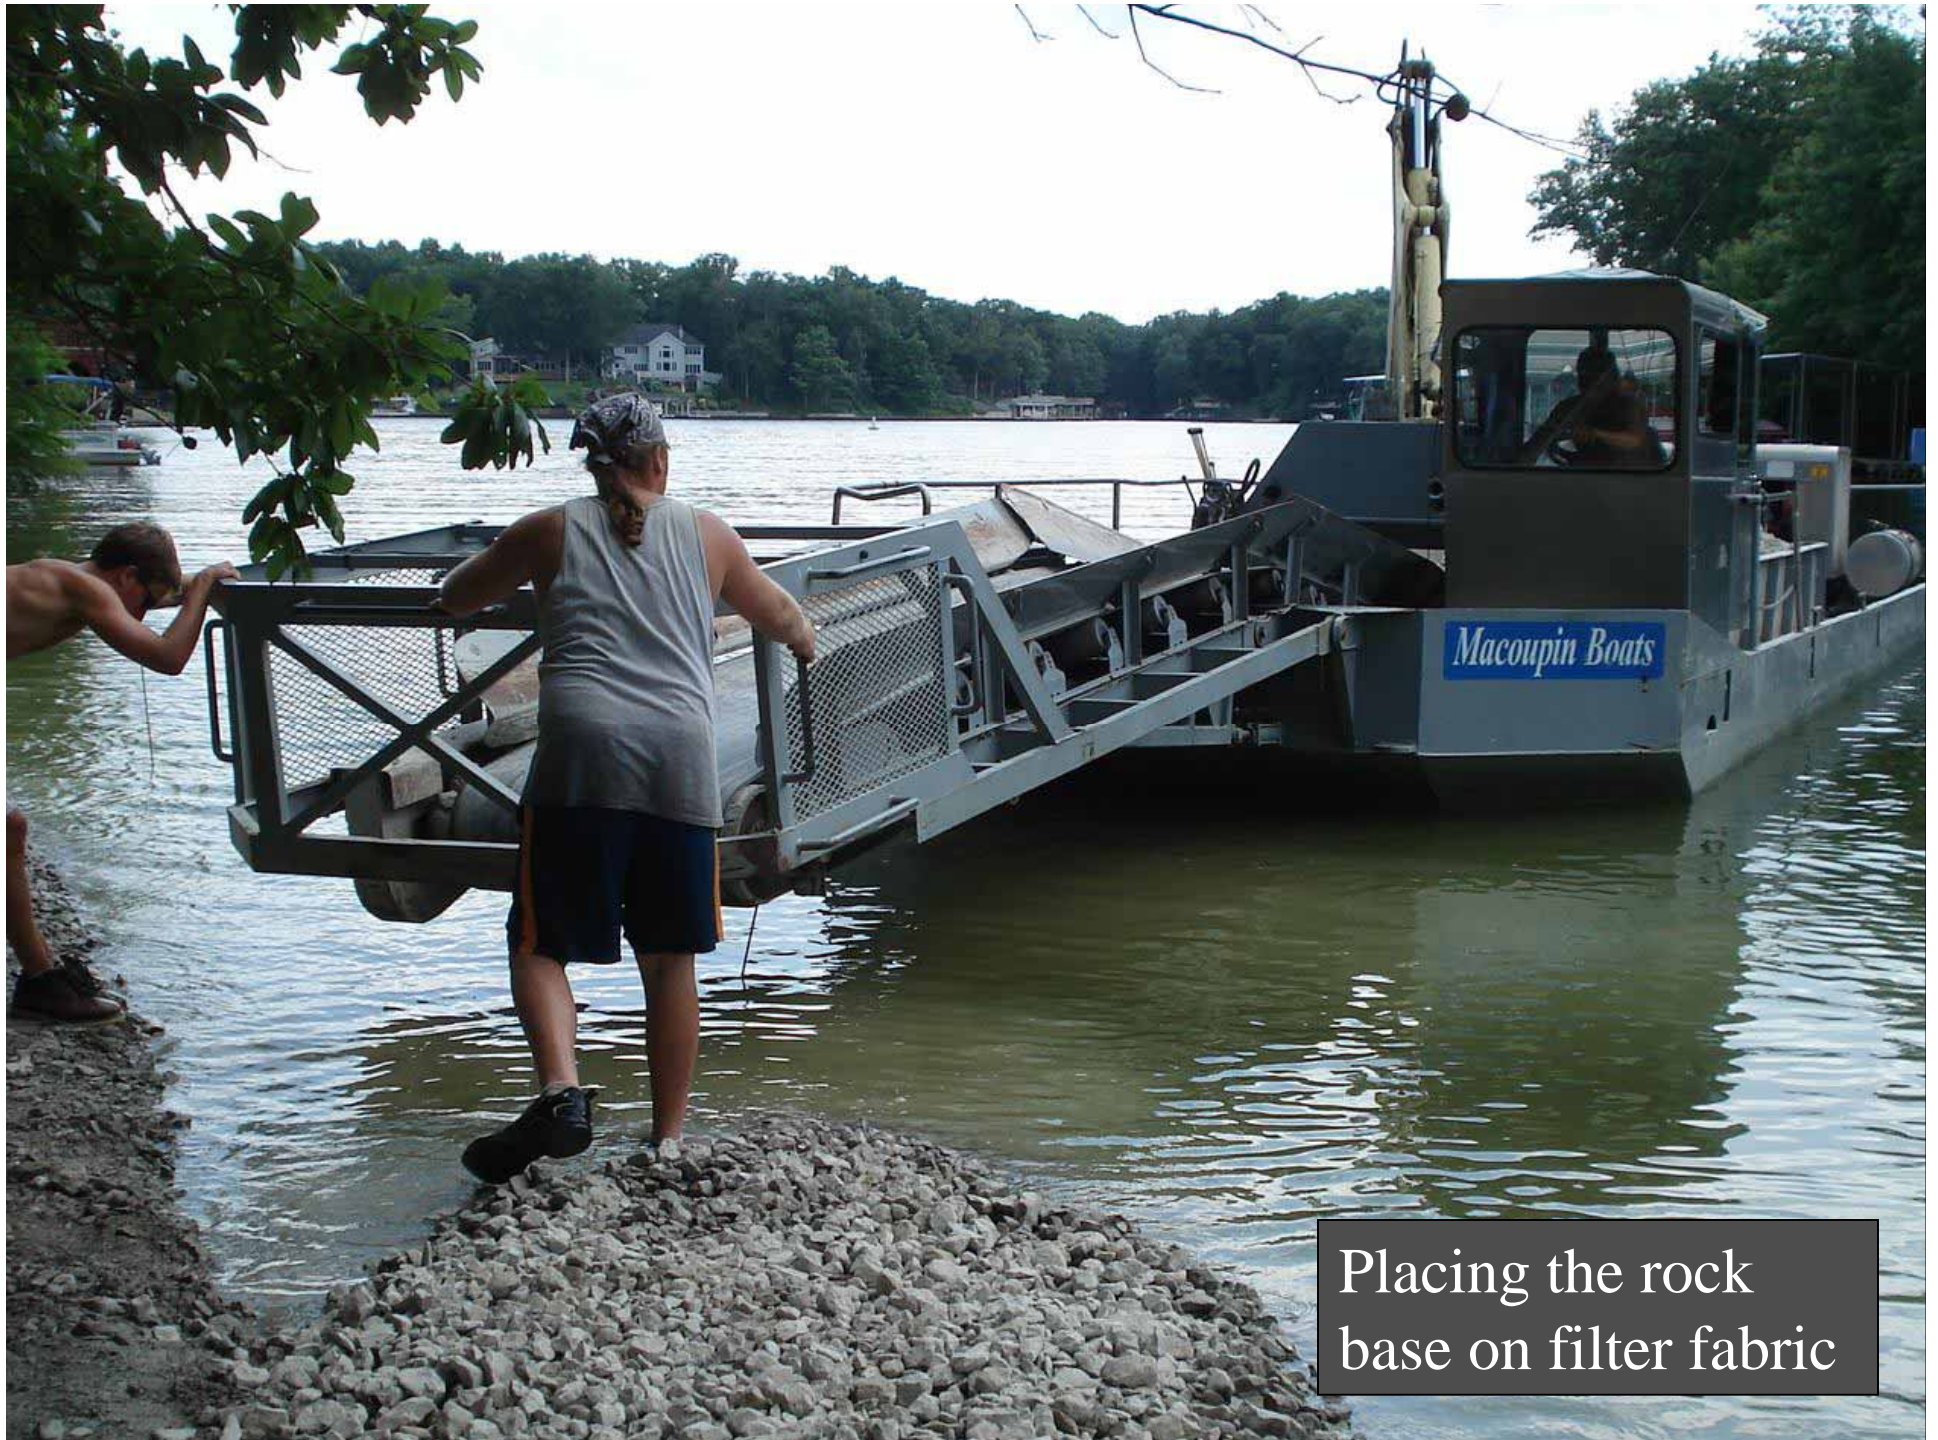
Placing the rock base on filter fabric

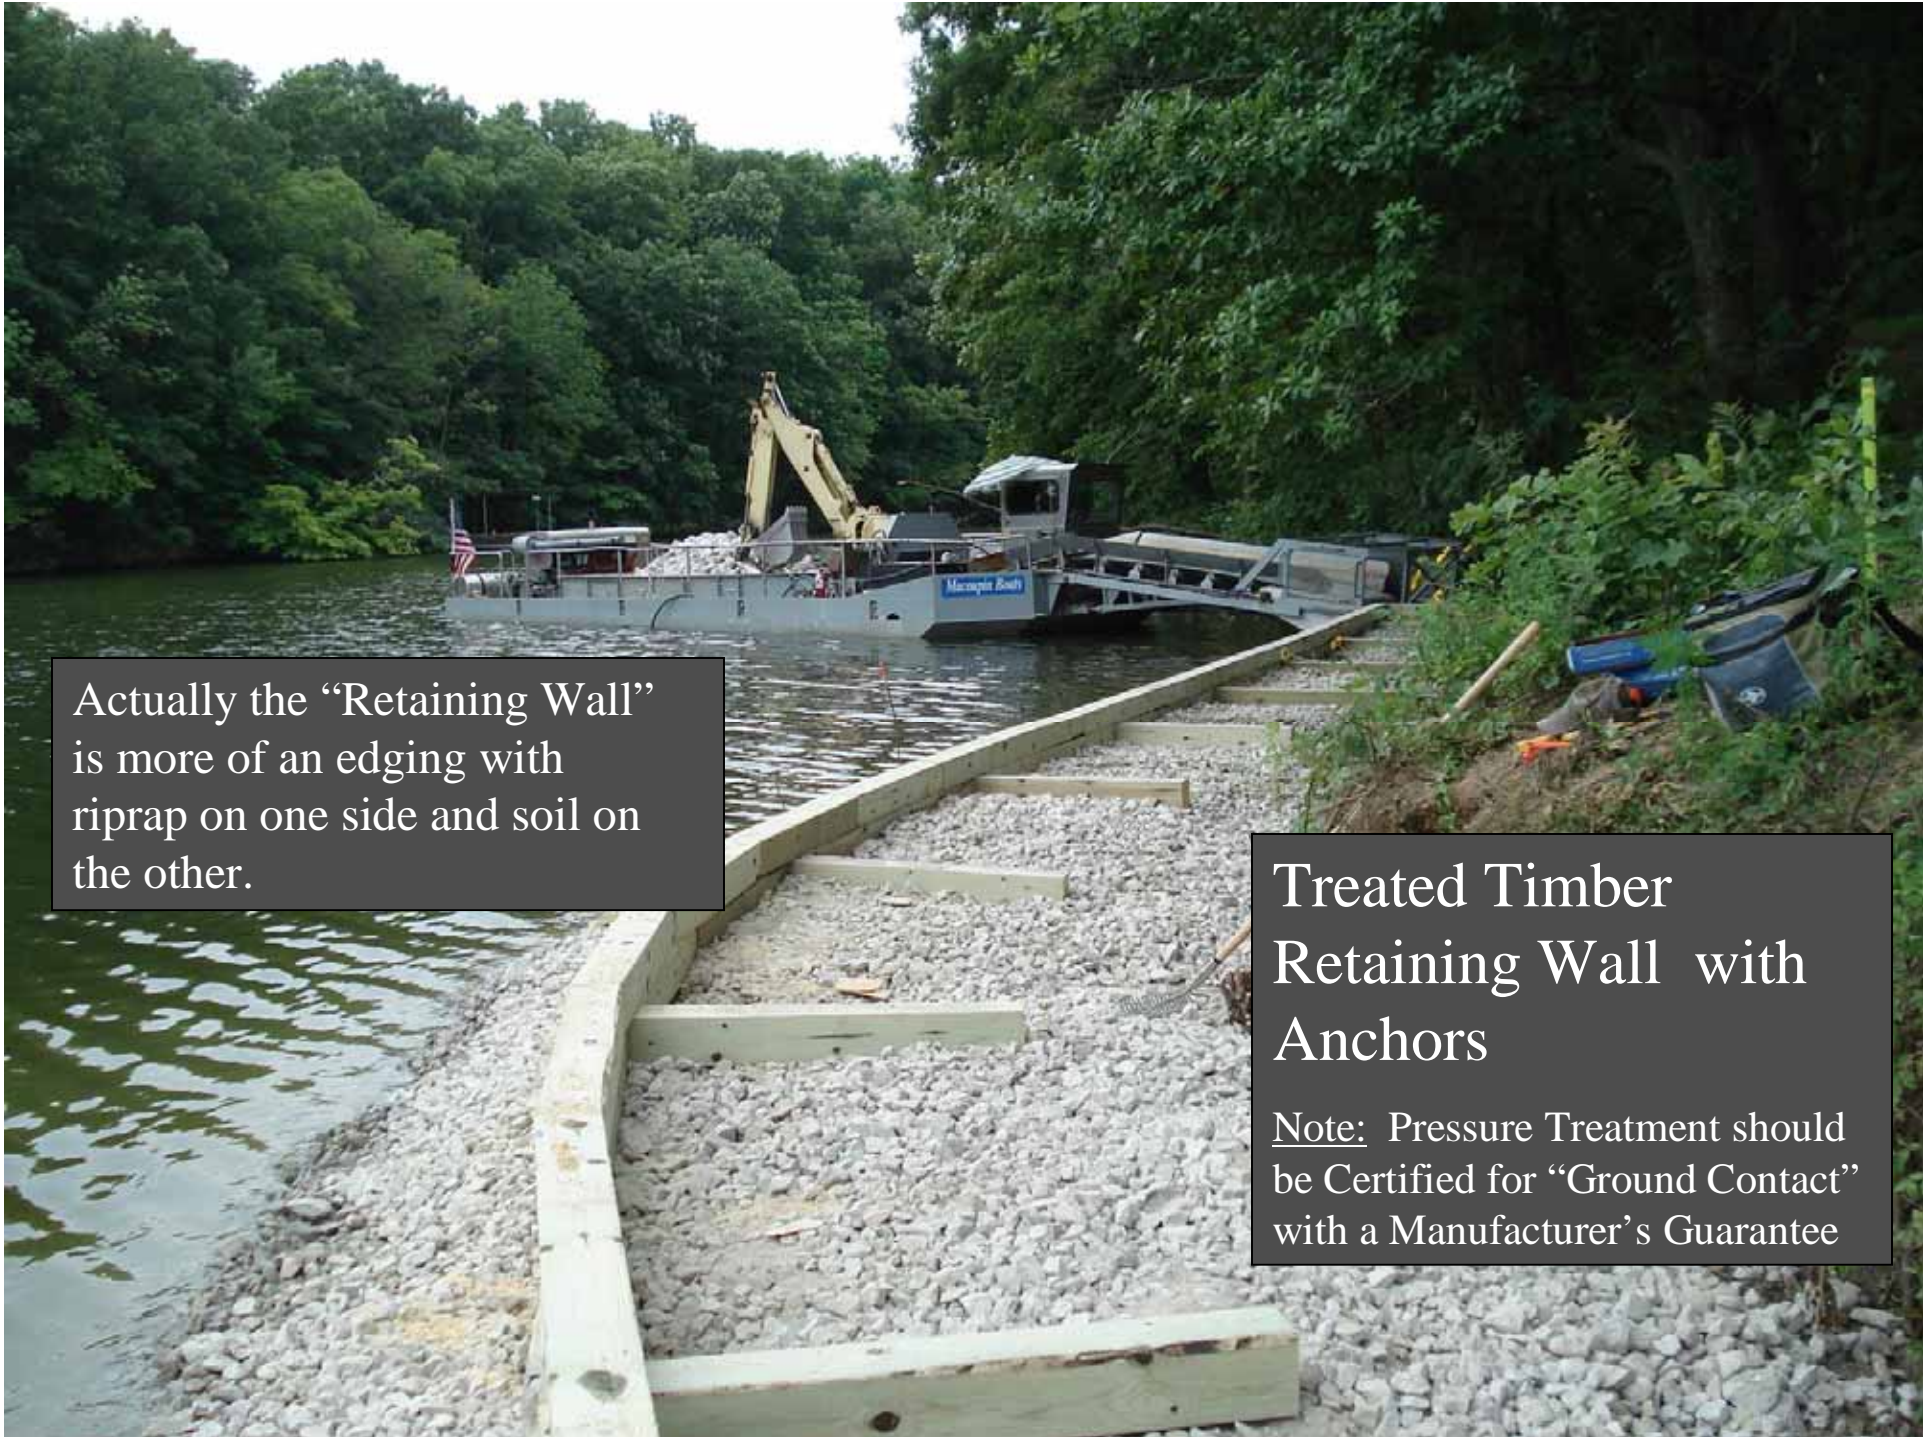
Actually the “Retaining Wall” is more of an edging with riprap on one side and soil on the other.

Treated Timber Retaining Wall with Anchors

Note: Pressure Treatment should be Certified for “Ground Contact” with a Manufacturer’s Guarantee

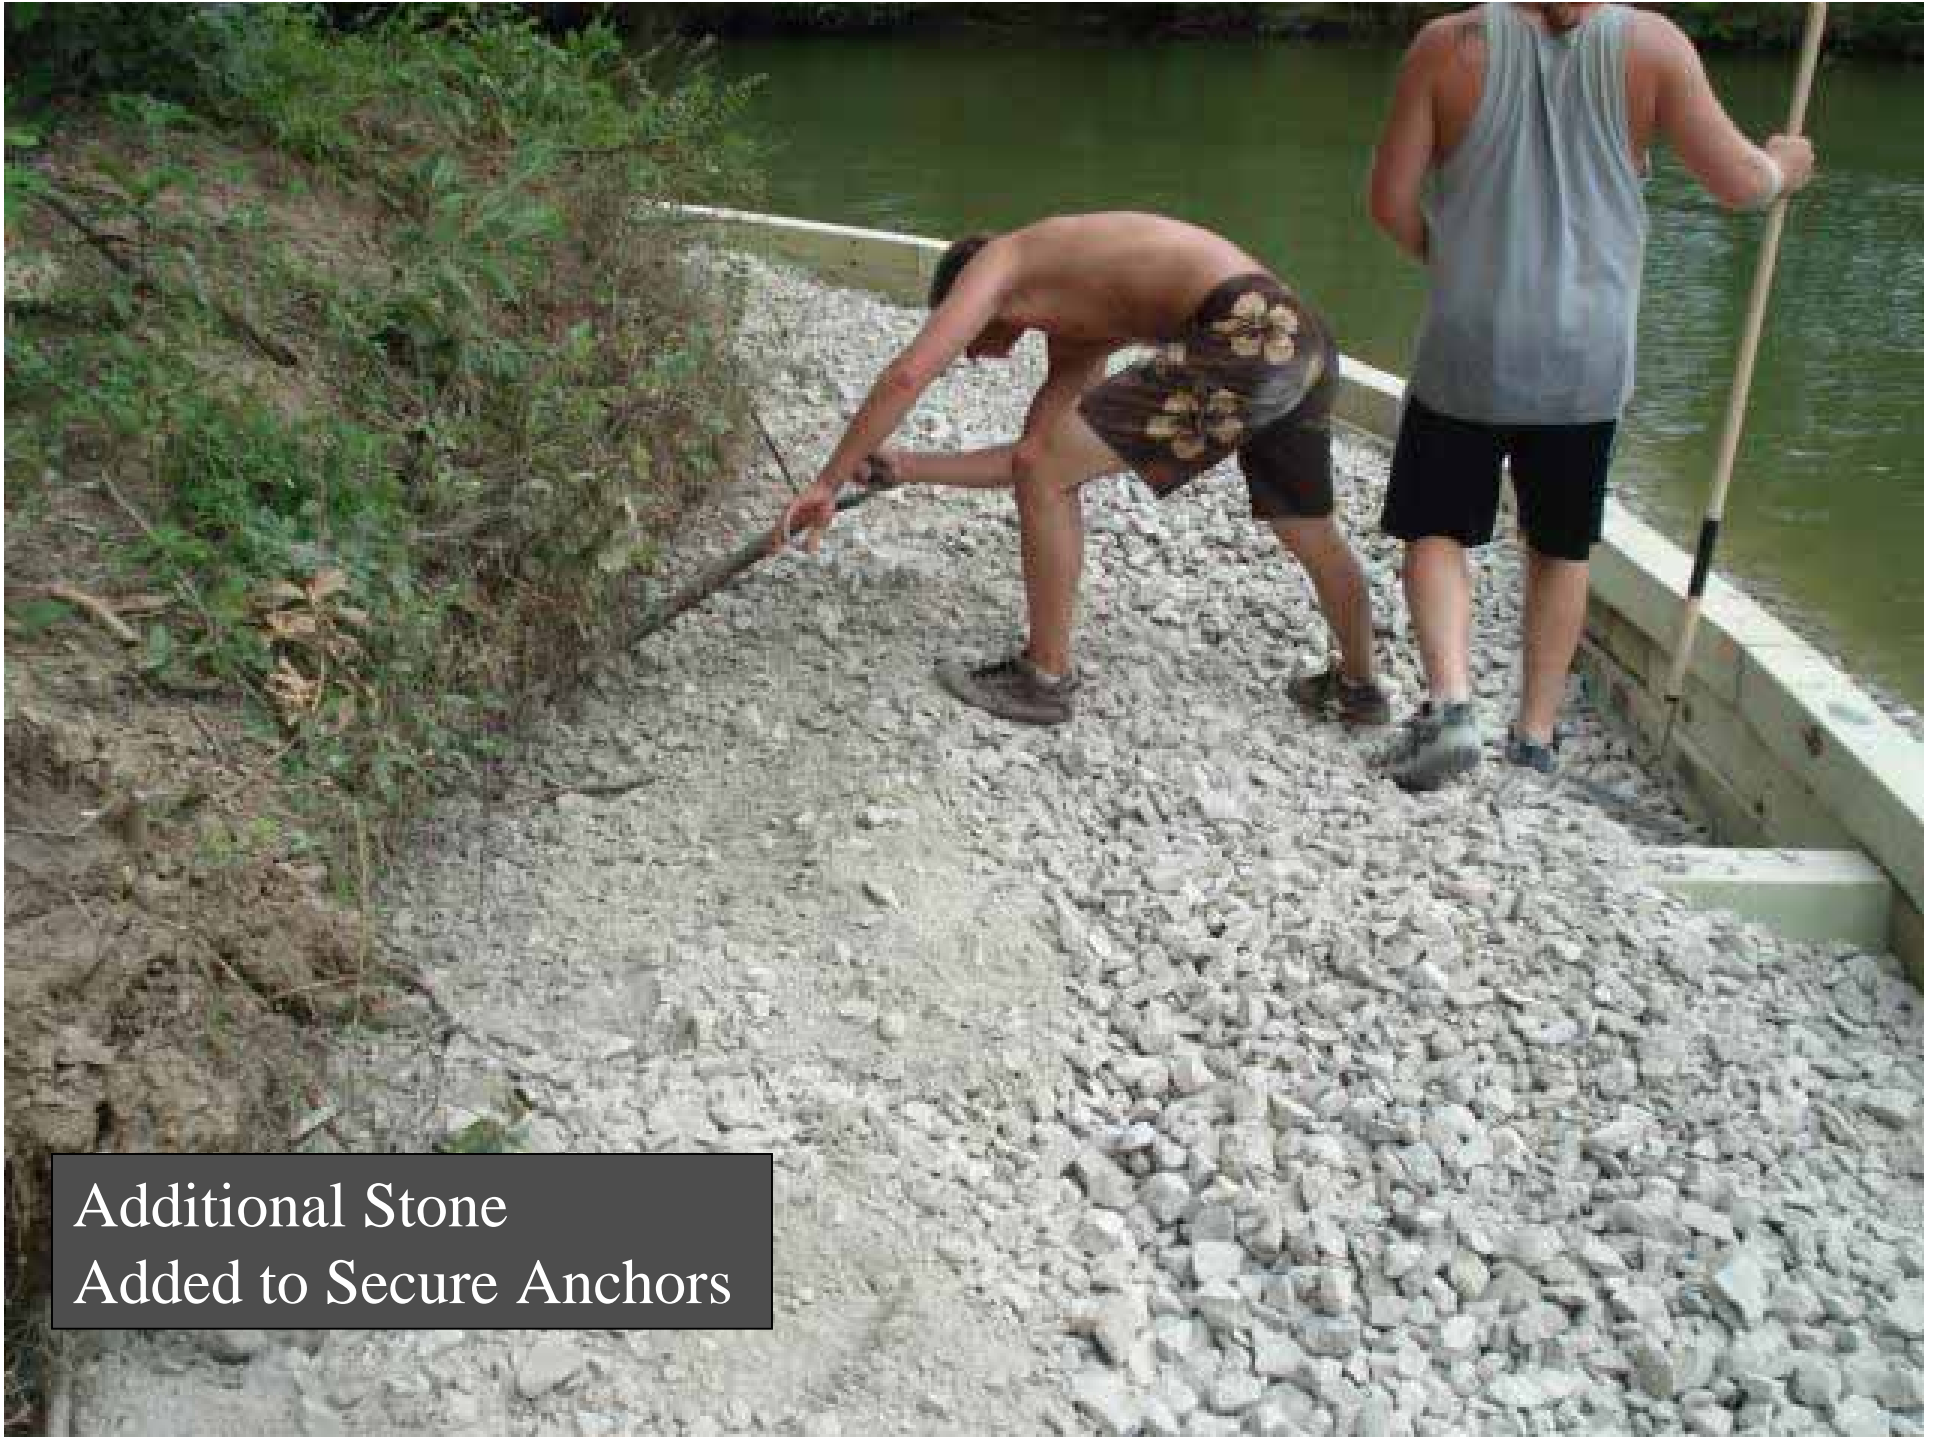
Additional Stone
Added to Secure Anchors

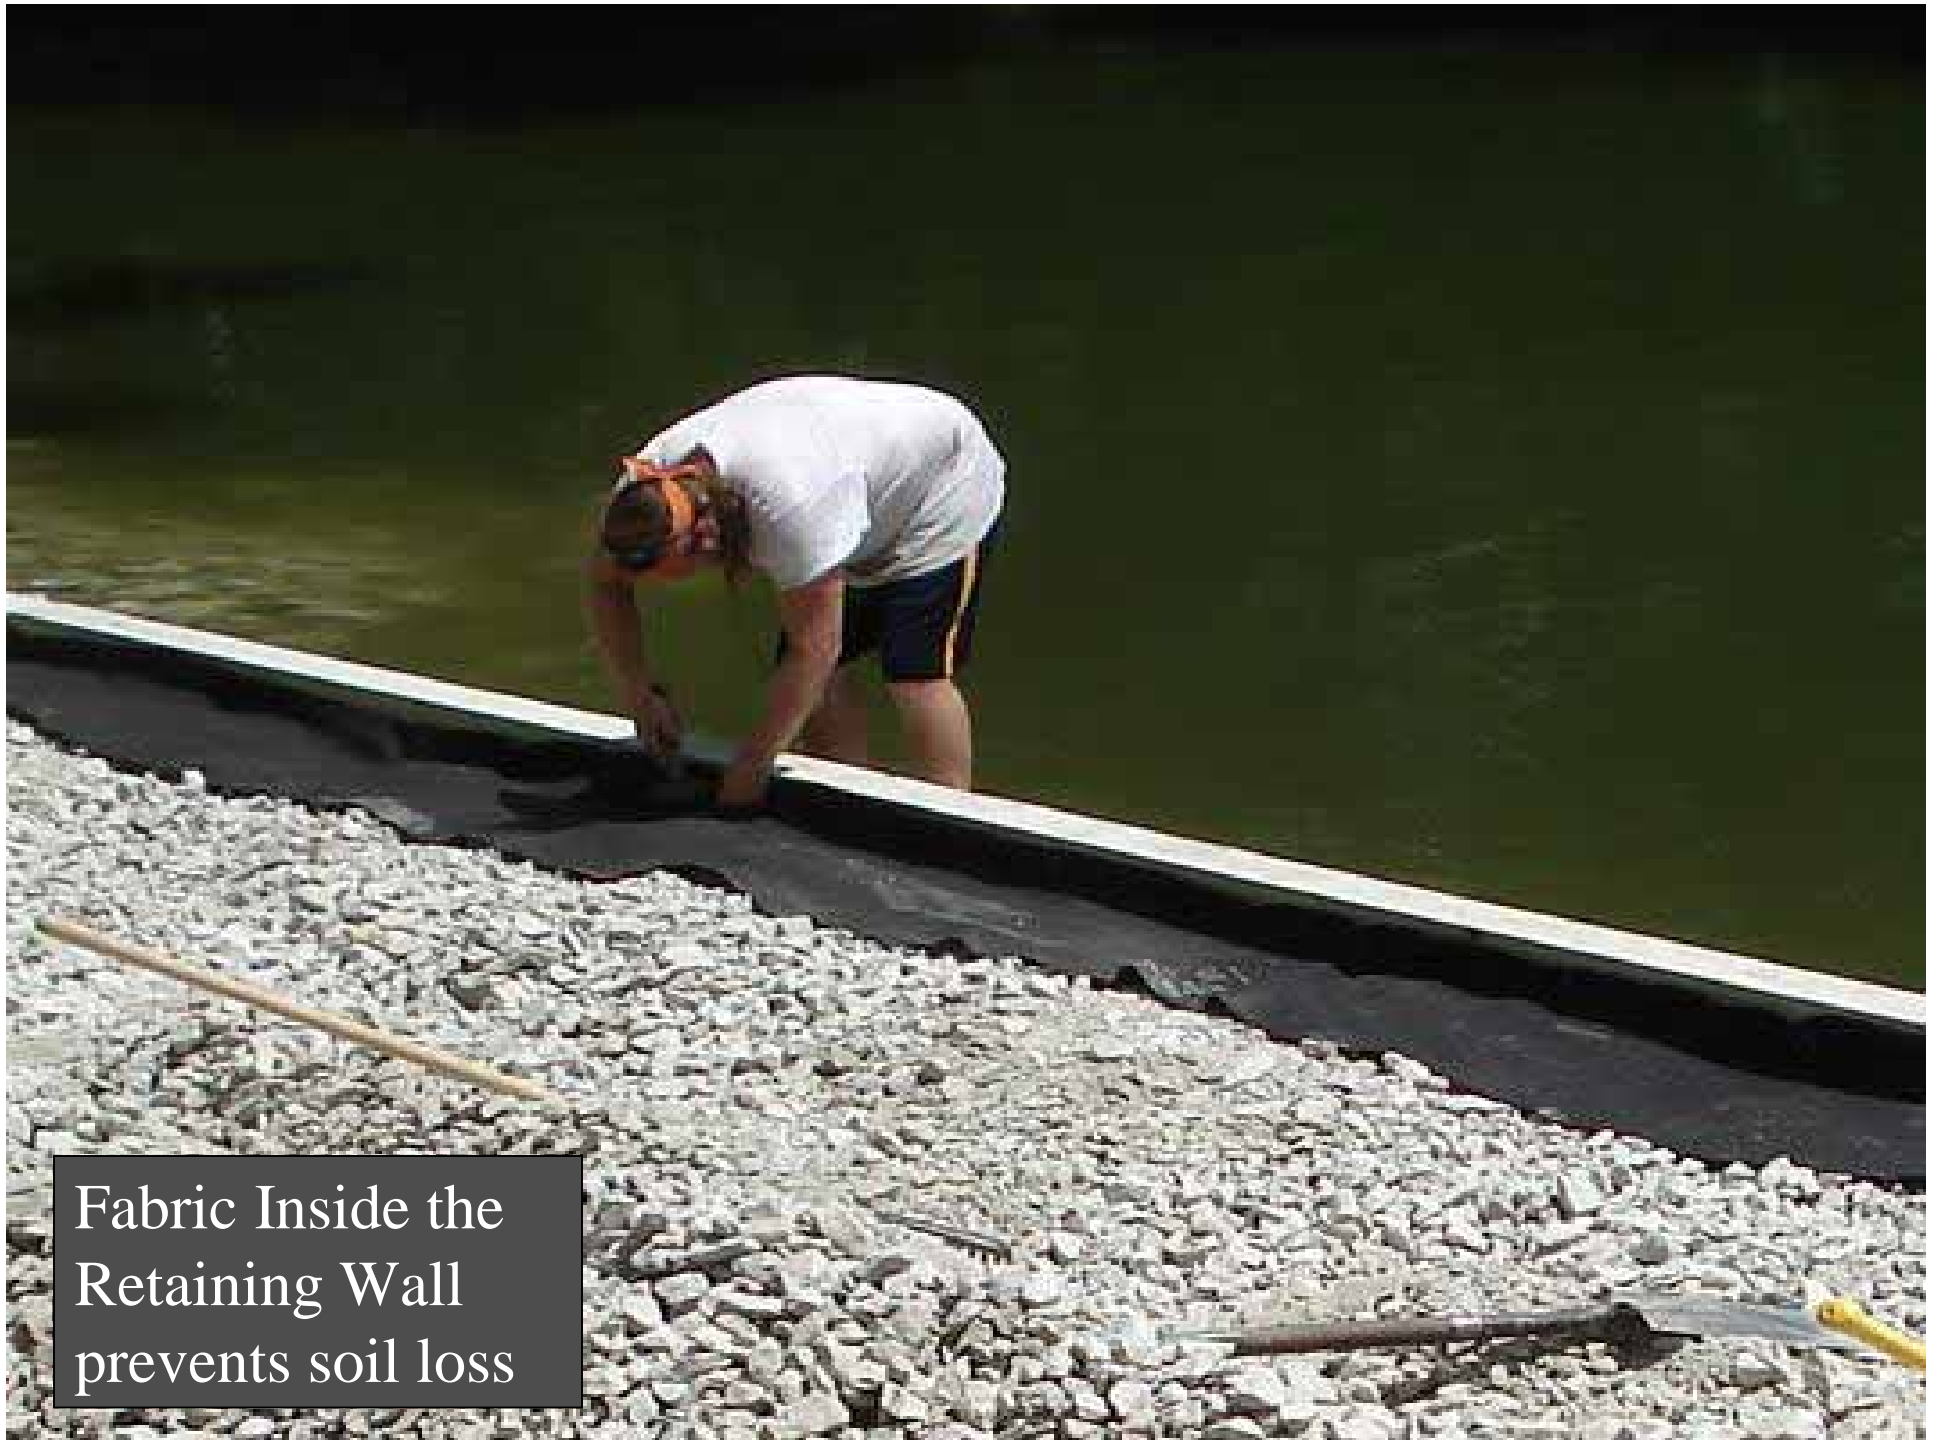
Fabric Inside the
Retaining Wall
prevents soil loss

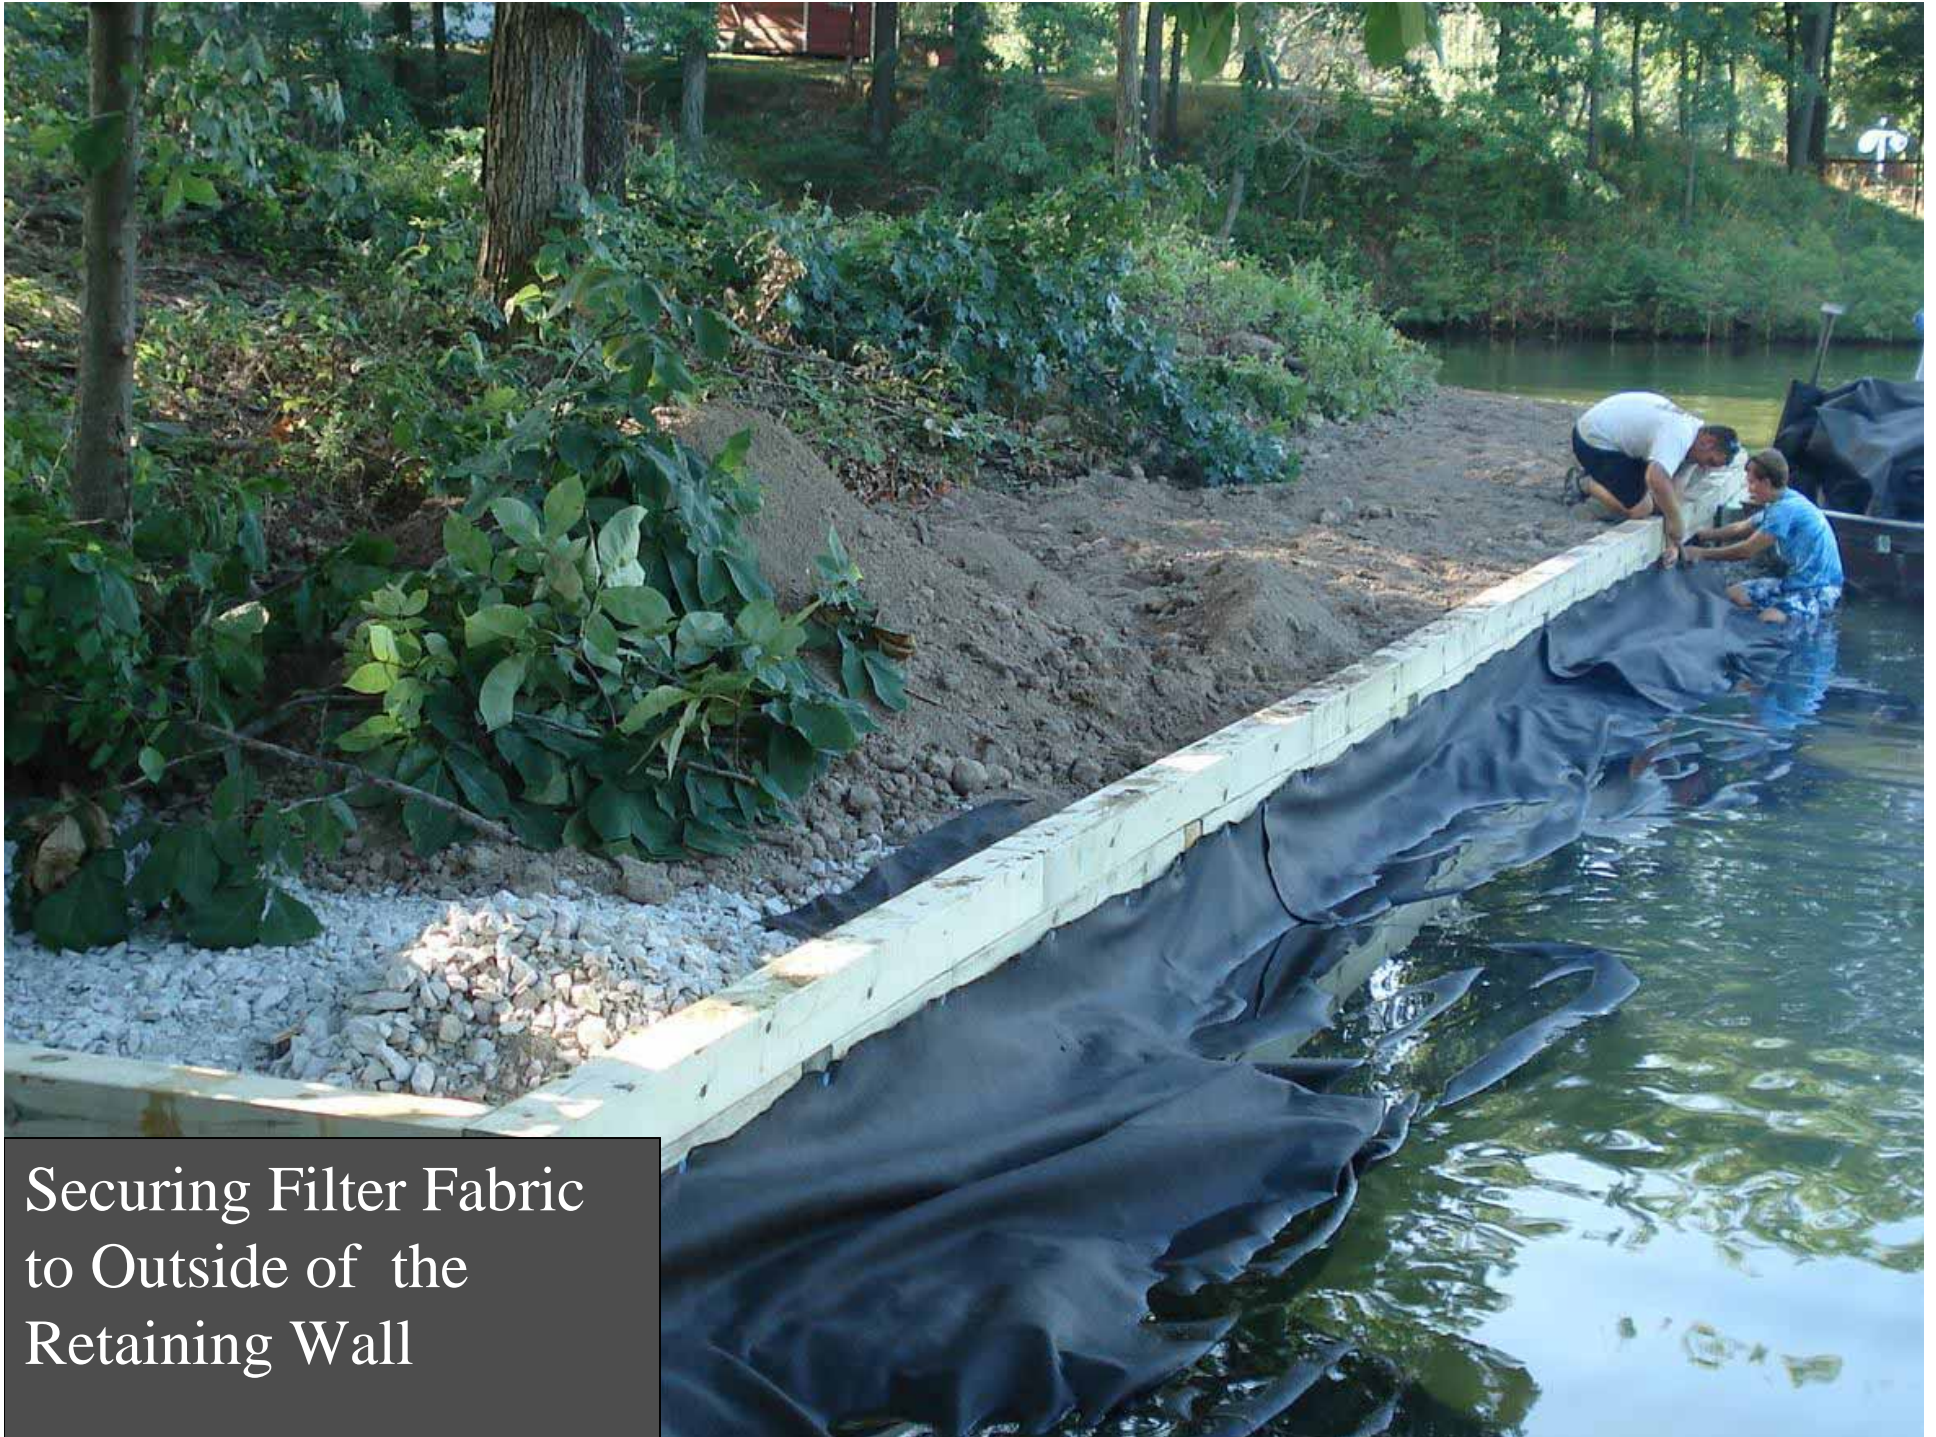
Securing Filter Fabric
to Outside of the
Retaining Wall

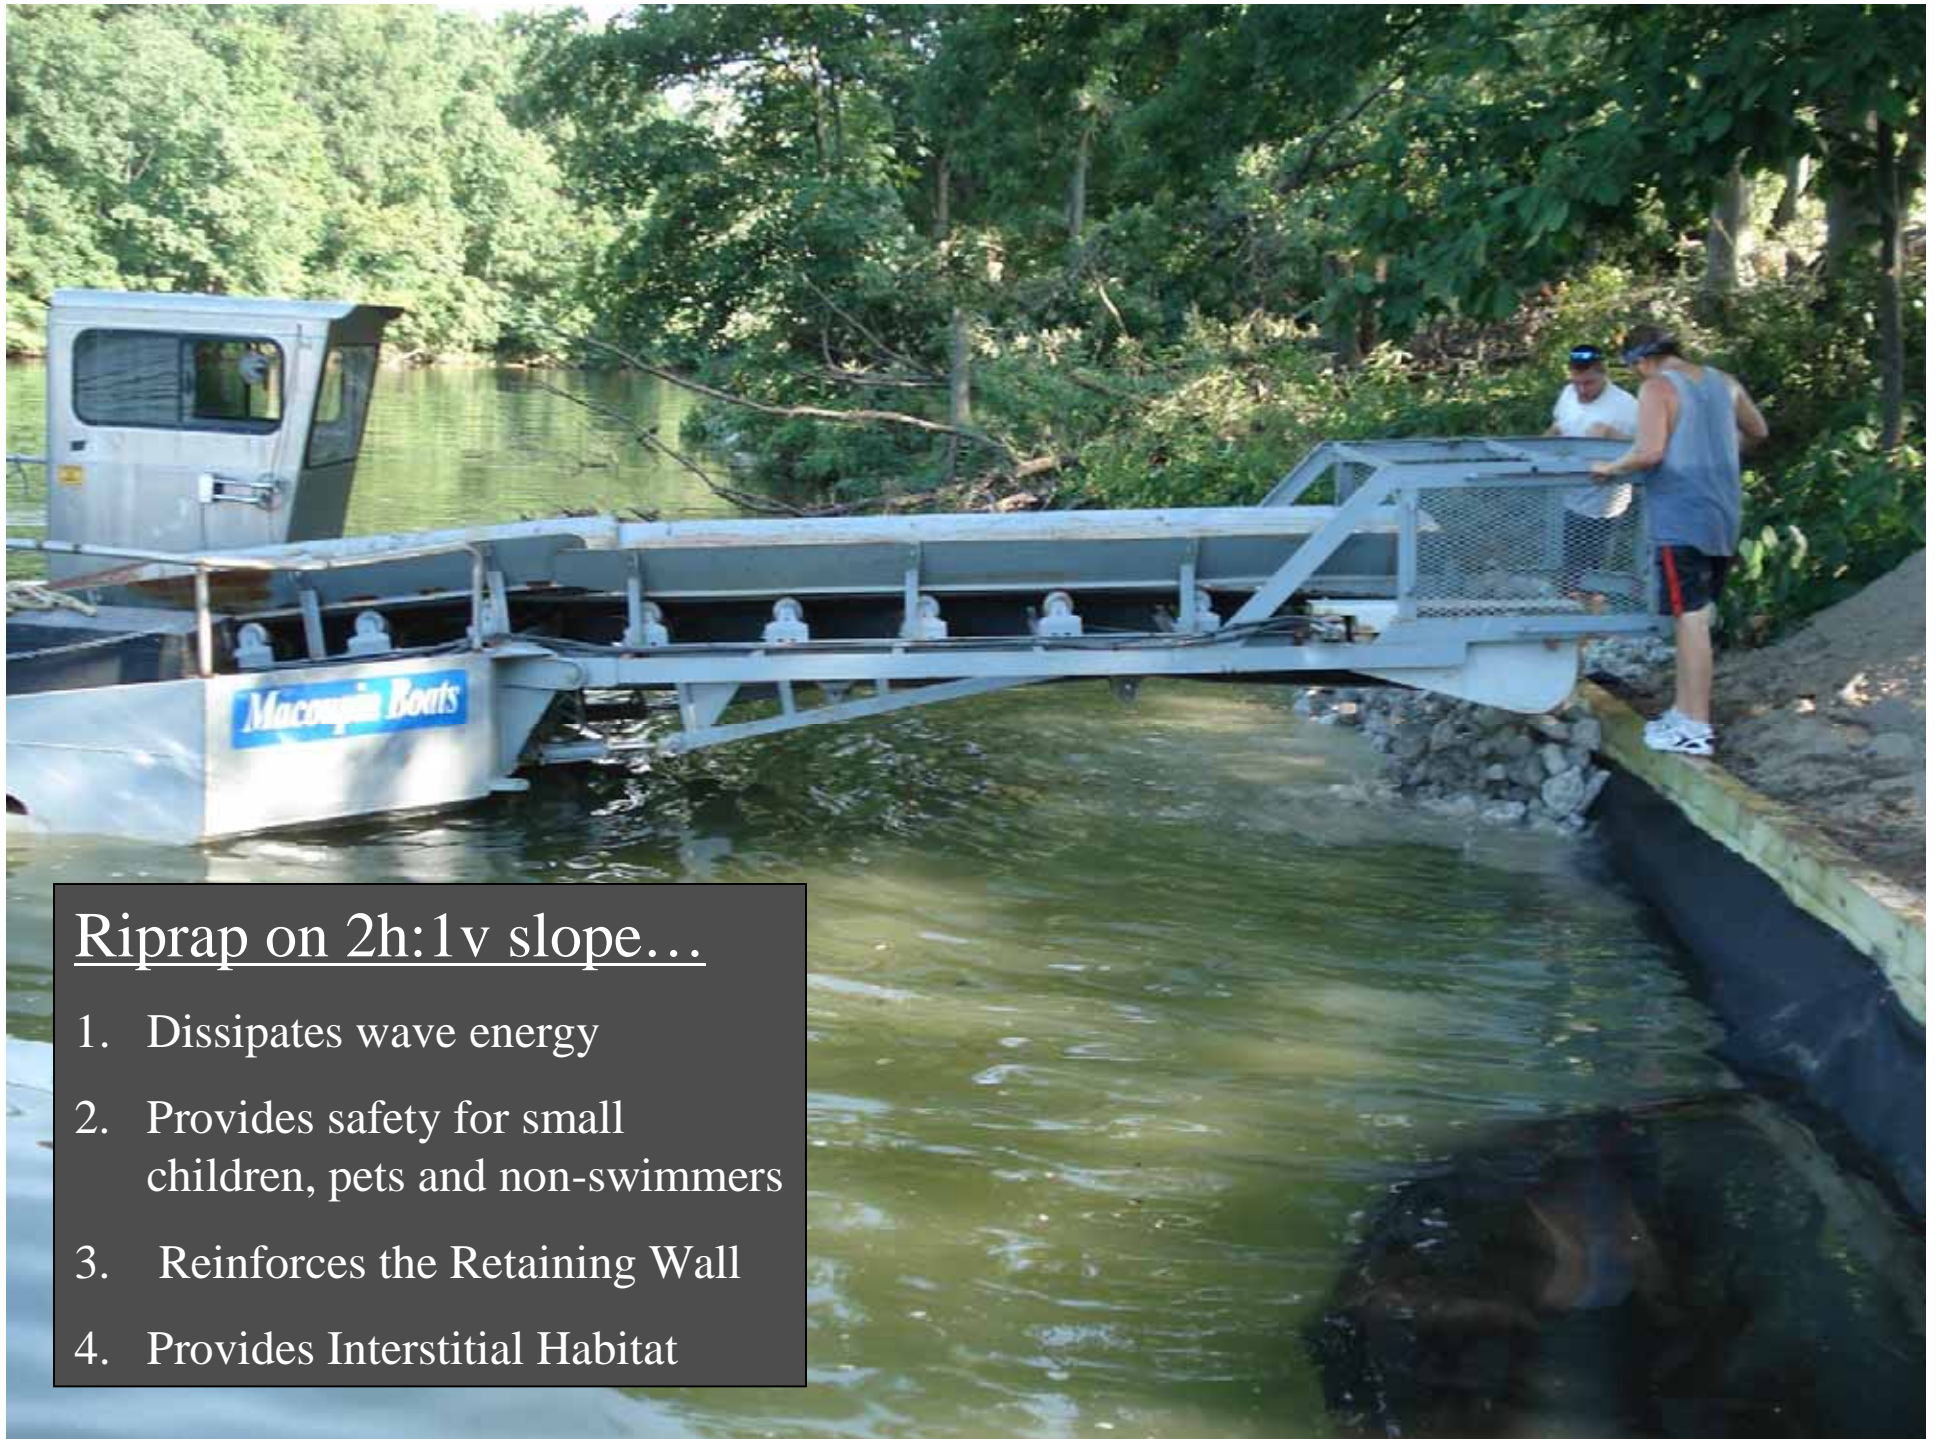
Riprap on 2h:1v slope...

1. Dissipates wave energy
2. Provides safety for small children, pets and non-swimmers
3. Reinforces the Retaining Wall
4. Provides Interstitial Habitat
