Lake Rip Rap, Inc.

2010 Illinois Lake Management Convention

“Erosion Control for Residential Shorelines”

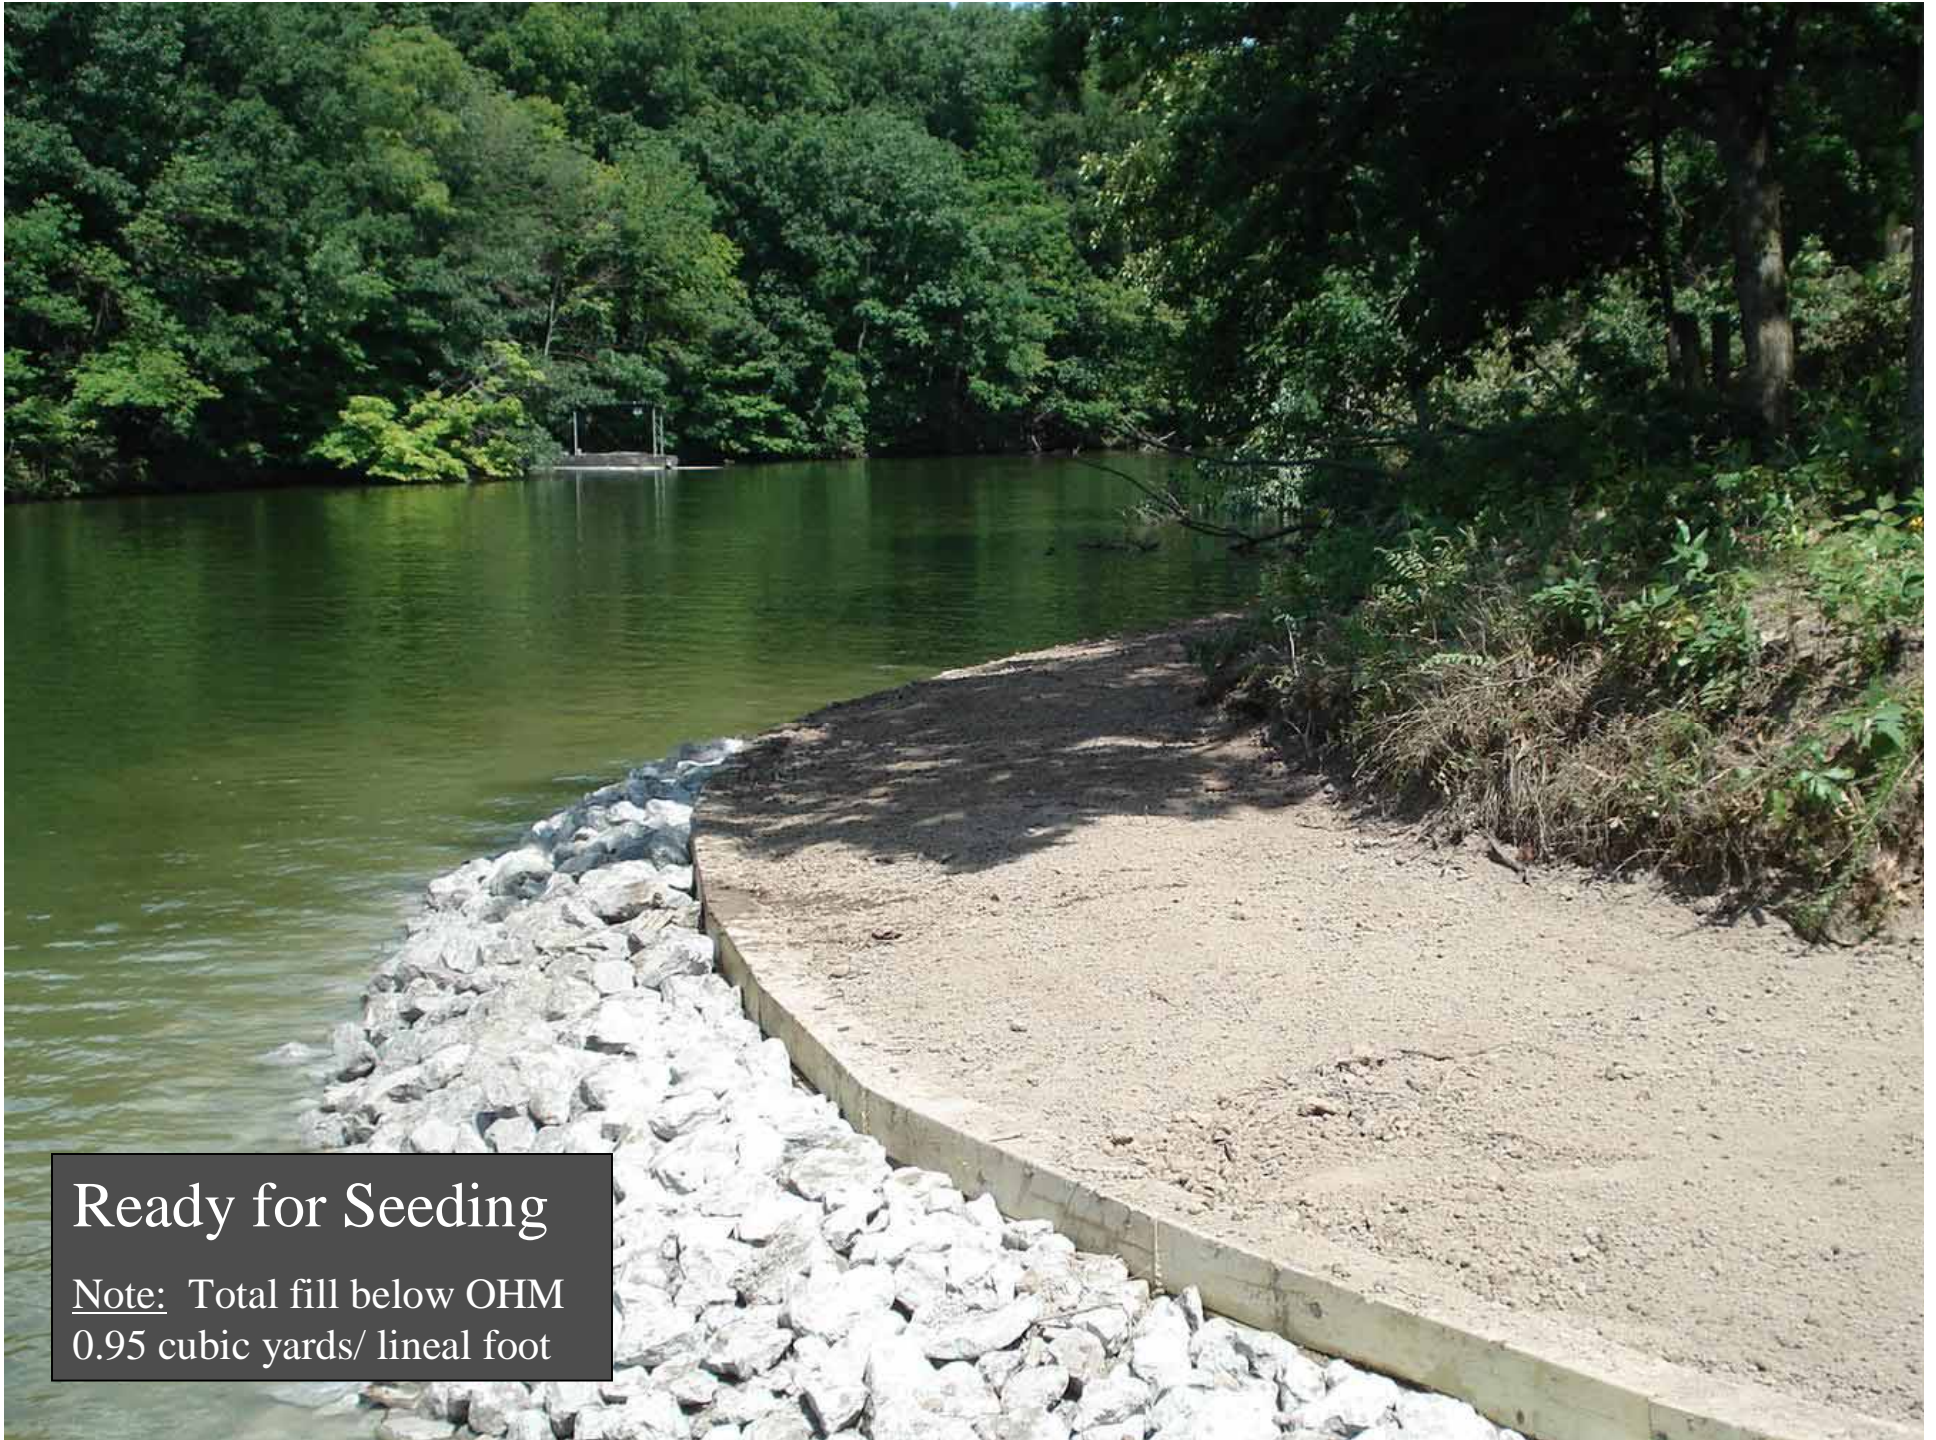
Ready for Seeding

Note: Total fill below OHM
0.95 cubic yards/ lineal foot

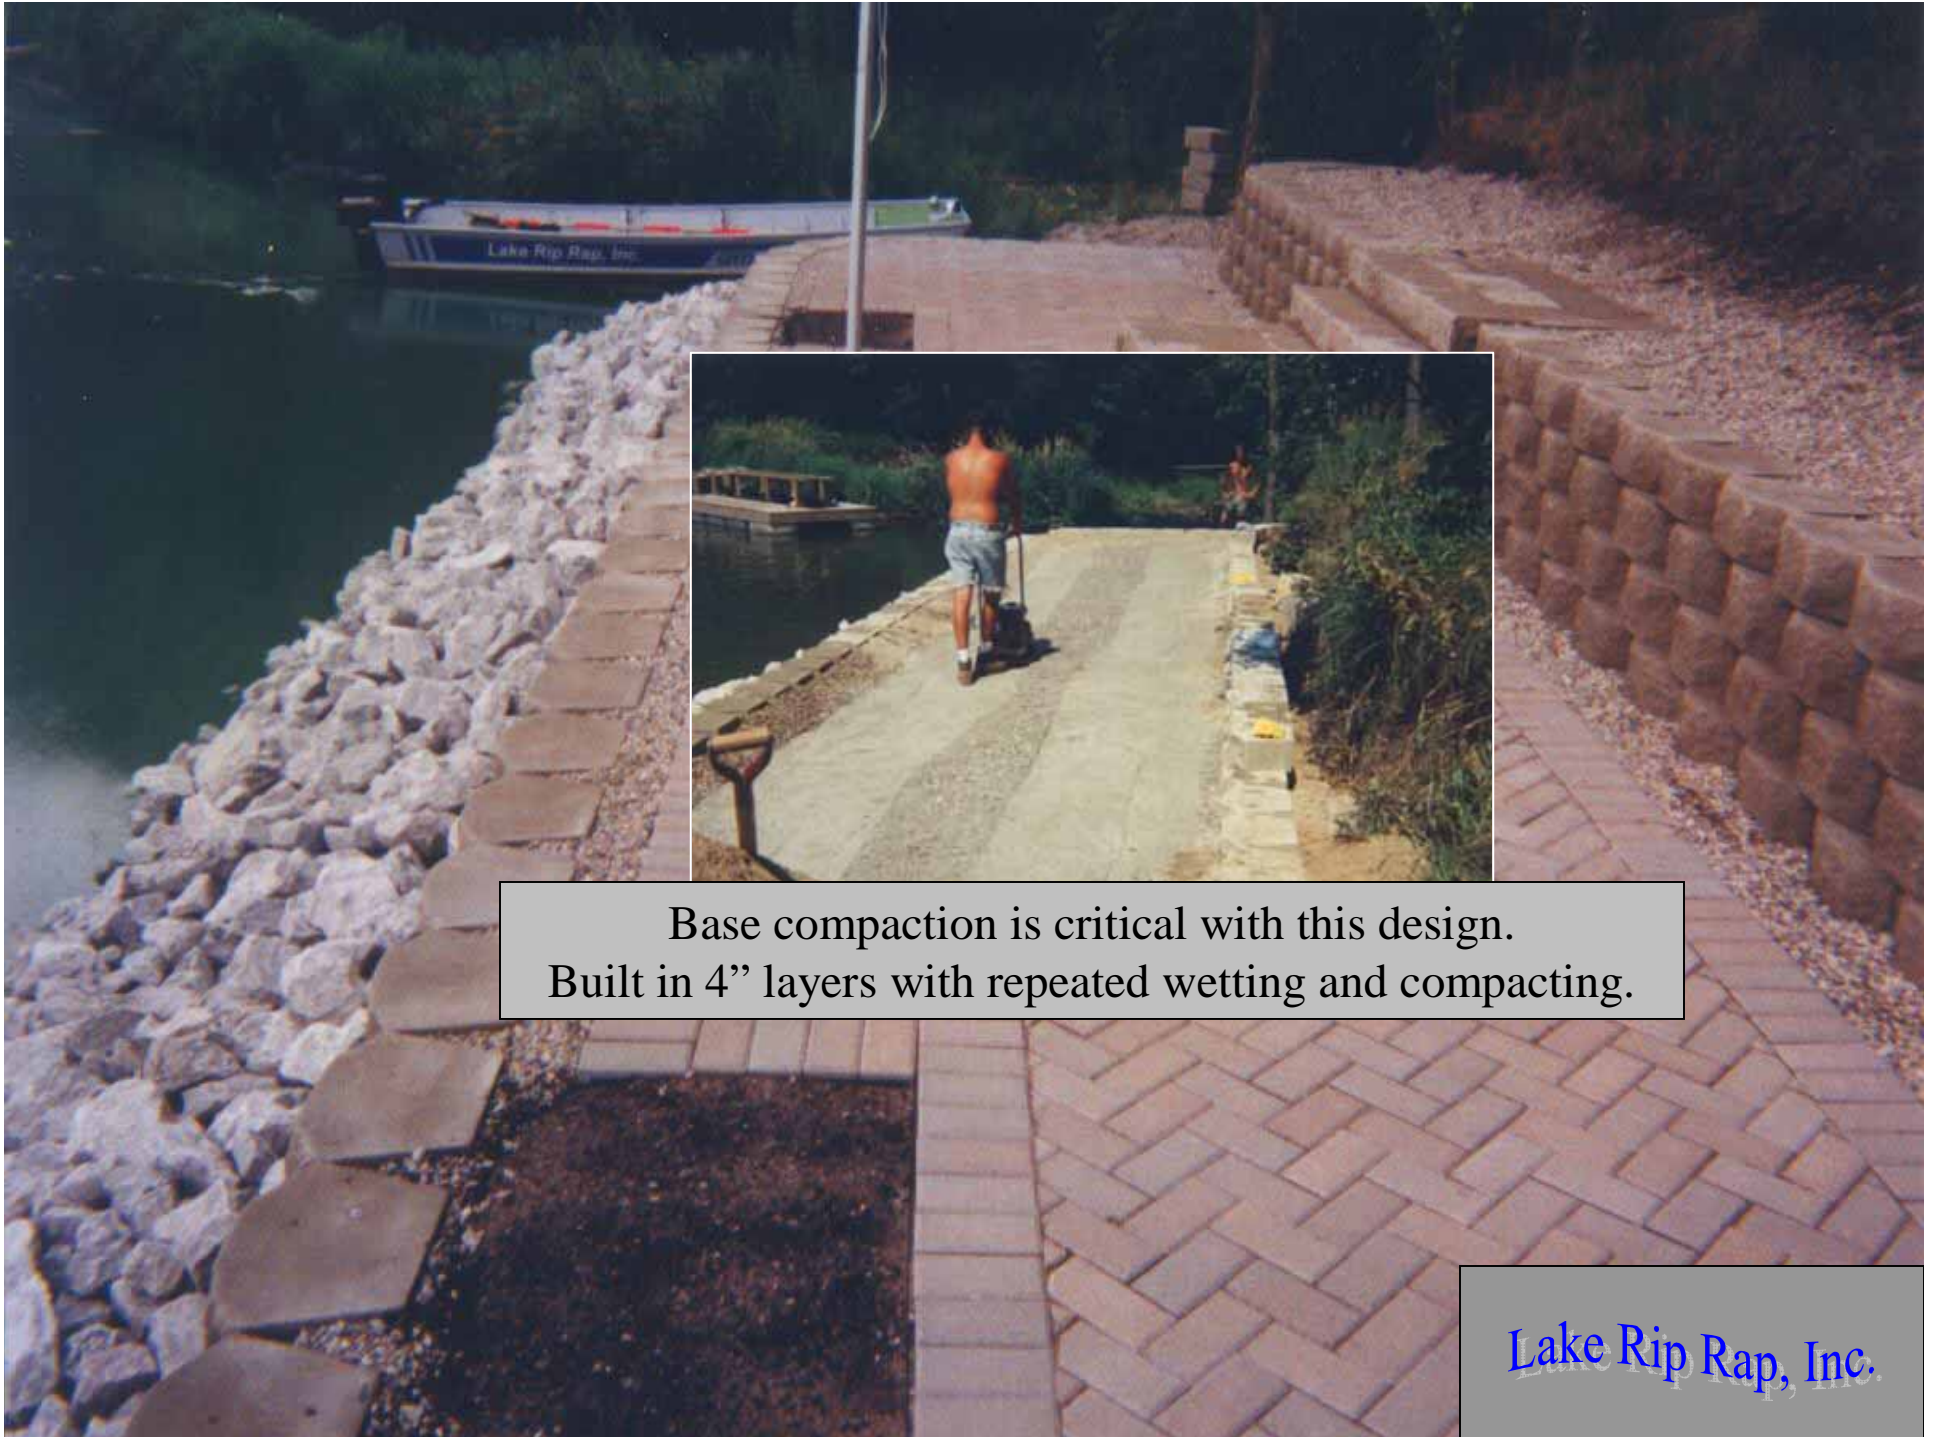
Base compaction is critical with this design.
Built in 4" layers with repeated wetting and compacting.

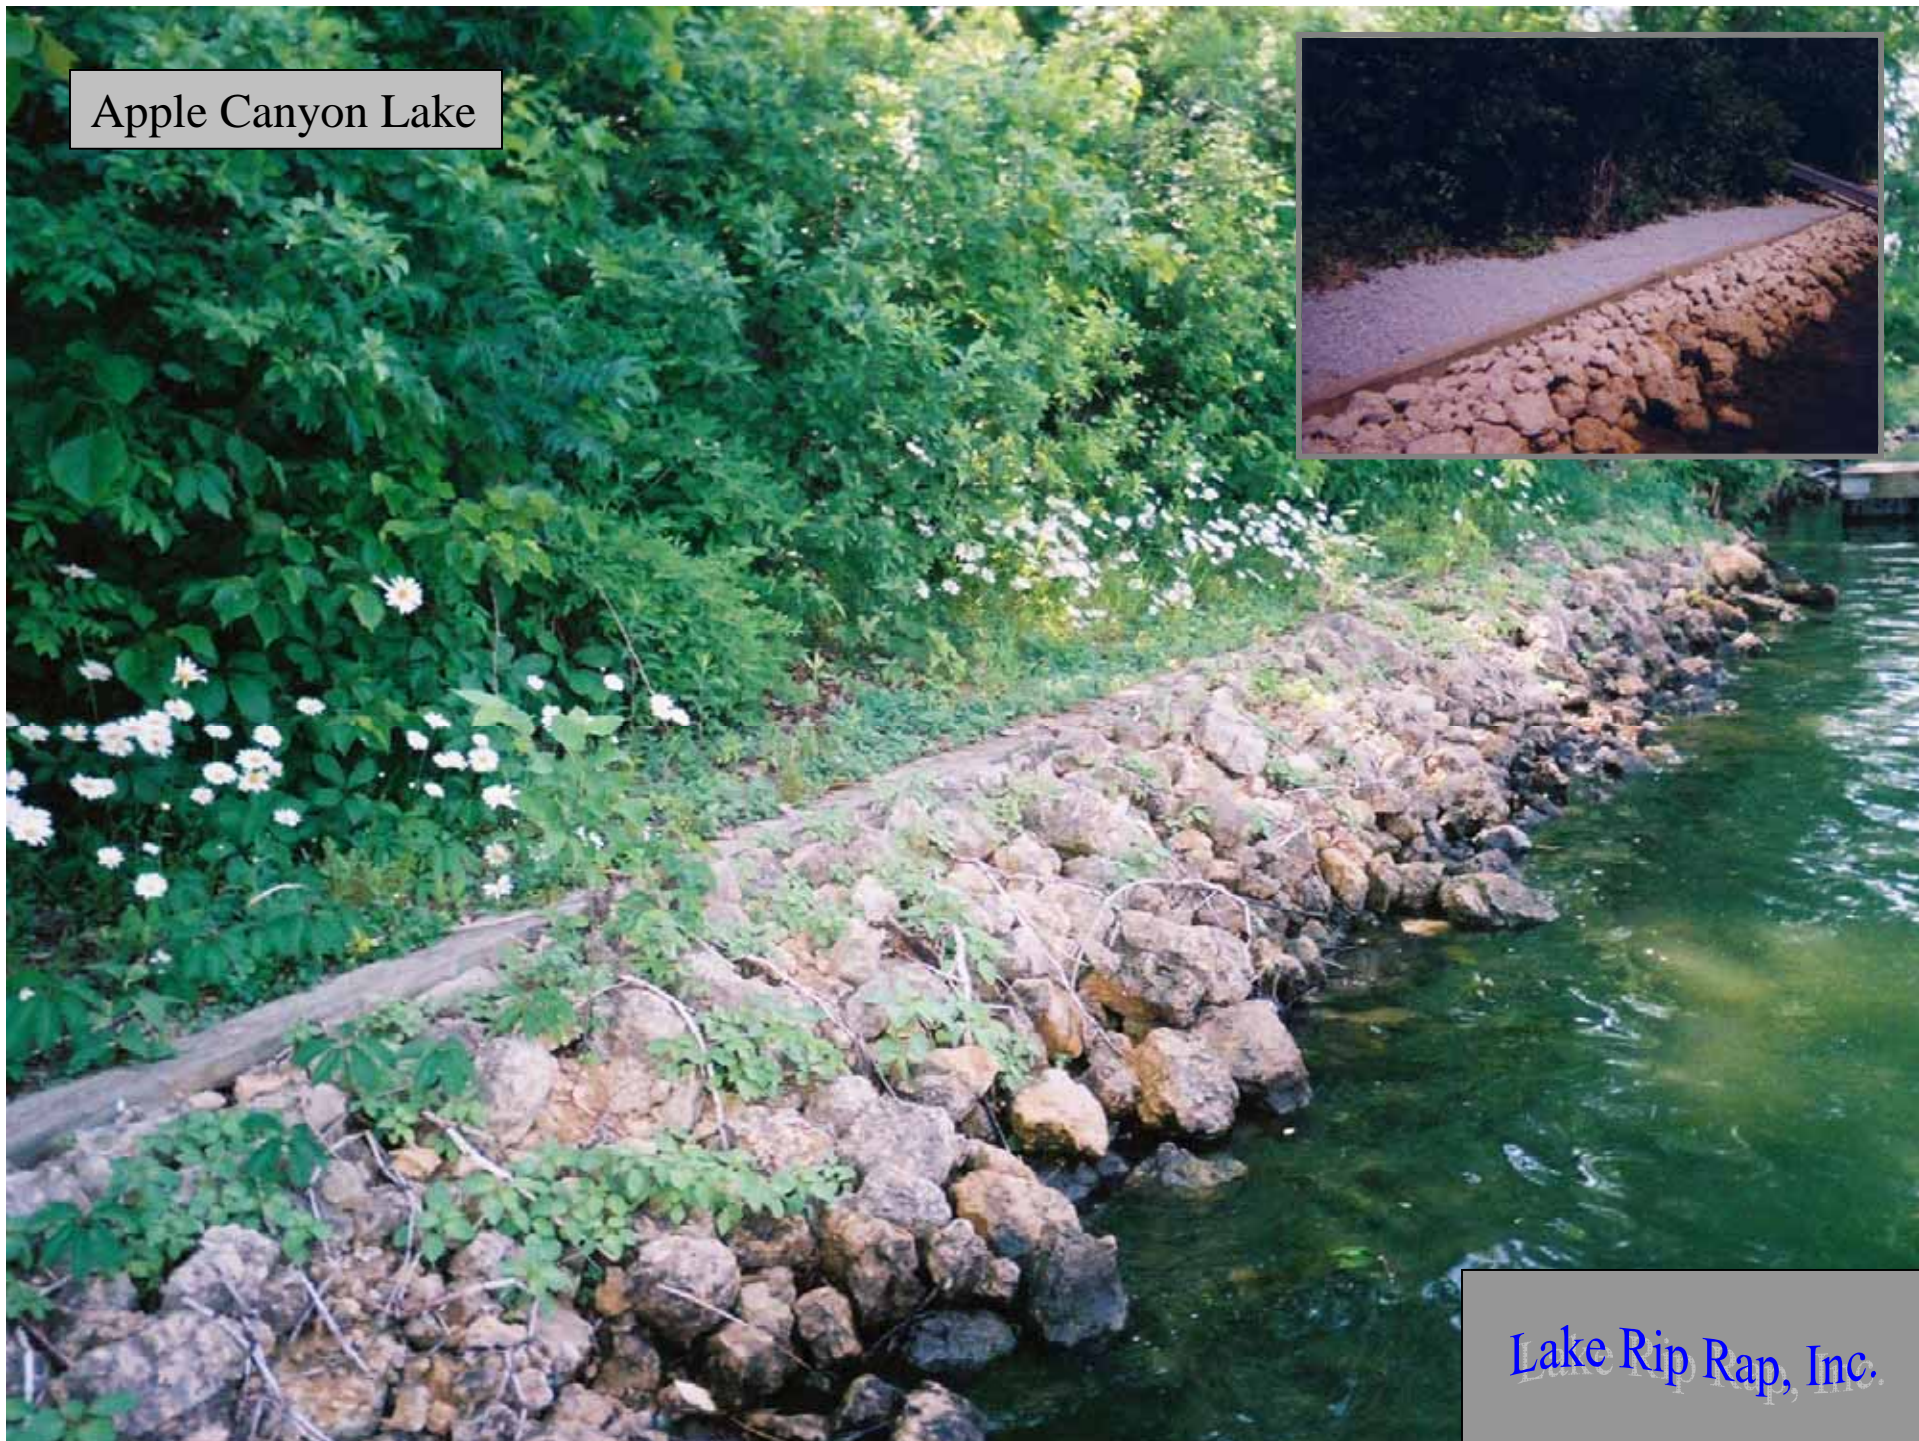
To reduce the overall cost, ordinary stone riprap was used with only a single layer of the more expensive boulders.

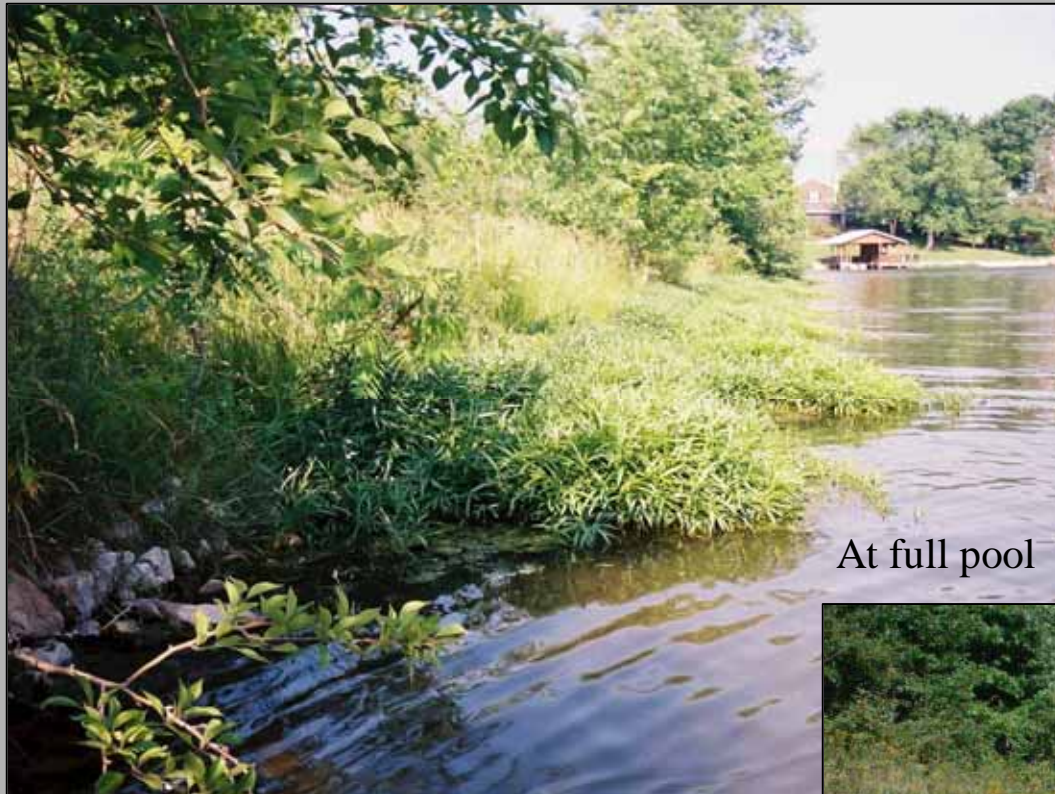
At full pool

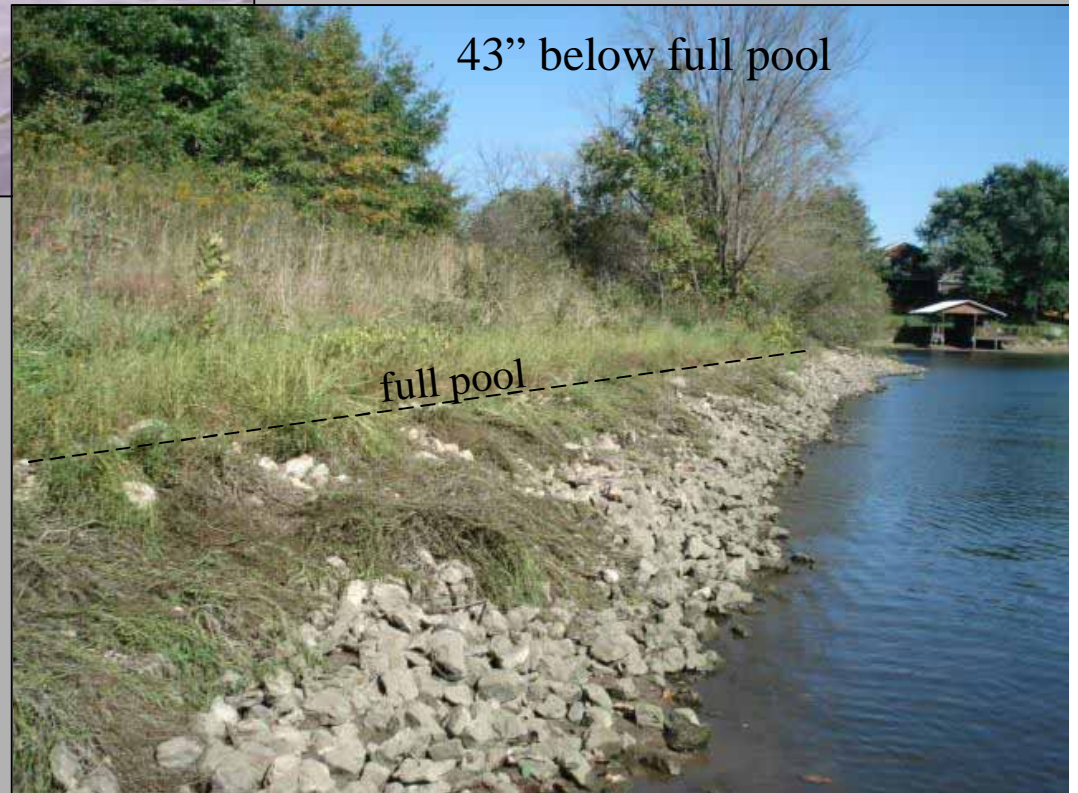
43" below full pool

Lean Revetment
after 15 years

This Lean Revetment has simply
dissipated the wave energy and ...
“Set the stage for a natural shoreline healing”.

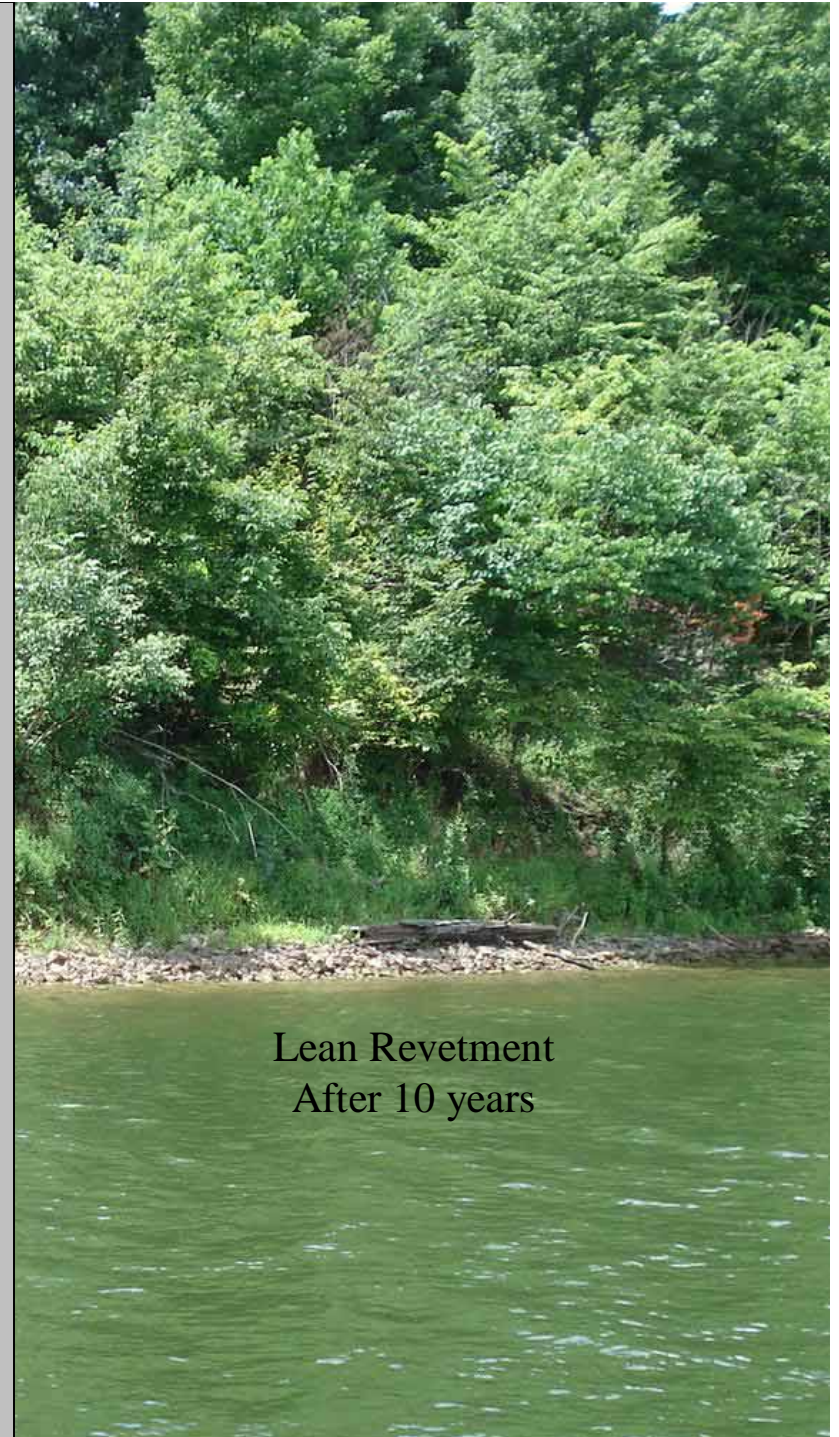
It appears as though this shoreline was never eroded...

But in fact, it had a 6 ft. high bank at the time of construction.

The bank has healed by natural slope reduction and natural plant colonization.

Lean Revetment
After 10 years

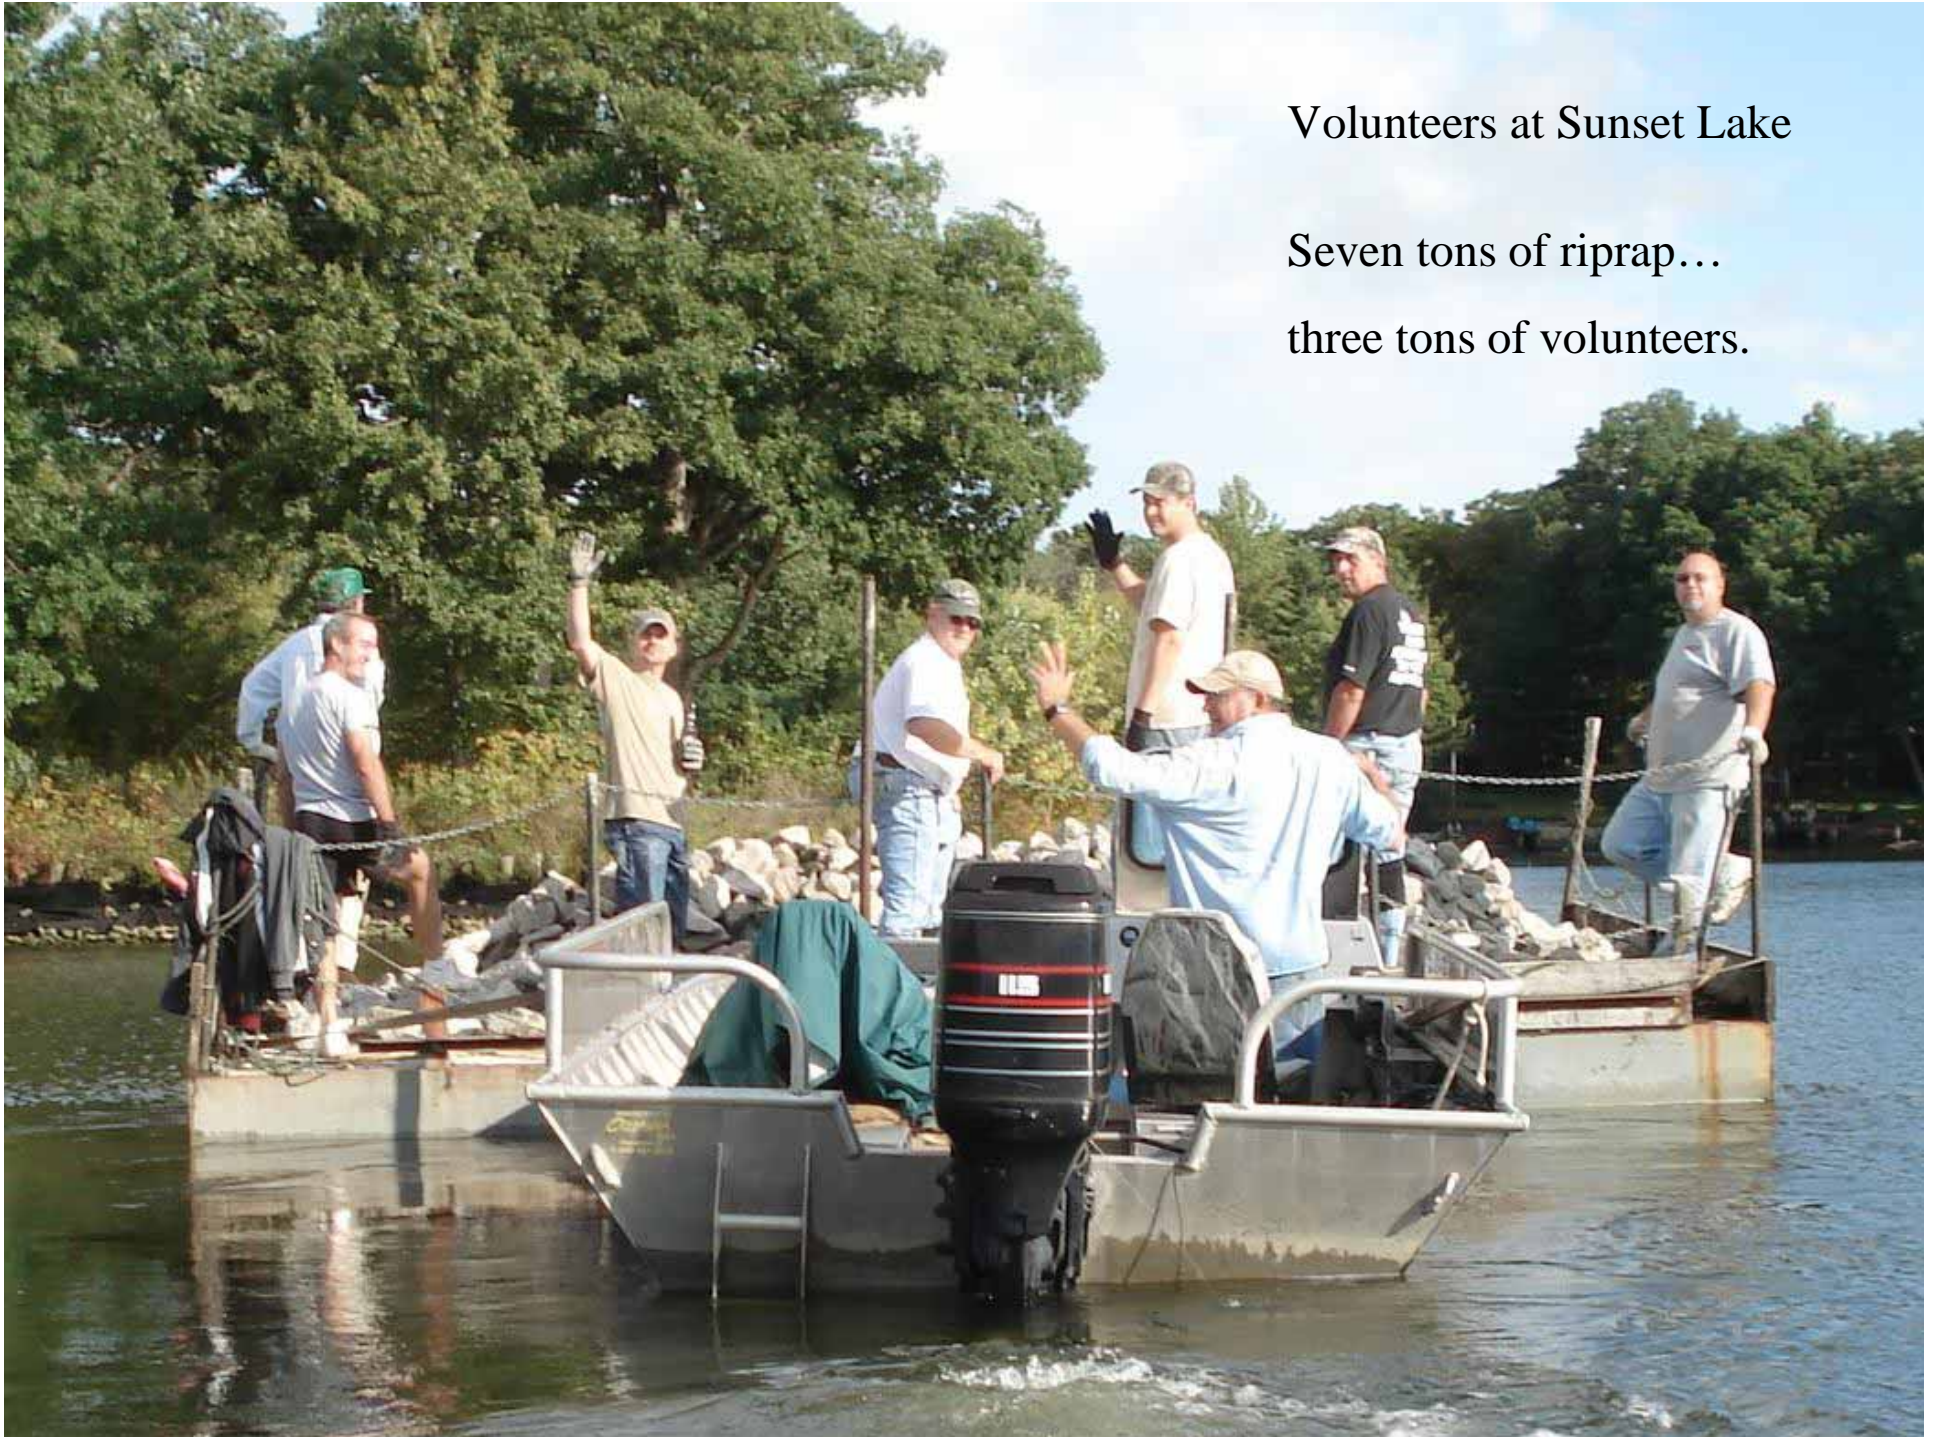
Proven by performance at Otter Lake...

Auto-feeder dispenses a full load of riprap
in 3 minutes

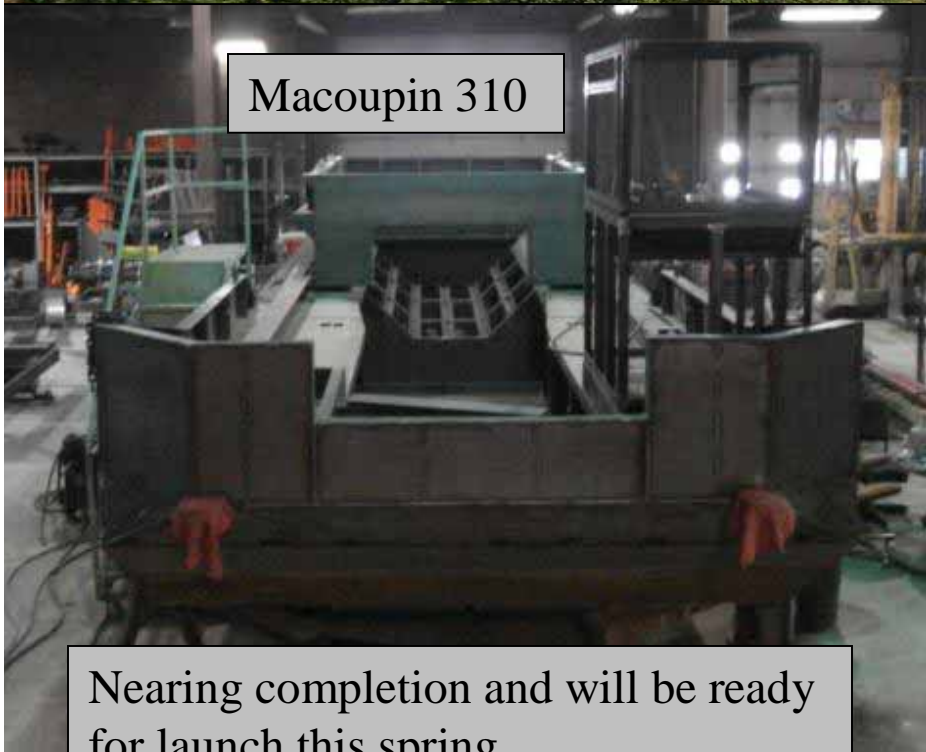
Macoupon 310

Nearing completion and will be ready for launch this spring.

A smaller version, with a payload of 10 tons, built for residential work.
