**Yellow Floating Heart
Eradication From Two Storm
Water Ponds Near
Delavan Lake**

**Heidi Bunk, DNR Lakes
Biologist**

**Audrey Greene, Walworth
County Lakes Specialist**

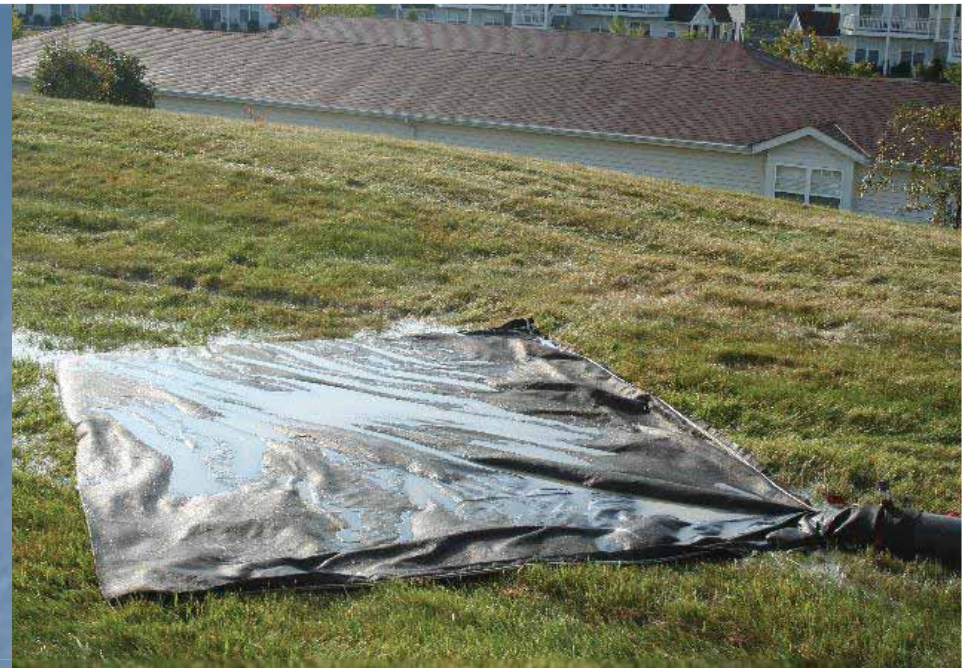
Rapid Response Plan Step 1

Dewater Ponds through sediment bags in order to retain all seeds

- Dewatering through Sewer System rejected - no data that sewage treatment would render seeds unviable
- Sediment bag pore holes required to be 2mm or less

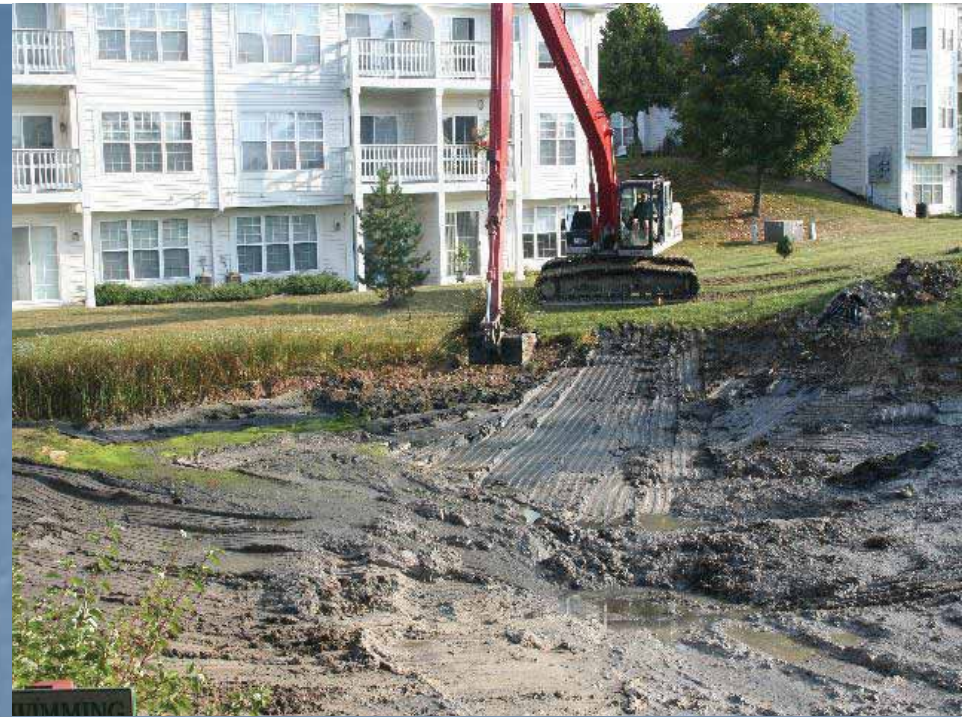
Rapid Response Plan Step 2

Dredge to Existing Clay Liner

- Place dredge spoils in newly excavated pits near ponds

Trucking spoils to alternate disposal site to bury or land spread was discussed & discarded – more expensive – greater chance that seeds could be dispersed

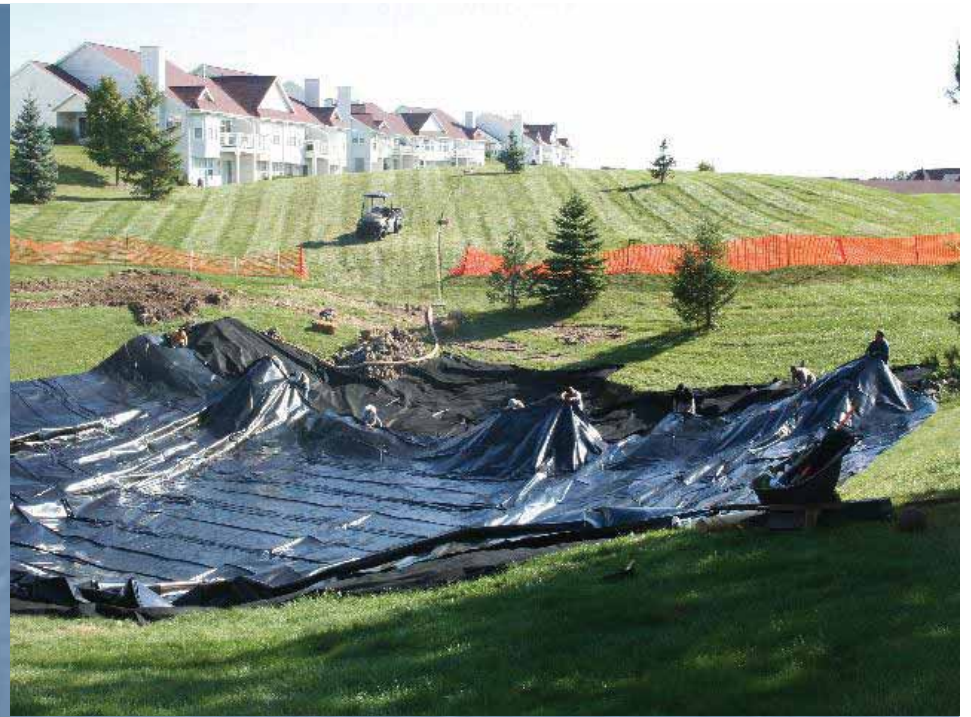
Rapid Response Plan Step 3

Place liner in ponds to prevent any remaining seeds from germinating

- Liner min. of 3 mm thick
- Min 5 year warranty

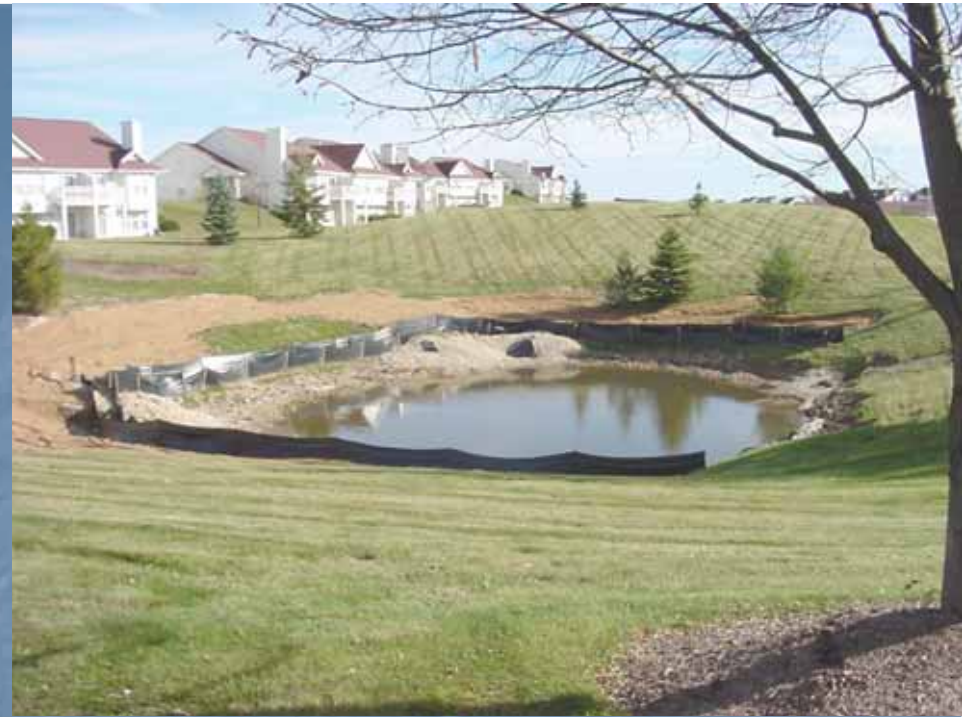
Rapid Response Plan Step 4 - 6

- 4. Cap Dredge Pits**
- 5. Allow Ponds to refill**
- 6. Monitor for 3 years**

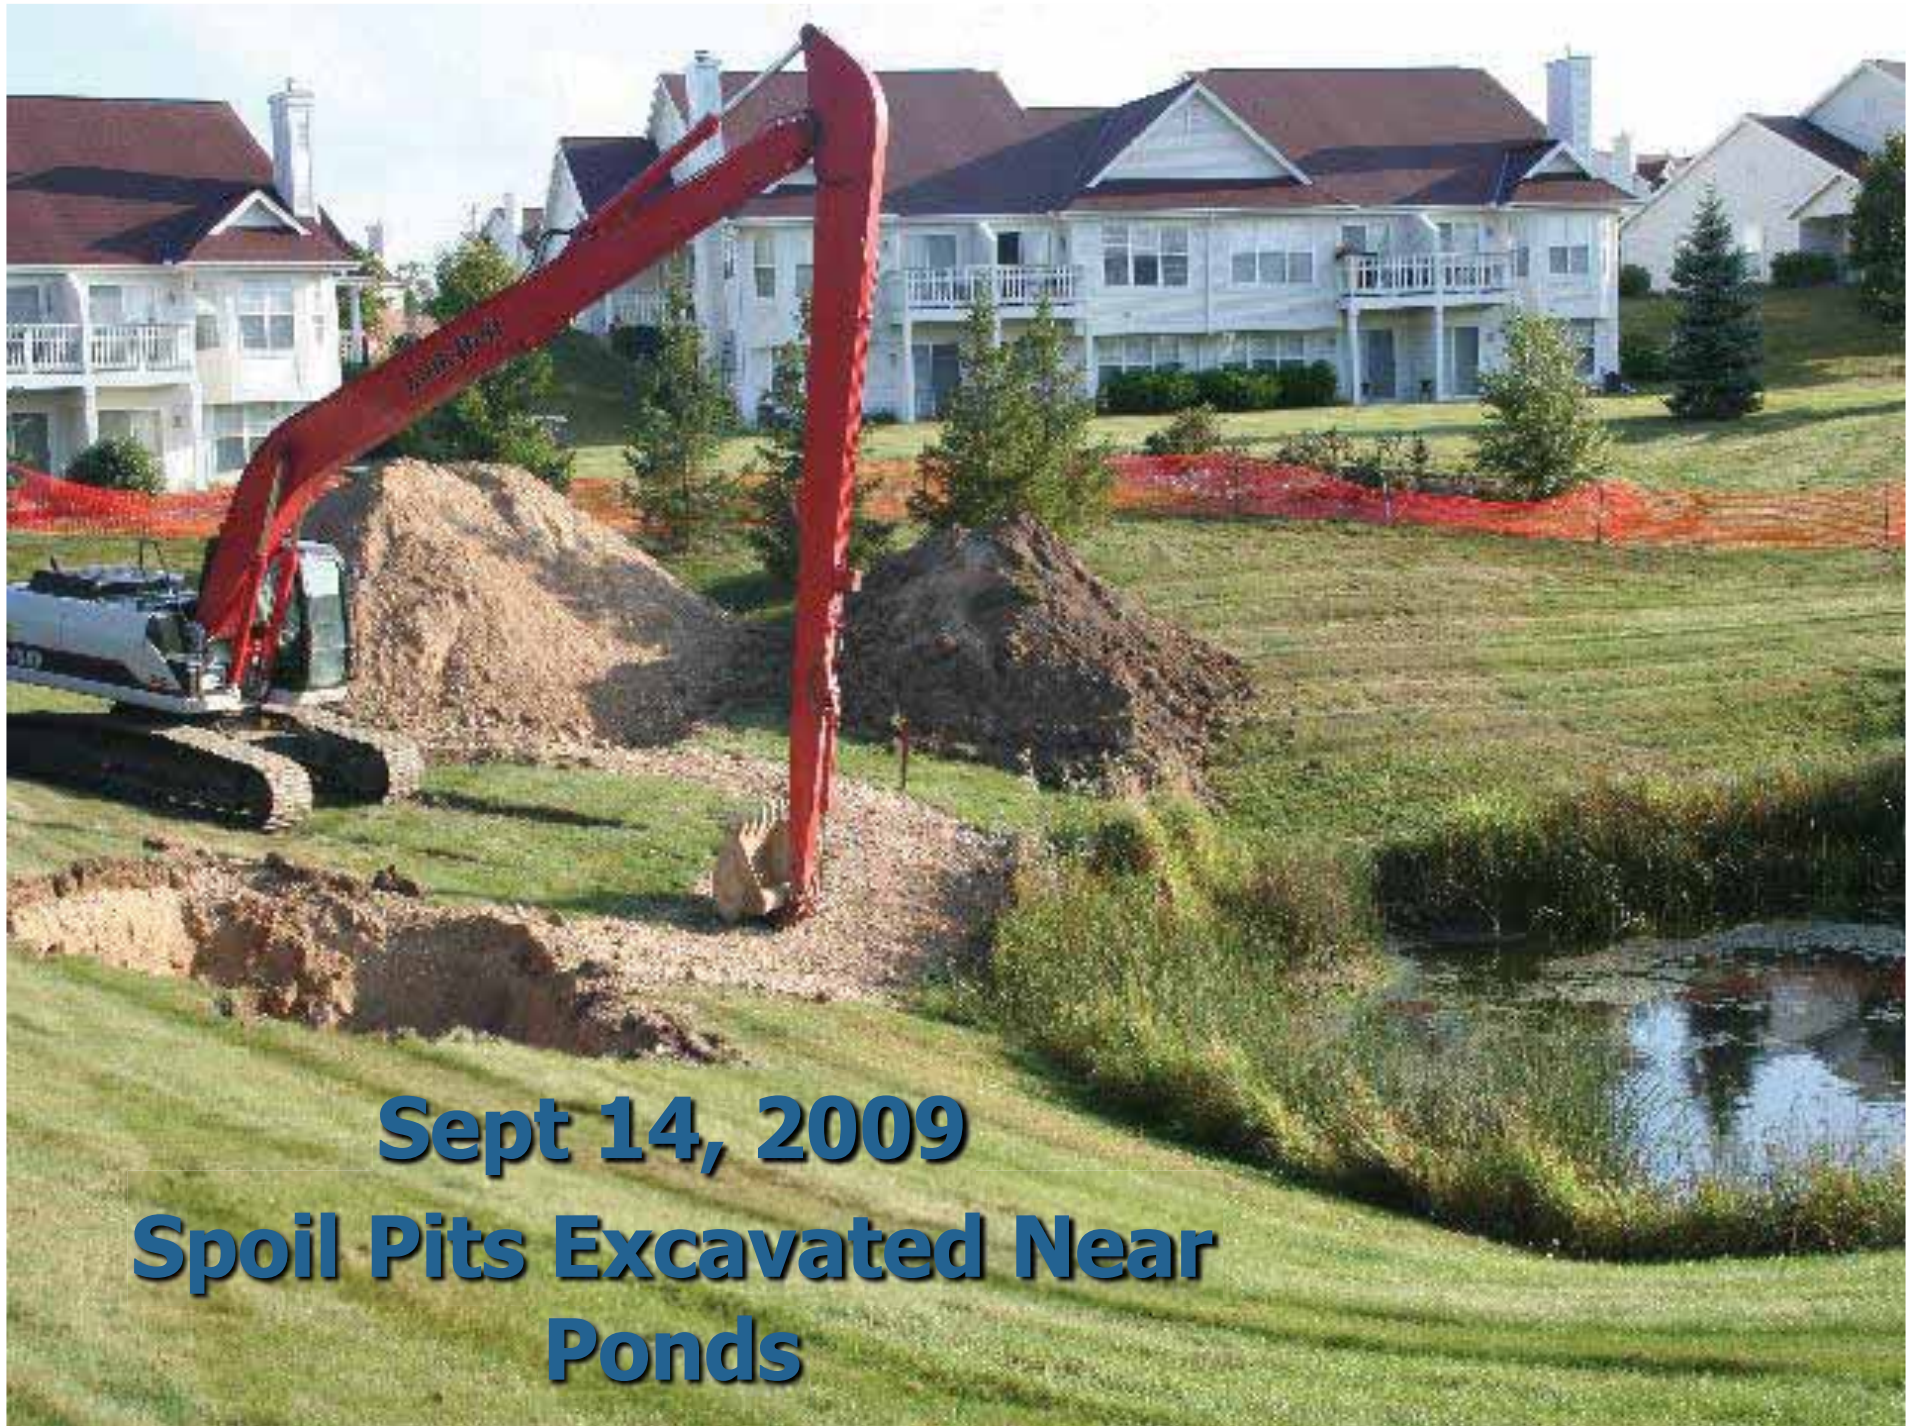
Sept 14, 2009
Spoil Pits Excavated Near
Ponds

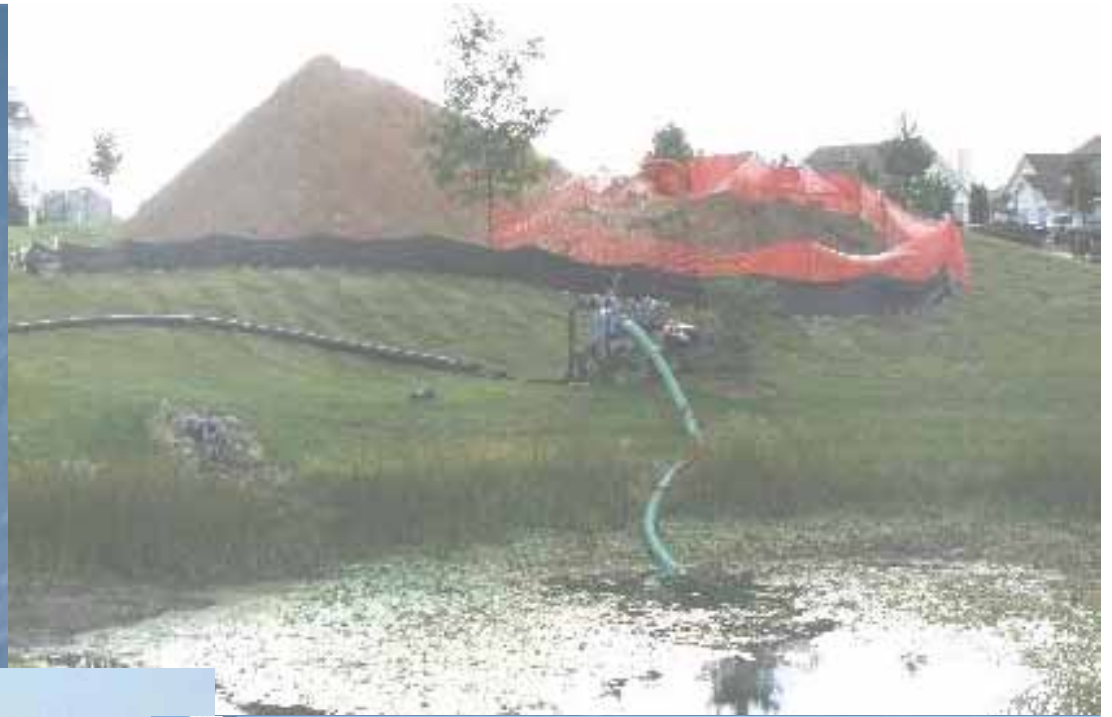
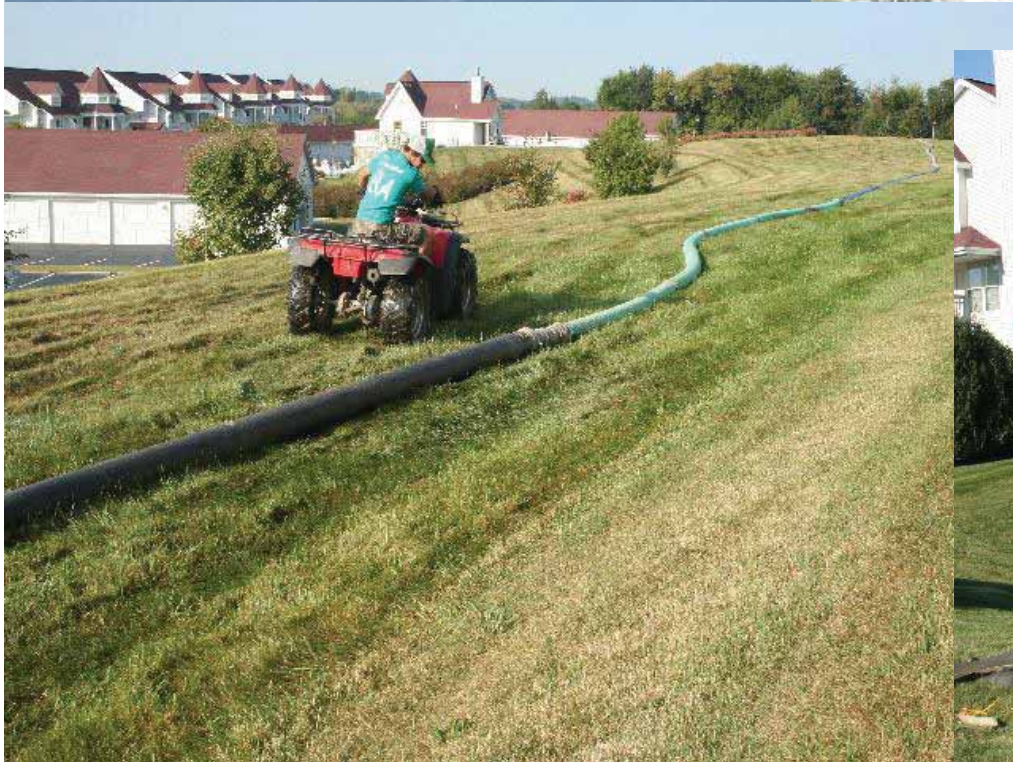
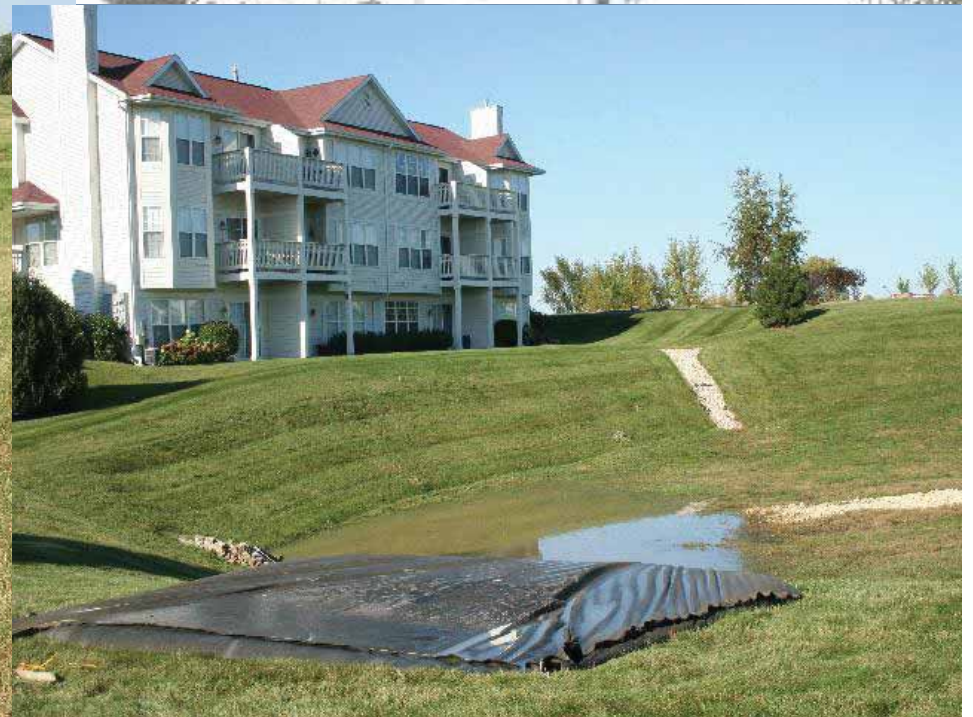
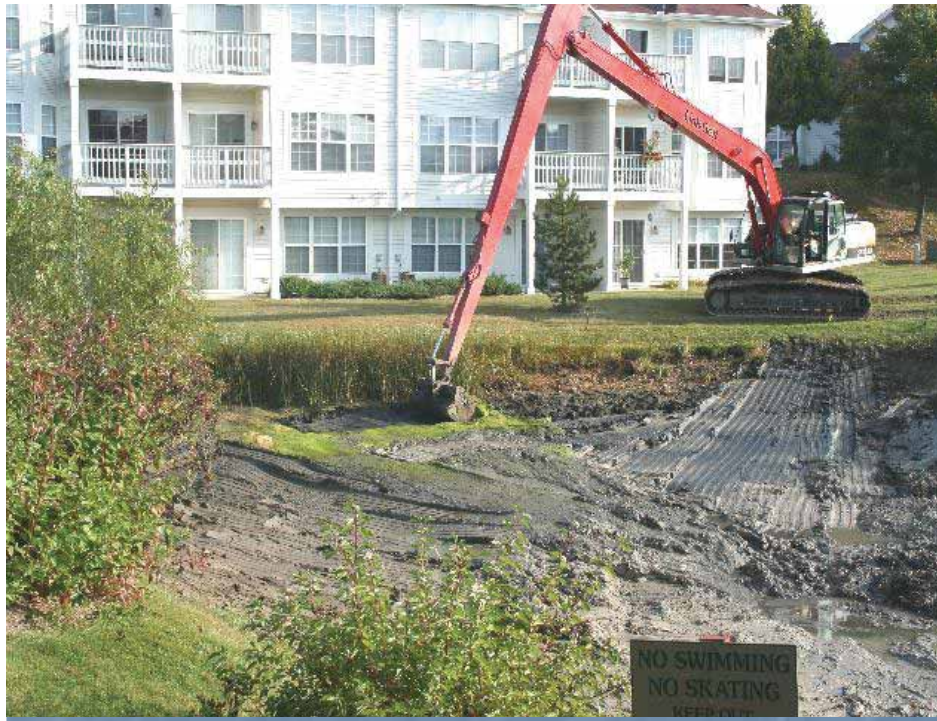
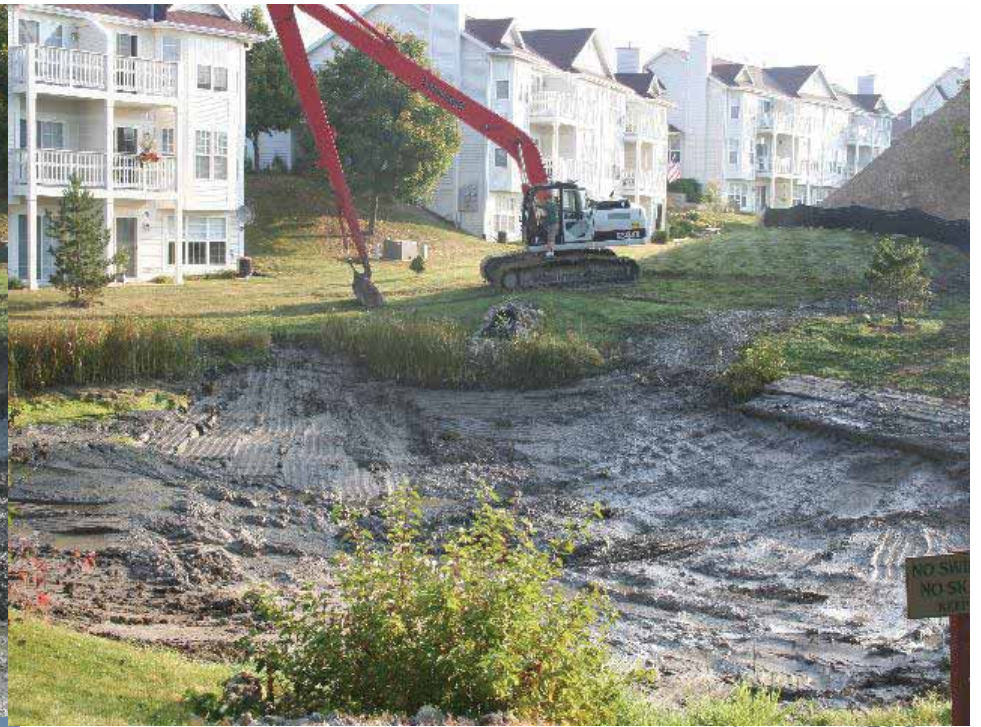
- Submersible Pump used - no oils/lubricant leakage issues
- Extra Sediment bags on site
- Sediment bags rated for 1200 gpm – pump will run at 600 – 700 gpm
- Sediment bags placed adjacent to dry stormwater detention basins

**Dewatering
9/17 & 9/18
Time to
Dewater:
approx. 4 hours/
pond**

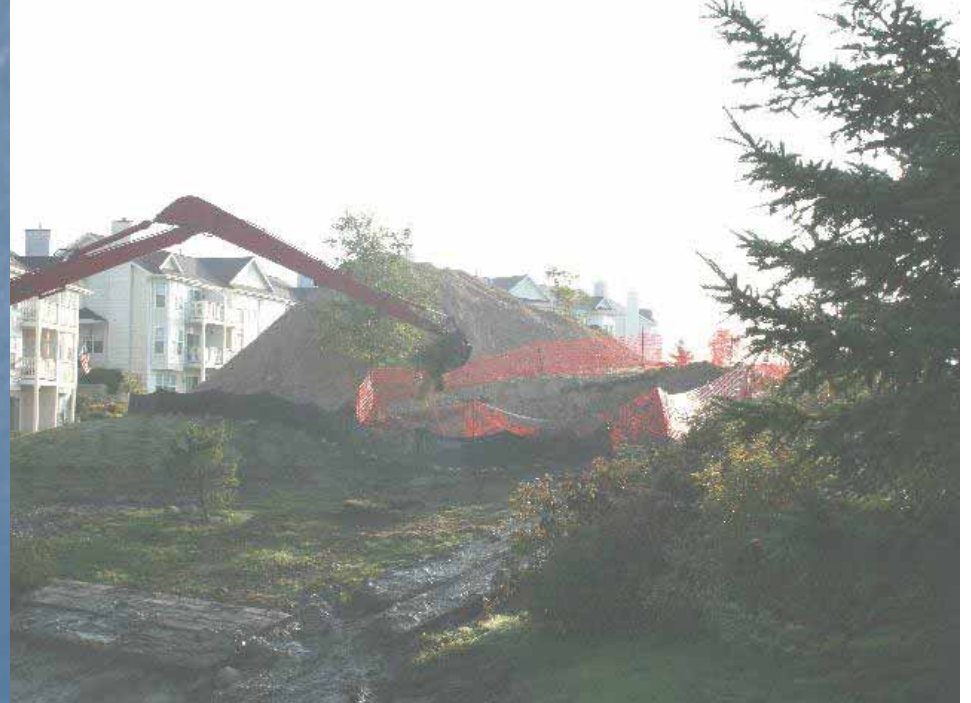
Dredging

- Remove all sediment down to existing clay liner
- shape & prep for liner

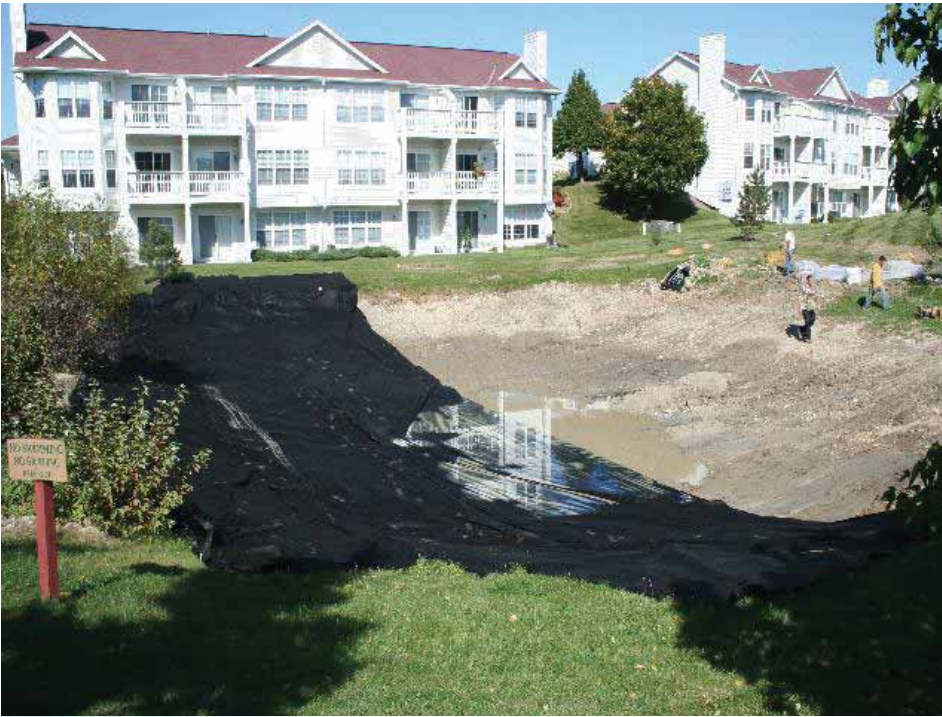
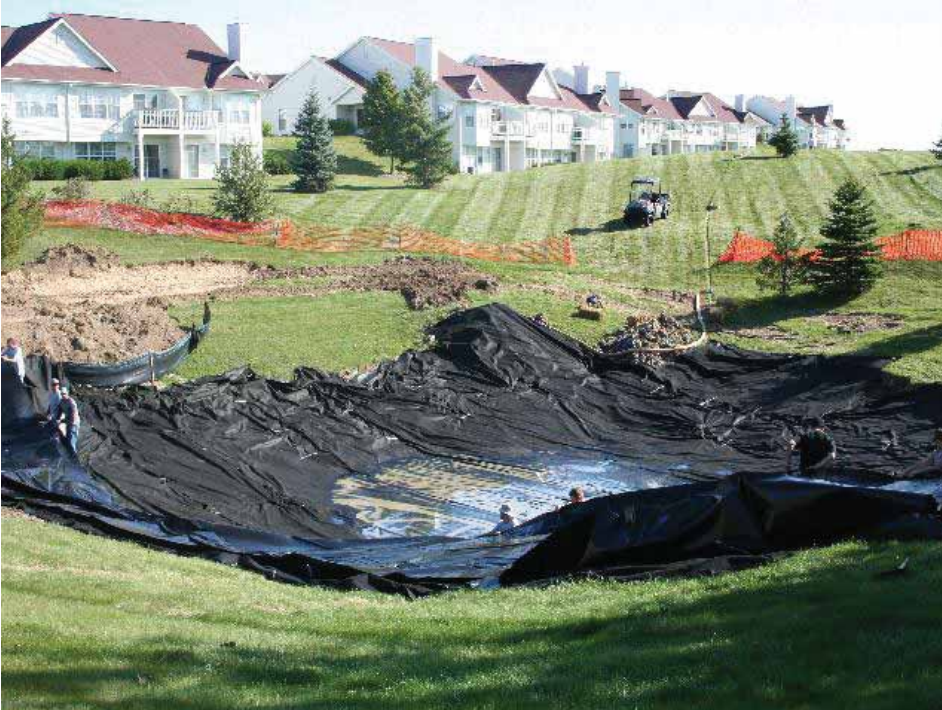
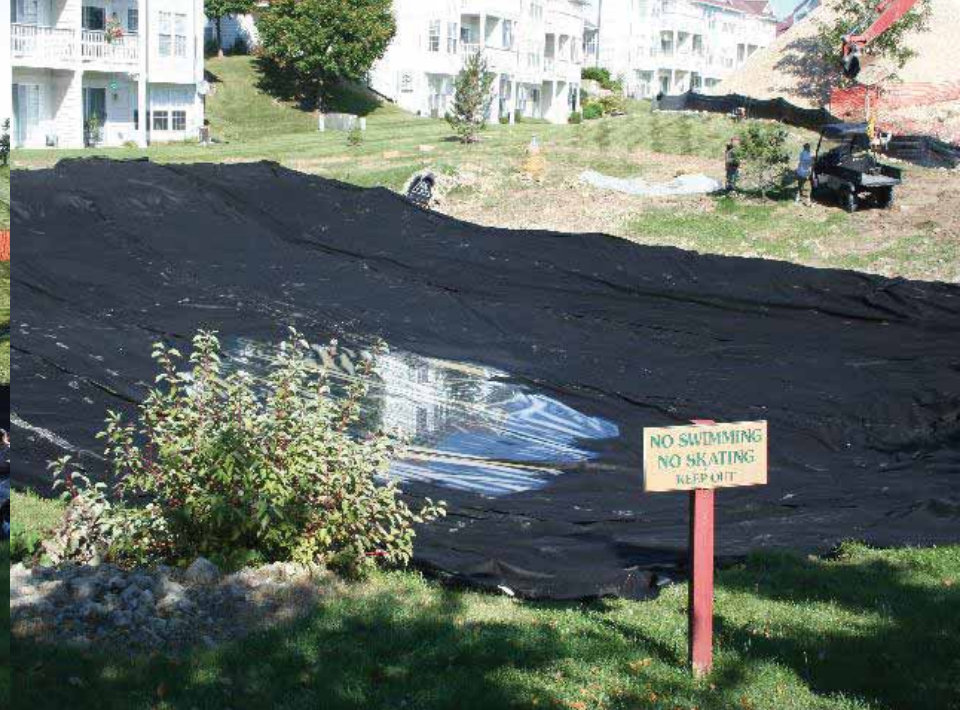
Pond Liner – Step 1

Under liner to protect the liner from sharp objects on bottom of ponds

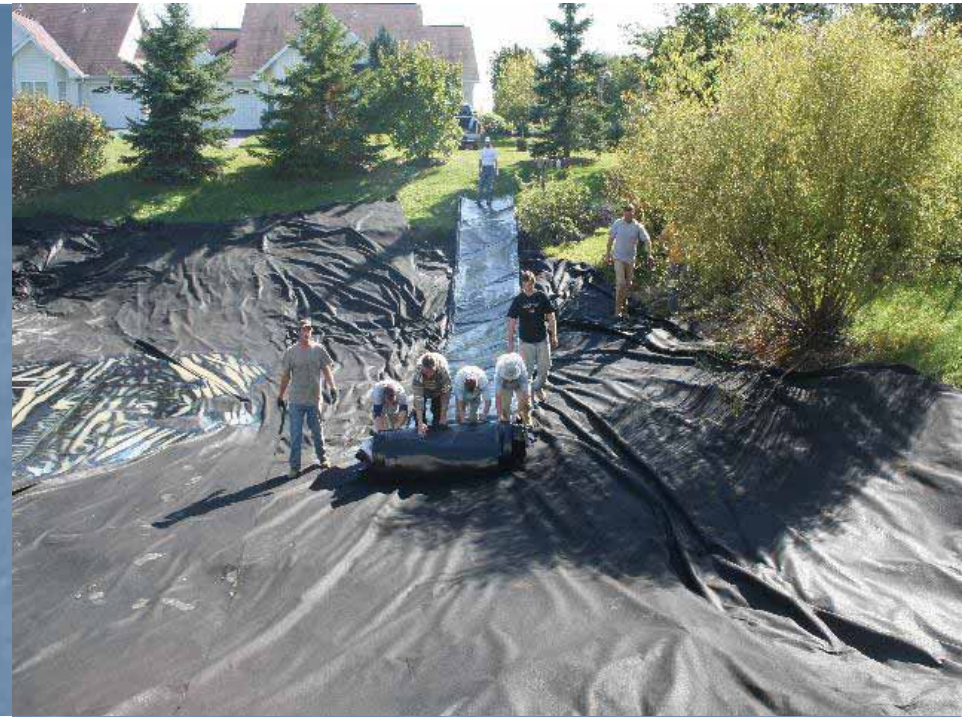
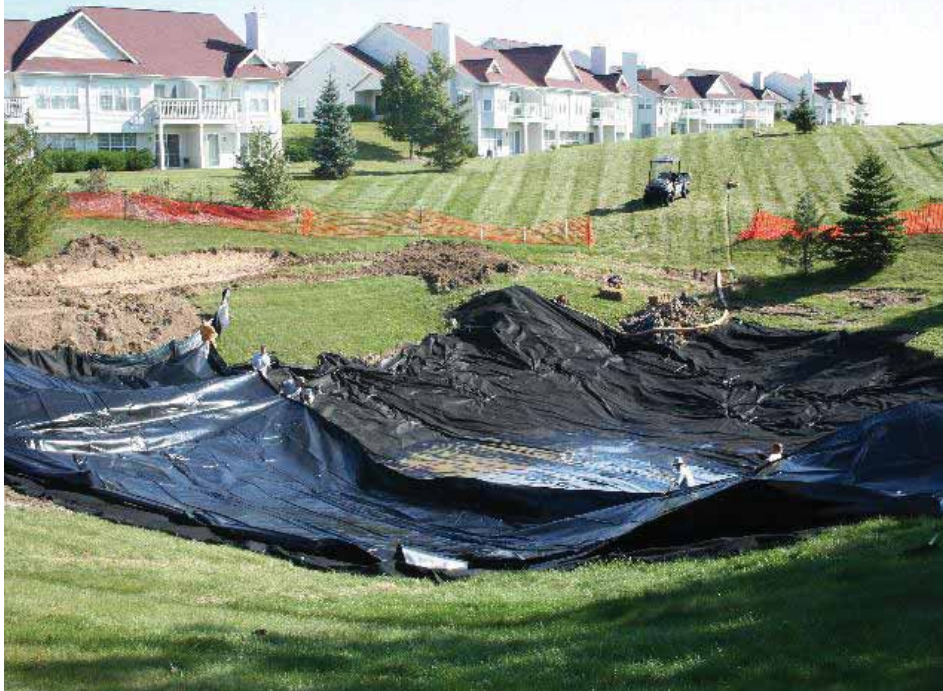
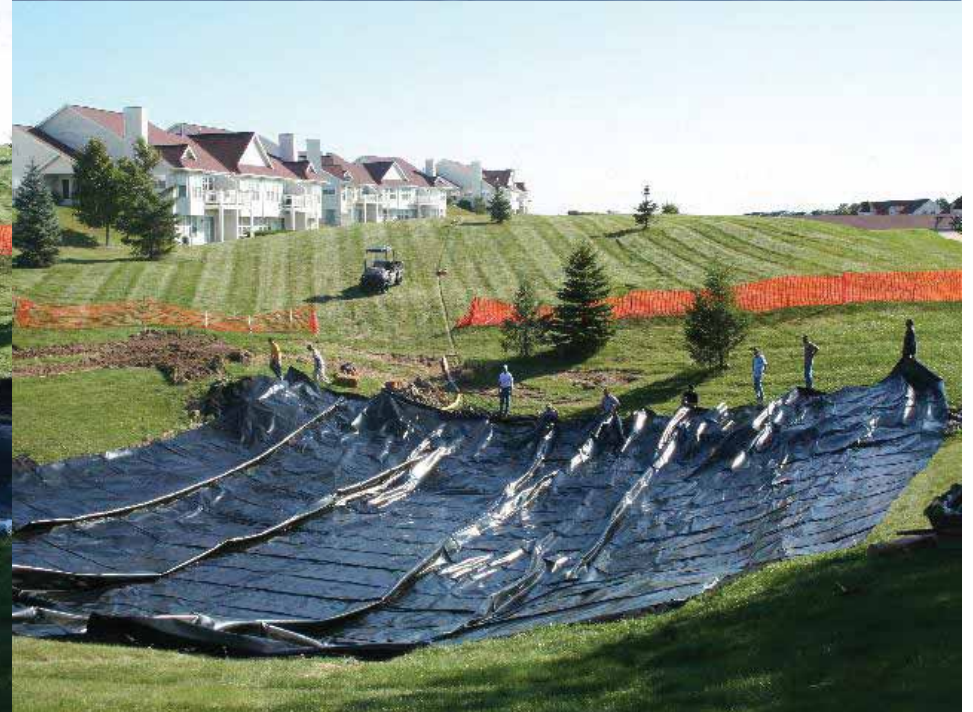
Pond Liner: Step 2

Liner is unfolded & laid across entire pond area

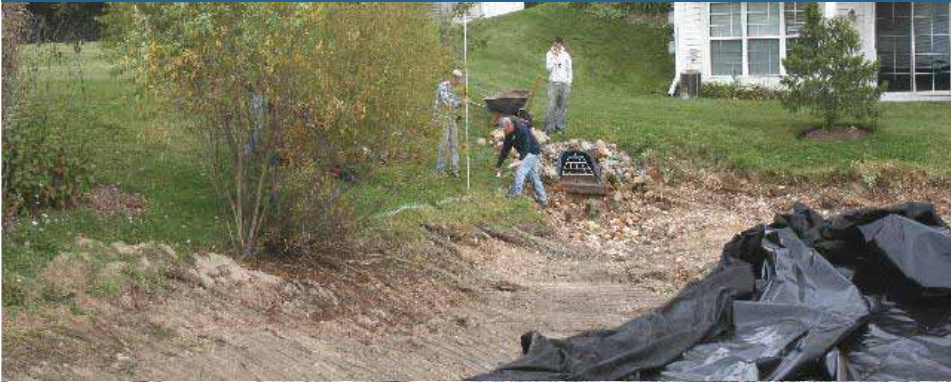
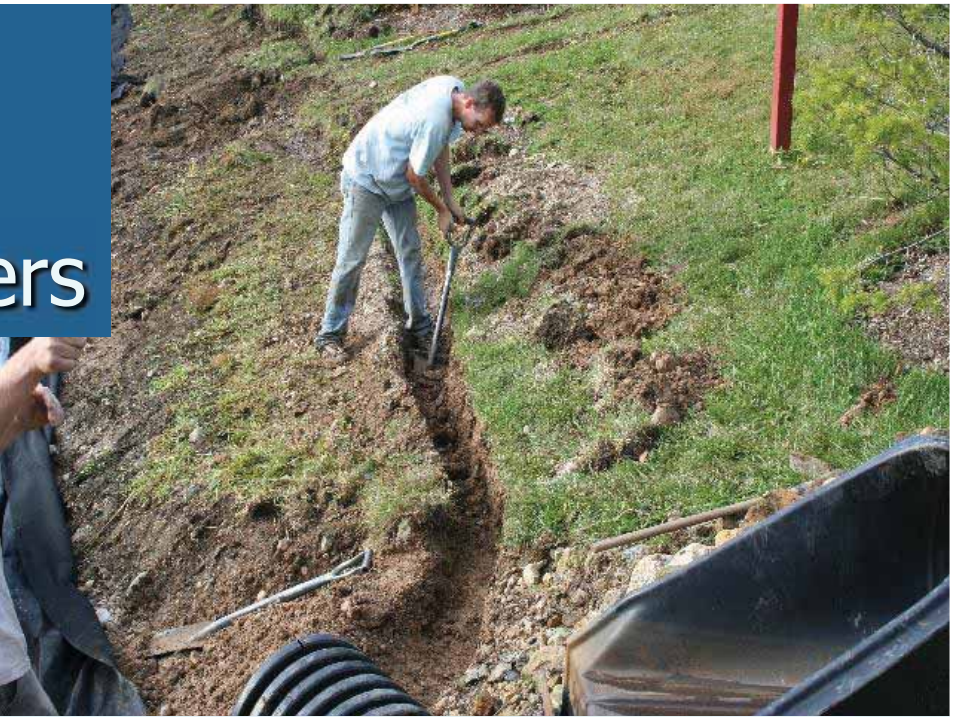
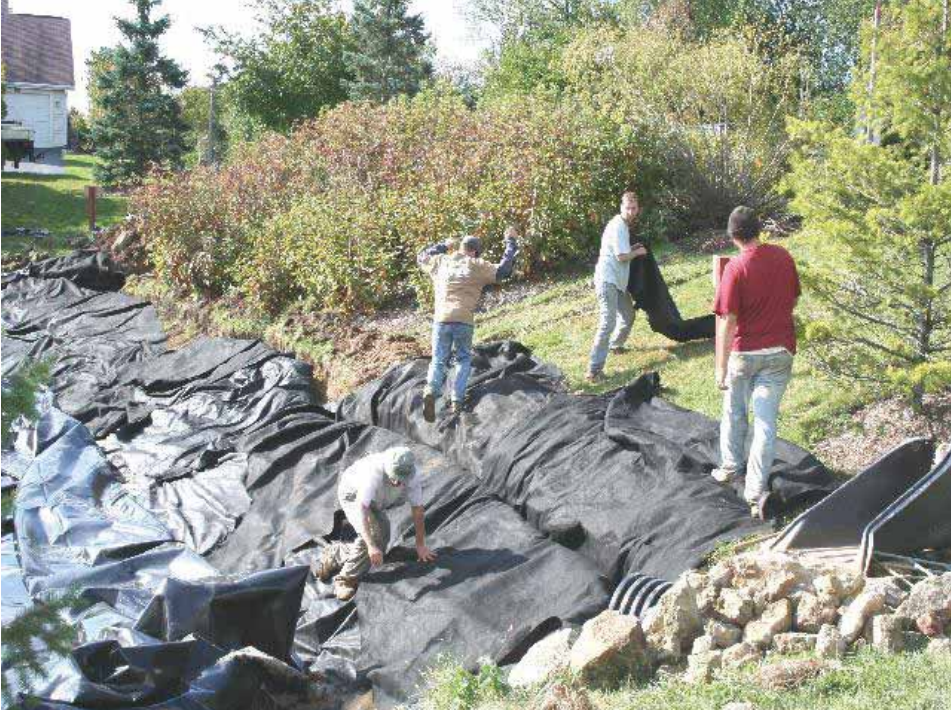
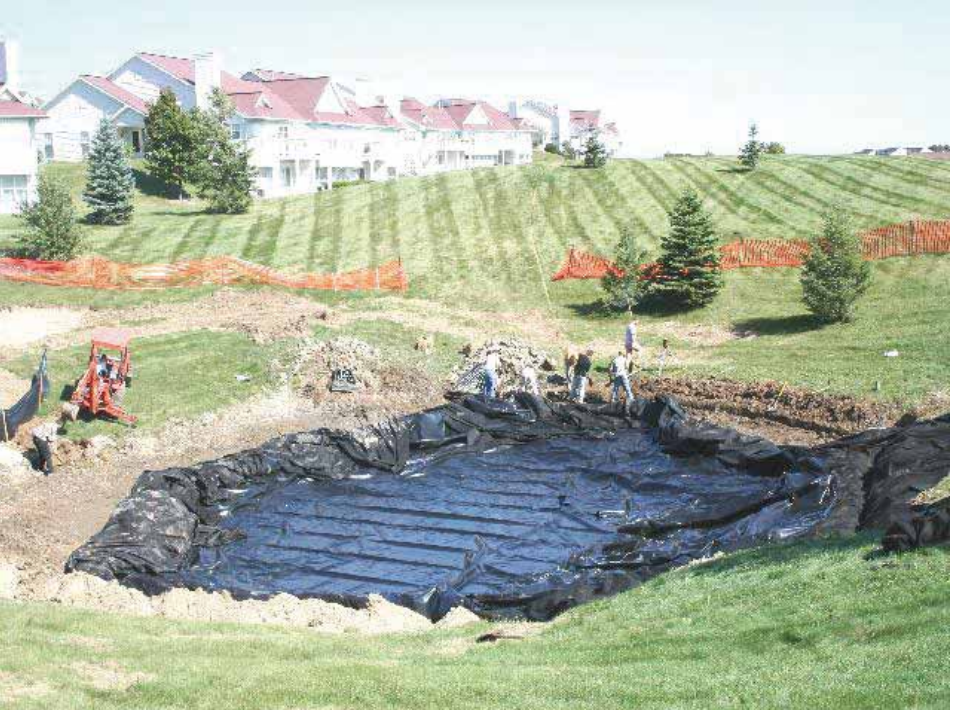
Liner: Step 3 Trenching & Burying Liners

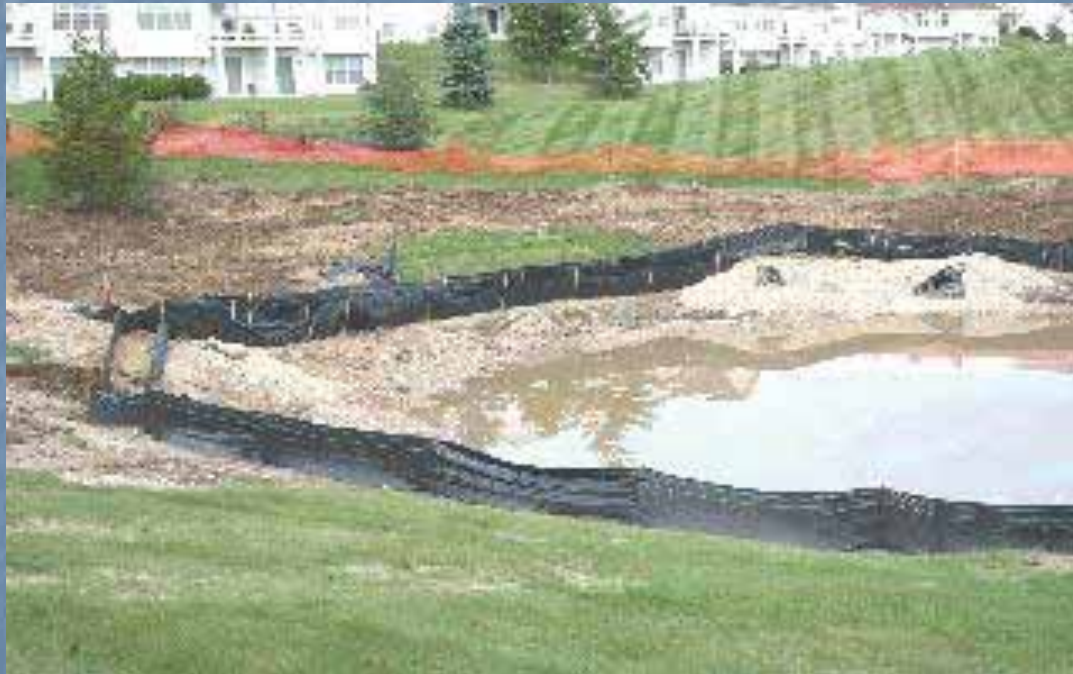
Double Silt Fence Between Work Pad & Pond Prevents Stray Seeds from Washing Back into Ponds

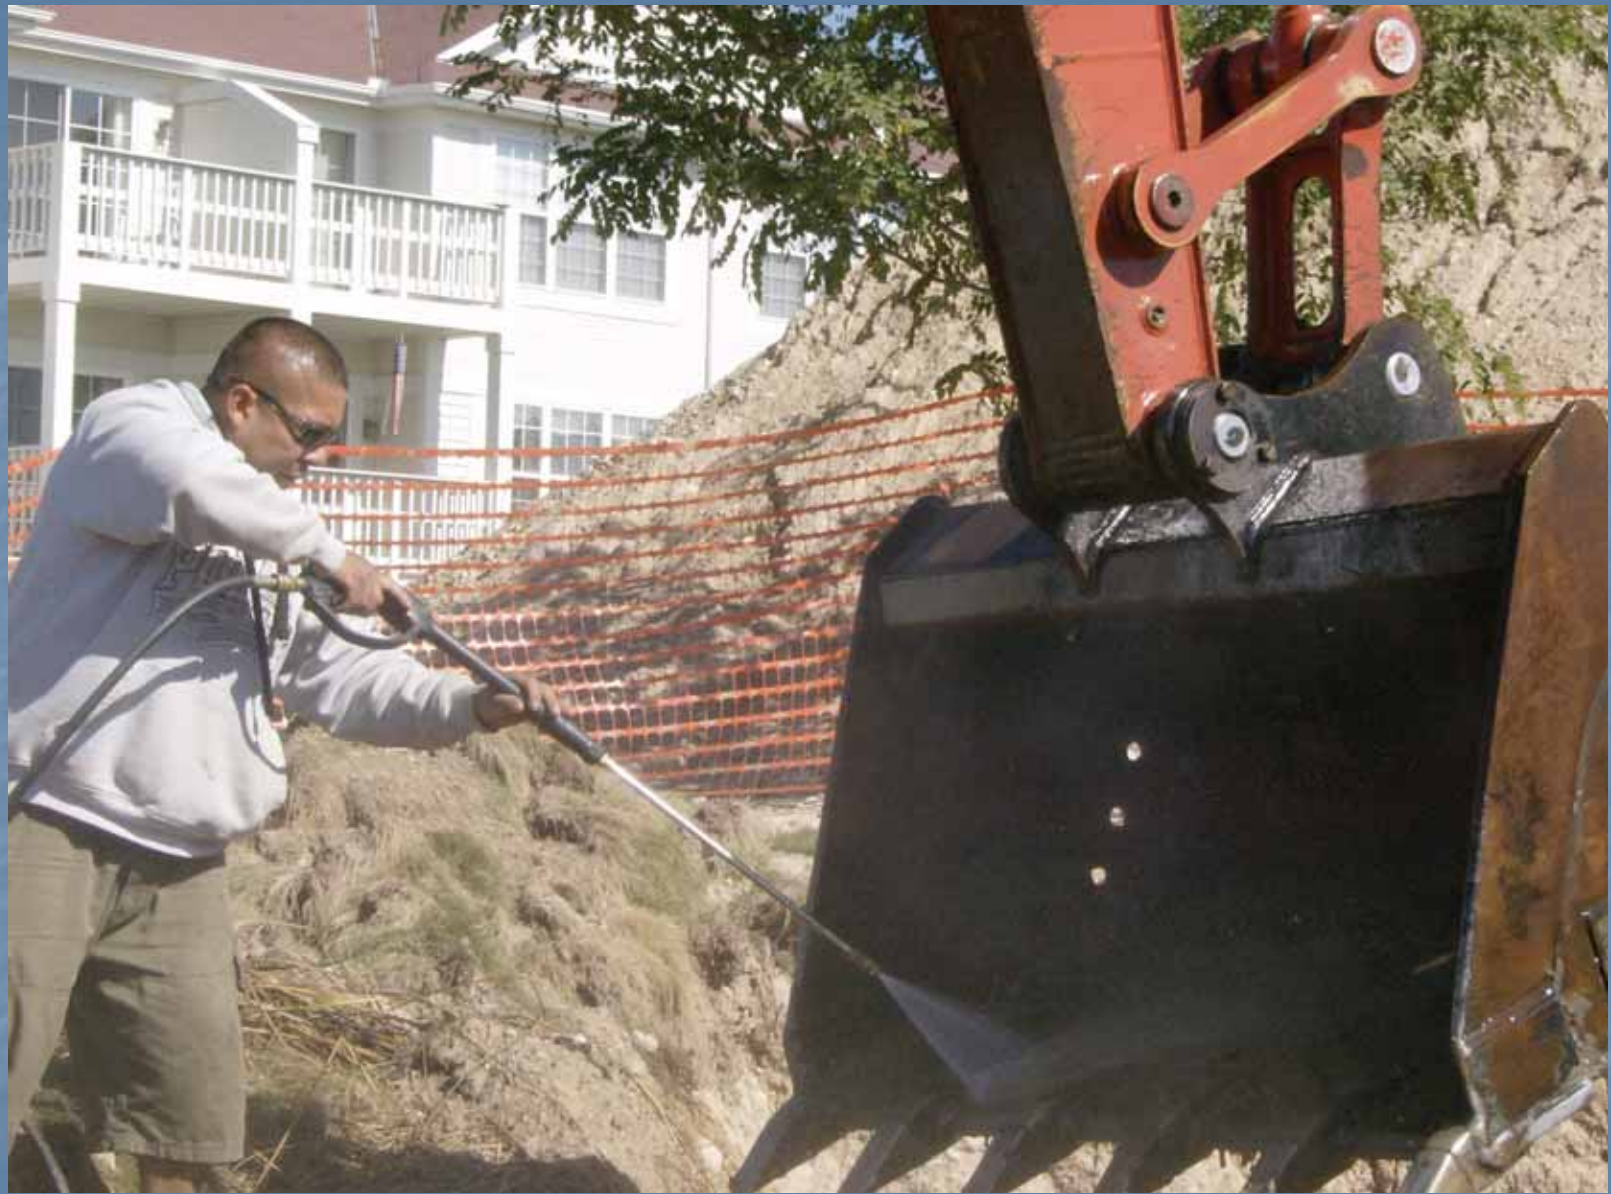
**Equipment
power washed
over spoil pit to
reduce chance of
recontamination**

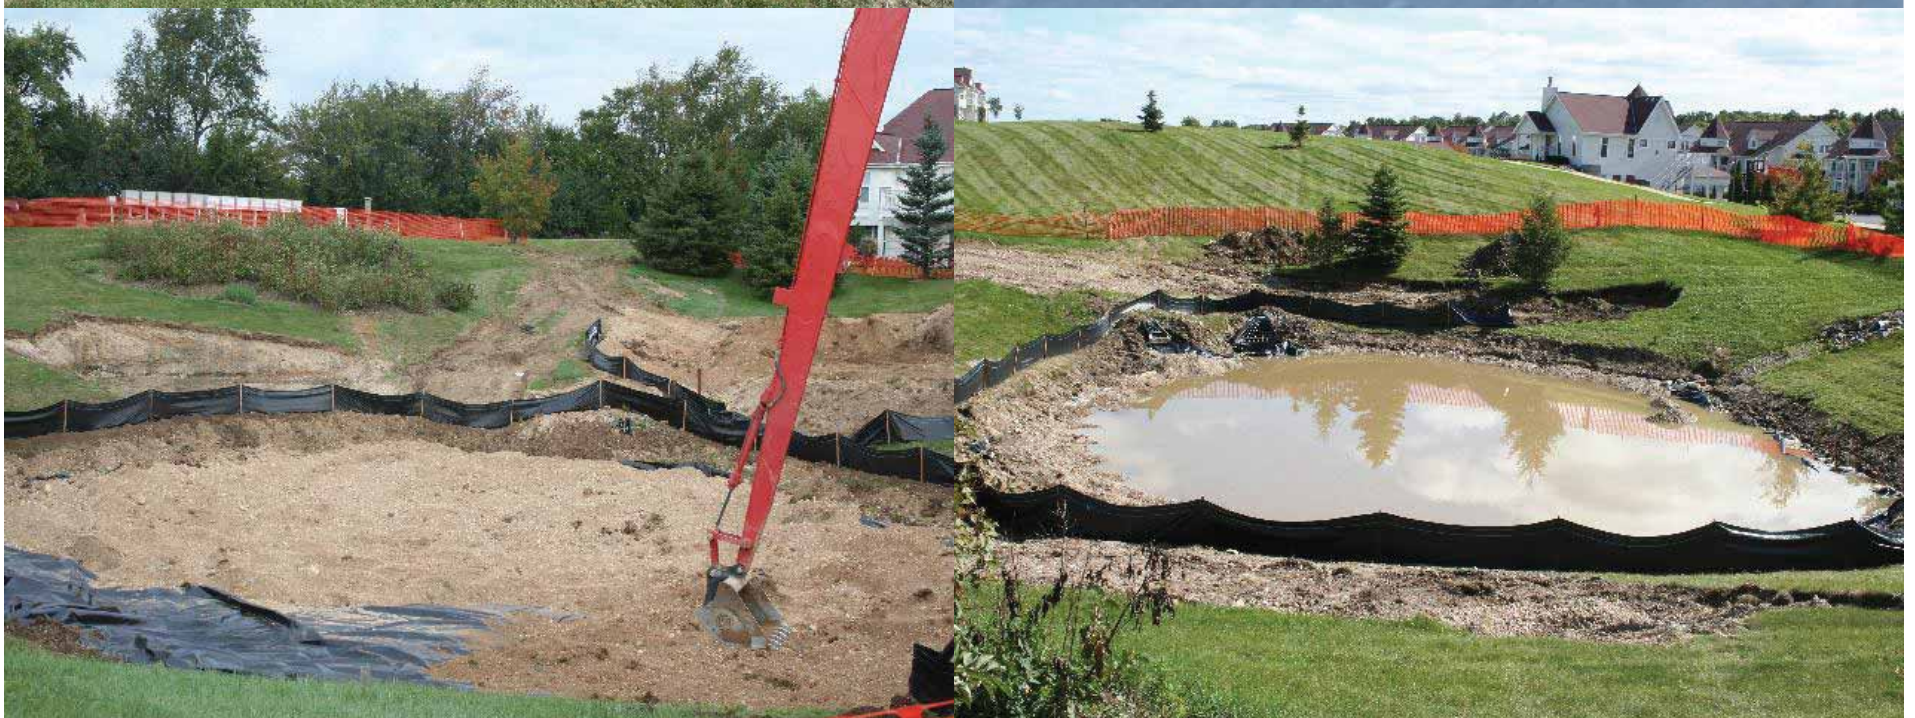
Liner: Step 4
Soil on liner
provides protection
from UV rays &
ballast to hold liner
in place

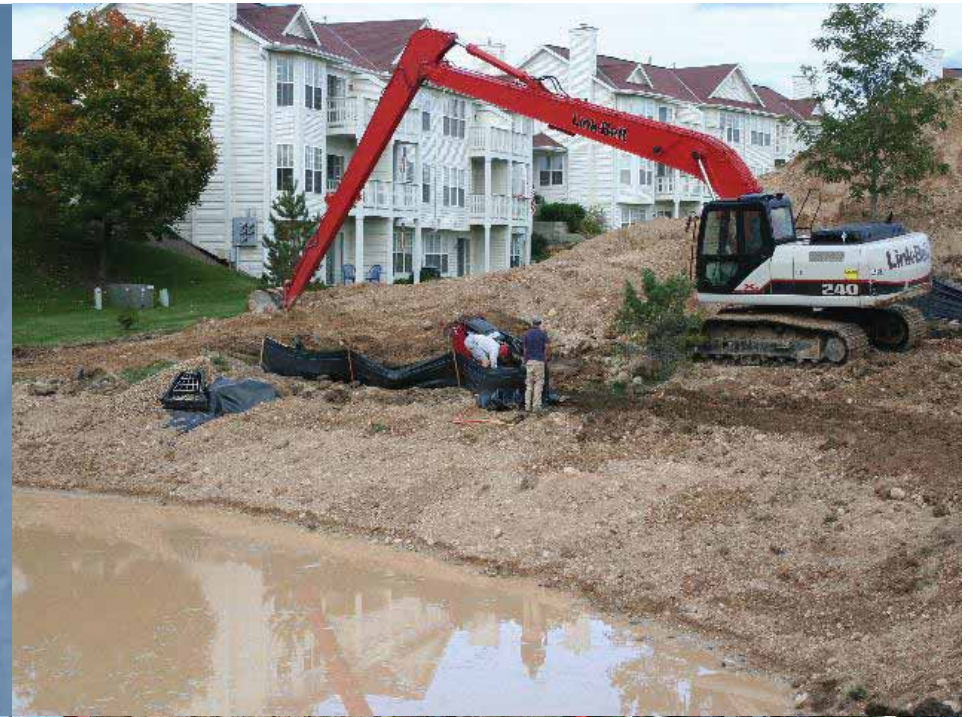
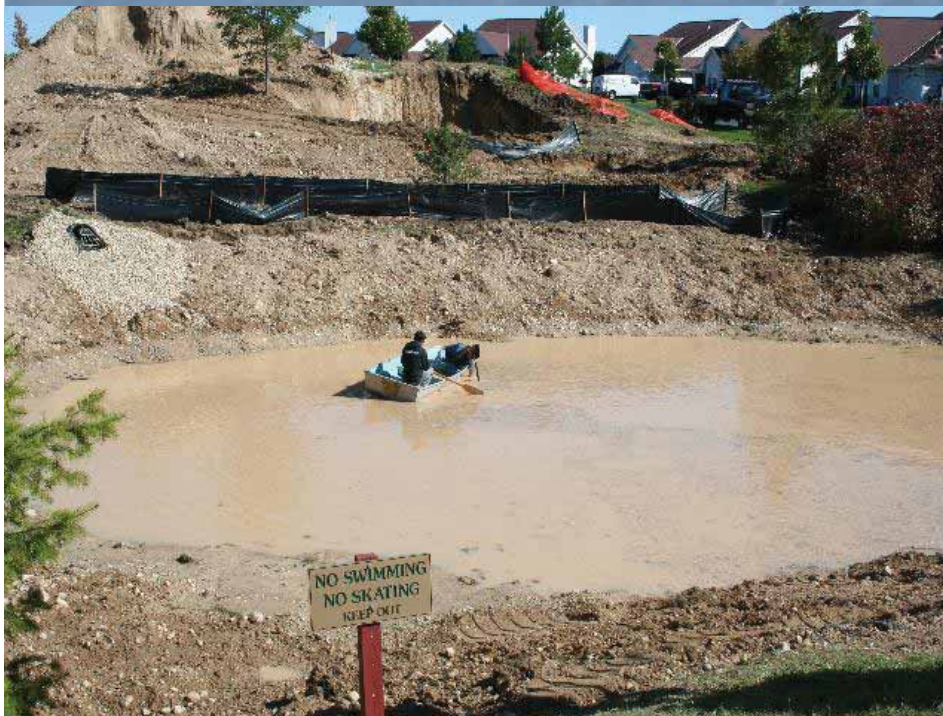
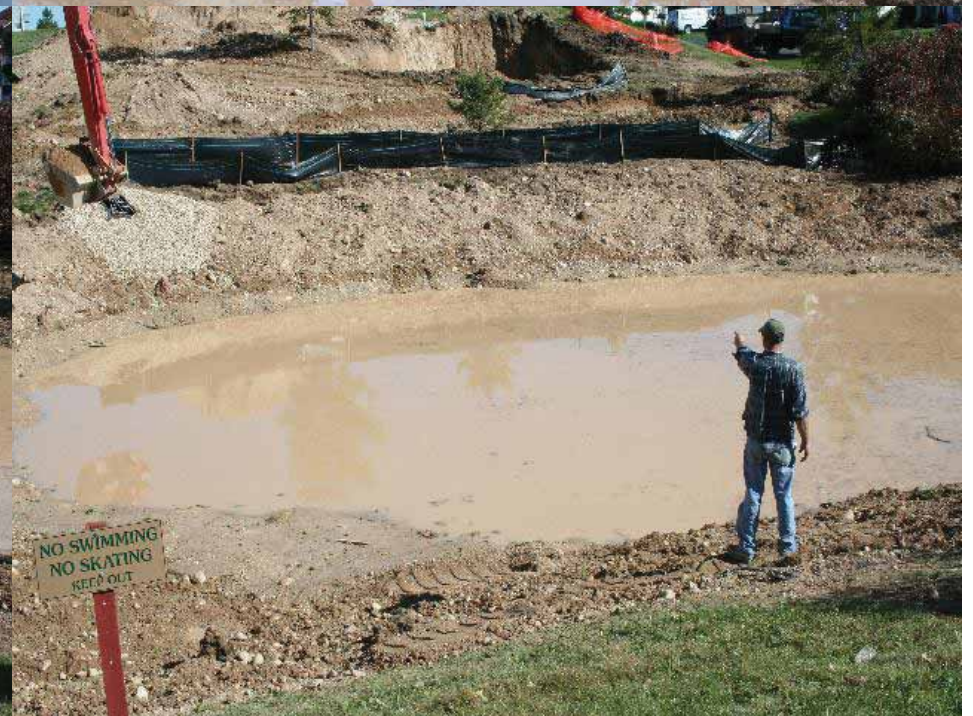
Placing soil on
rain filled North
pond liner more
challenging
