**Yellow Floating Heart
Eradication From Two Storm
Water Ponds Near
Delavan Lake**

**Heidi Bunk, DNR Lakes
Biologist**

**Audrey Greene, Walworth
County Lakes Specialist**

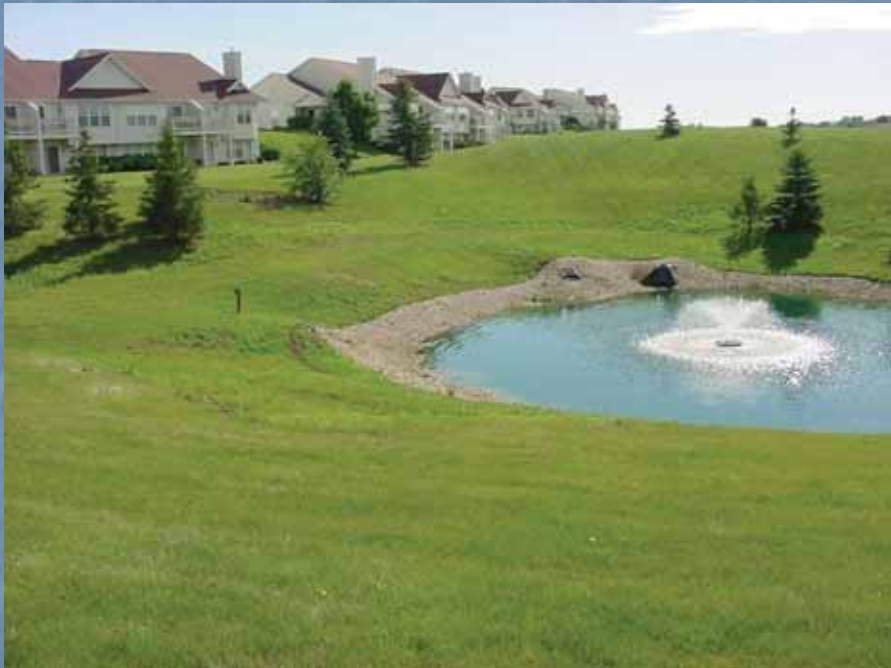
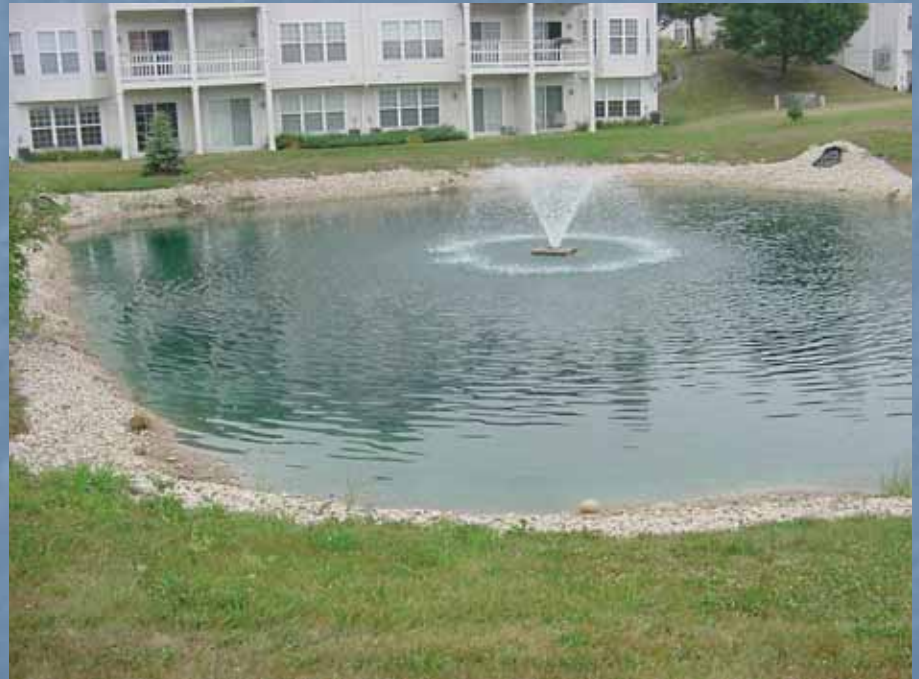
Final Steps: Erosion control matting
Final Landscaping Spring 2010
Pictures from June 10th, 2010

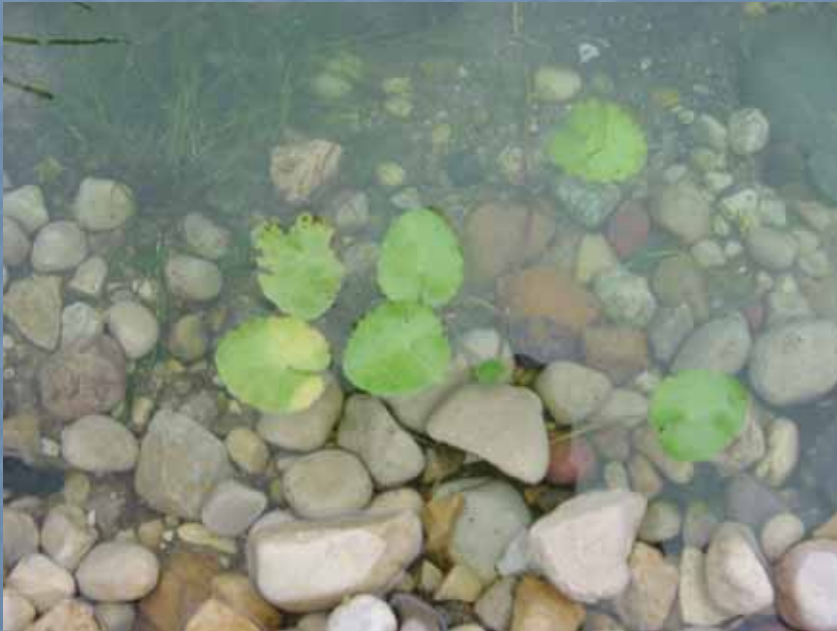
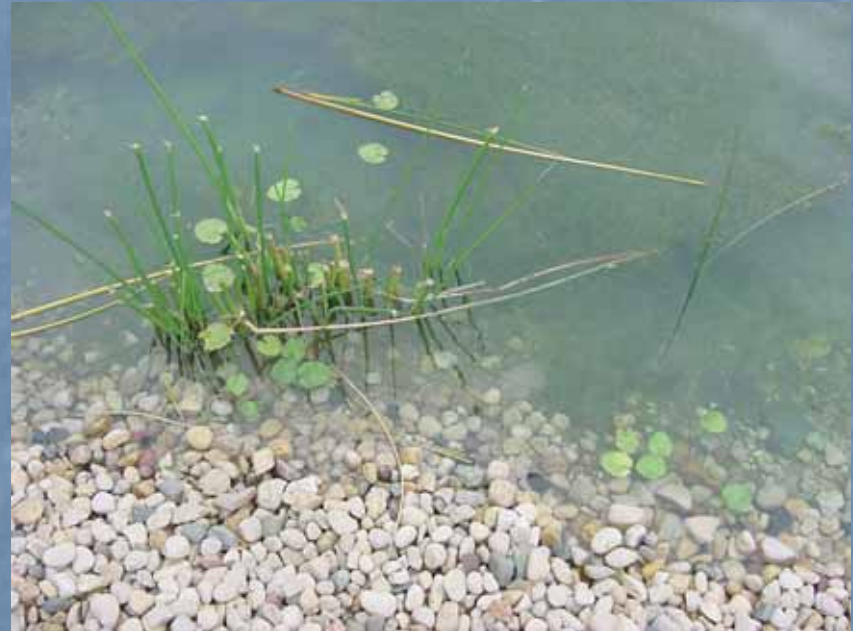
Ponds were monitored every other week in 2010 – A few plants found September 1st, 2010 and removed
