12+ inches of rain
+ steep topography =
muddy waters

Randy Stowe
Apple Canyon Lake

- Apple Canyon Lake (ACL) was formed in 1969 by damming Hell's Branch, an Apple River tributary in Jo Daviess County.
- The 450 acre lake is the focal point of a 2,700 acre / 2,727 lot recreation-based residential community.
- The balance of the 9,870 acre watershed is dominated by agricultural uses, with cropland comprising 50% of the watershed.

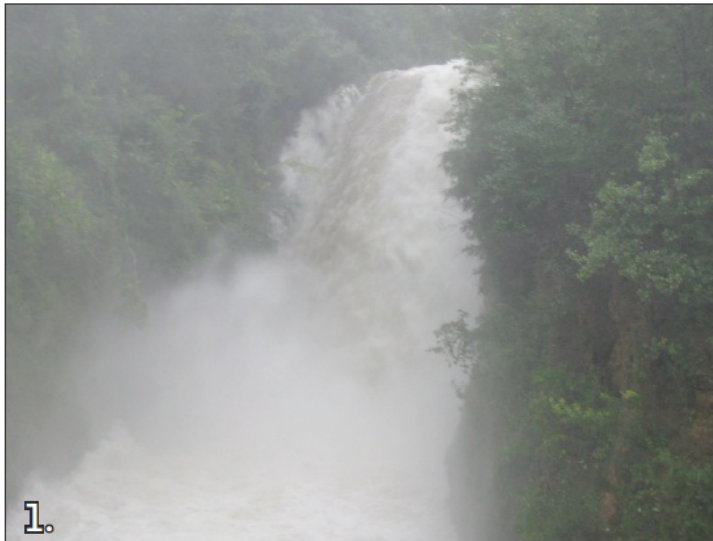
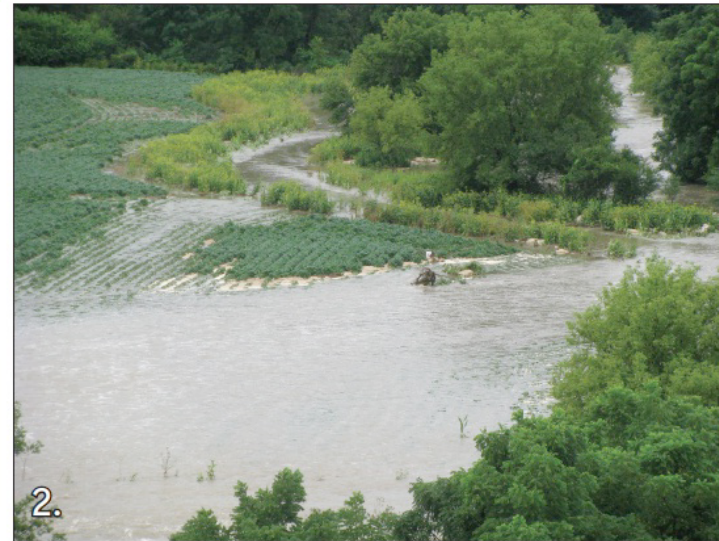
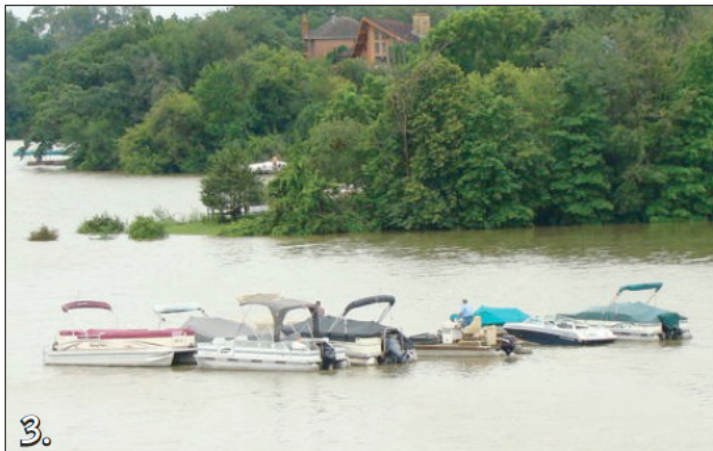
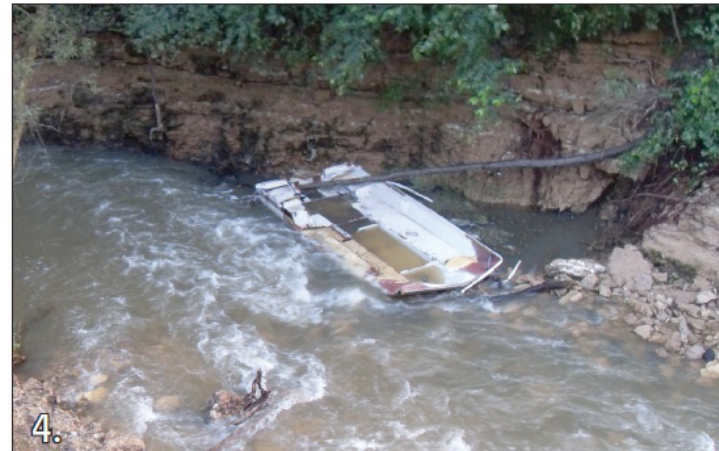
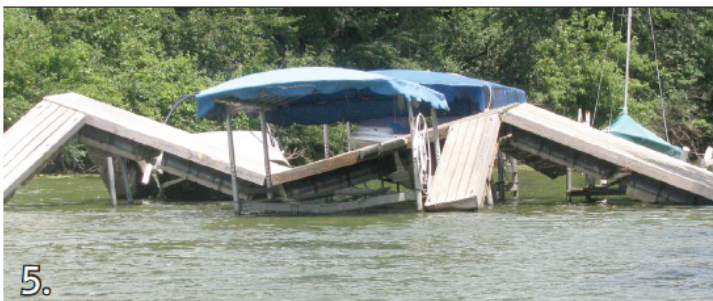
Scenes from the Flood of 2010; still plenty of work to be done

1. The force of the water raged over the spillway and above the walls for several days. 2. Hell's Branch Creek flowed into the the "lower 80" flooding the walking trail. 3. Maintenance crew member Mark Krueger secures a renegade dock with boats still attached. 4. At least one boat went over the spillway, but maintenance crew members discovered fiberglass remnants further down the creek, leading them to believe there were more. 5. A majority of docks were damaged; maintenance and K&S Marine crews worked diligently to secure, reposition, and repair them.

It was challenging to say the least, but in as little as one week ACL staff from all departments, and crew from K&S Marine worked diligently to get the lake cleared and the amenities open after the storms and floods of July 23 and 24. Amenity updates were posted in a number of places daily and by Friday afternoon, July 30, most of the amenities were open for use. At this point the trails remain closed for an undetermined amount of time due to the severe damage. We would like to thank you for your ongoing patience as we continue to clean up after the storm.

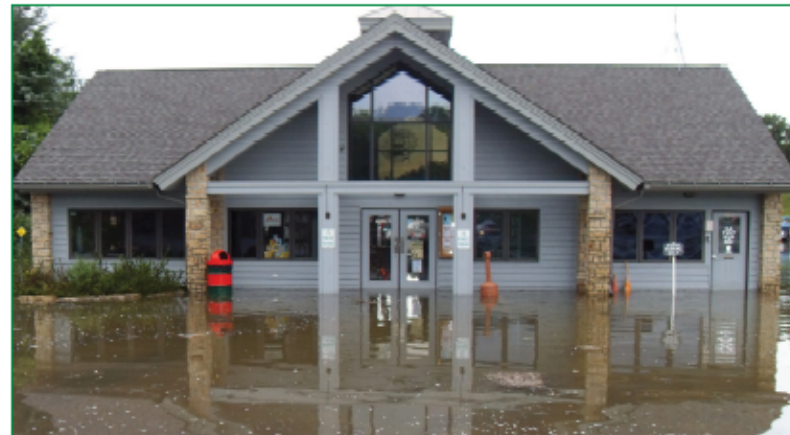
“The lake and the beach are both closed,” Davis said. “There is too much debris out

there now for people to boat and we are going to have to get several loads of sand to the beach to restore it. We had several docks that rose and fell with the water levels and they have to be anchored again to be usable. It’s going to be a long process, but we will do it a little at a time and get it done correctly so that our residents will be safe when they use our amenities.”

Davis said the trail system would take some time to restore, as some of the ruts are more than a foot deep.

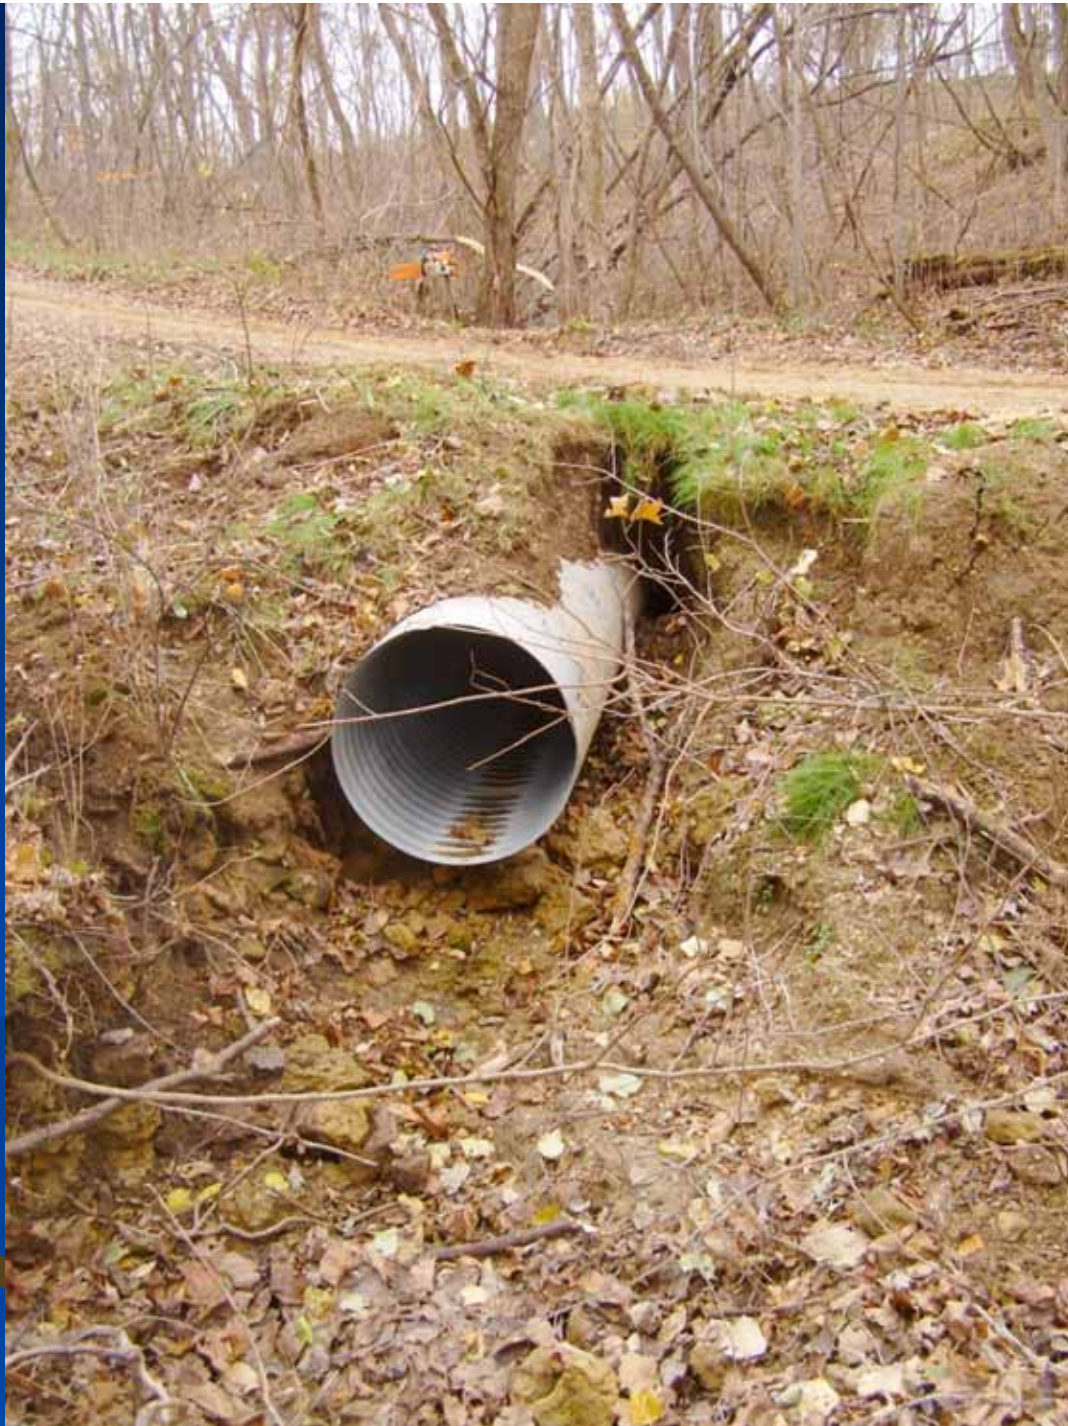
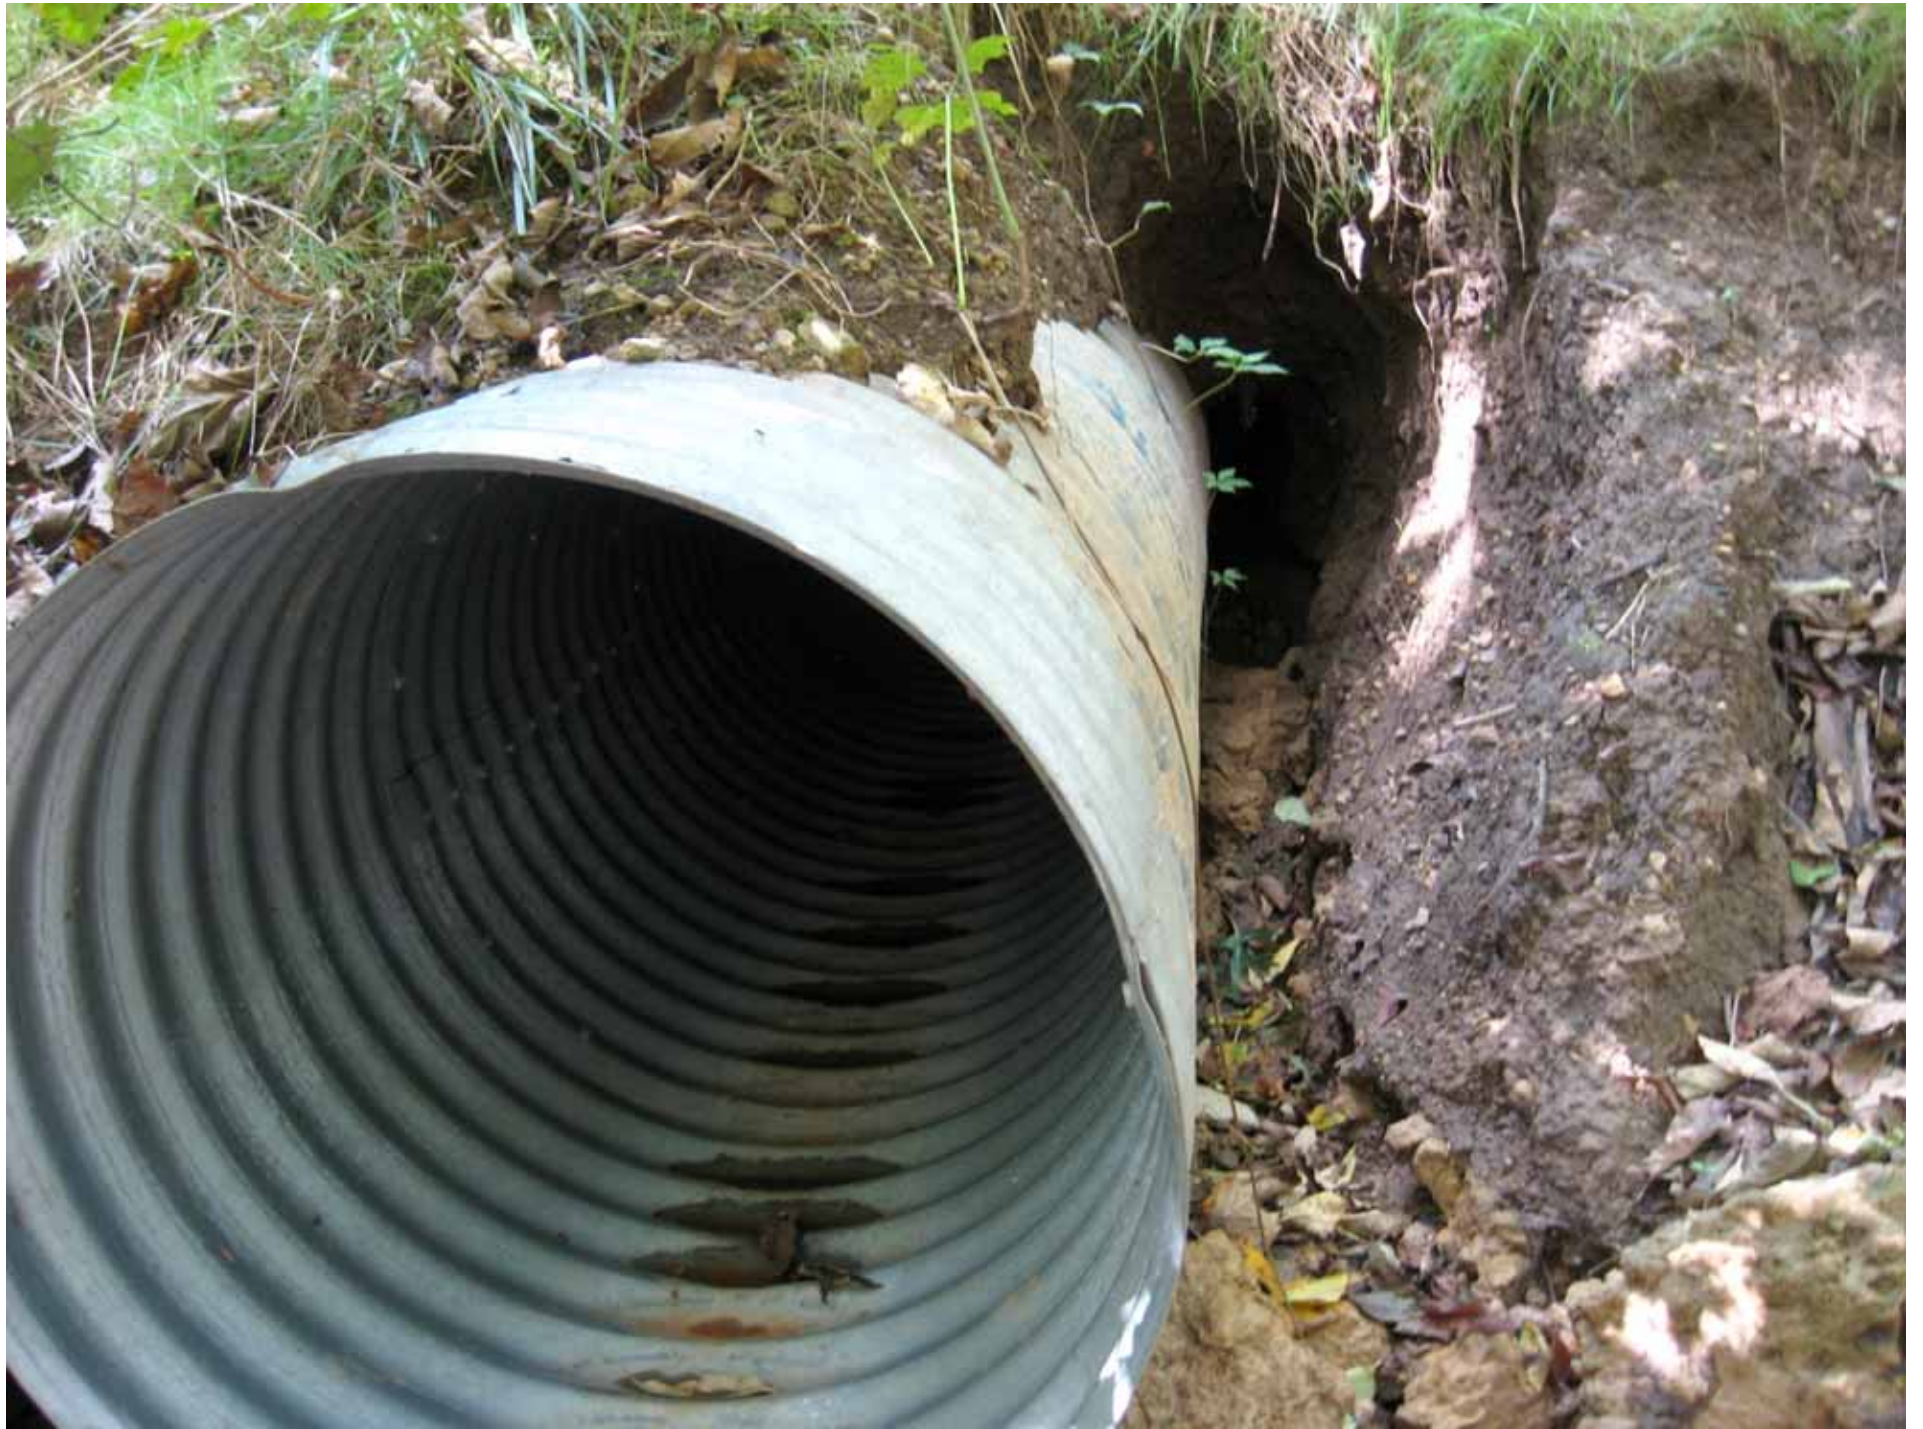
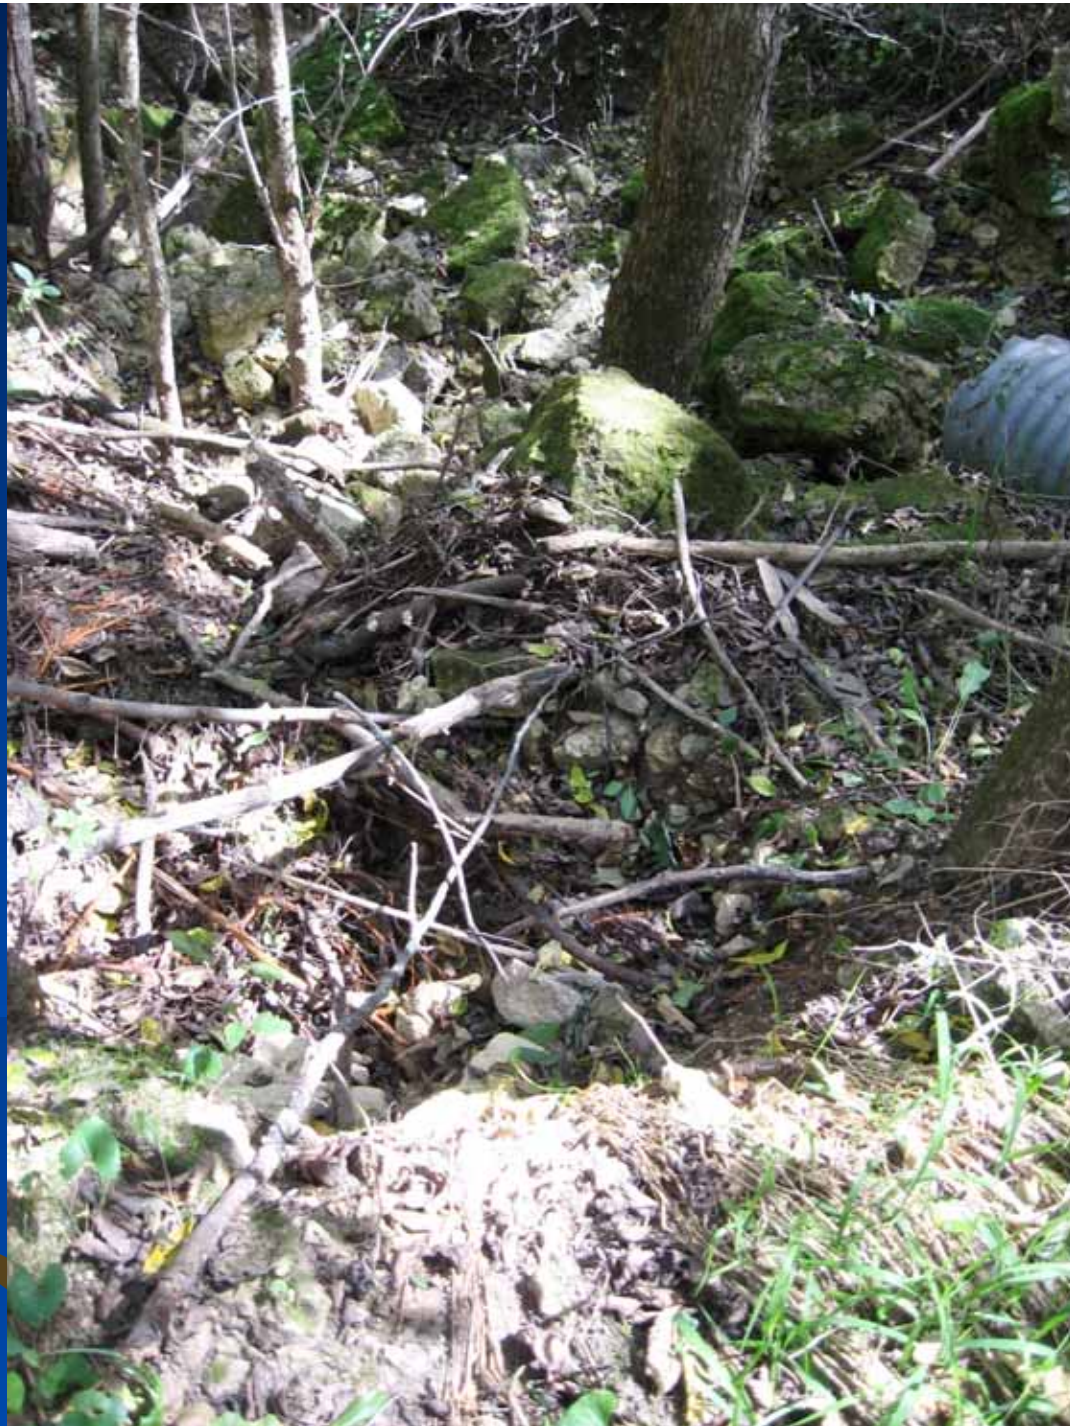
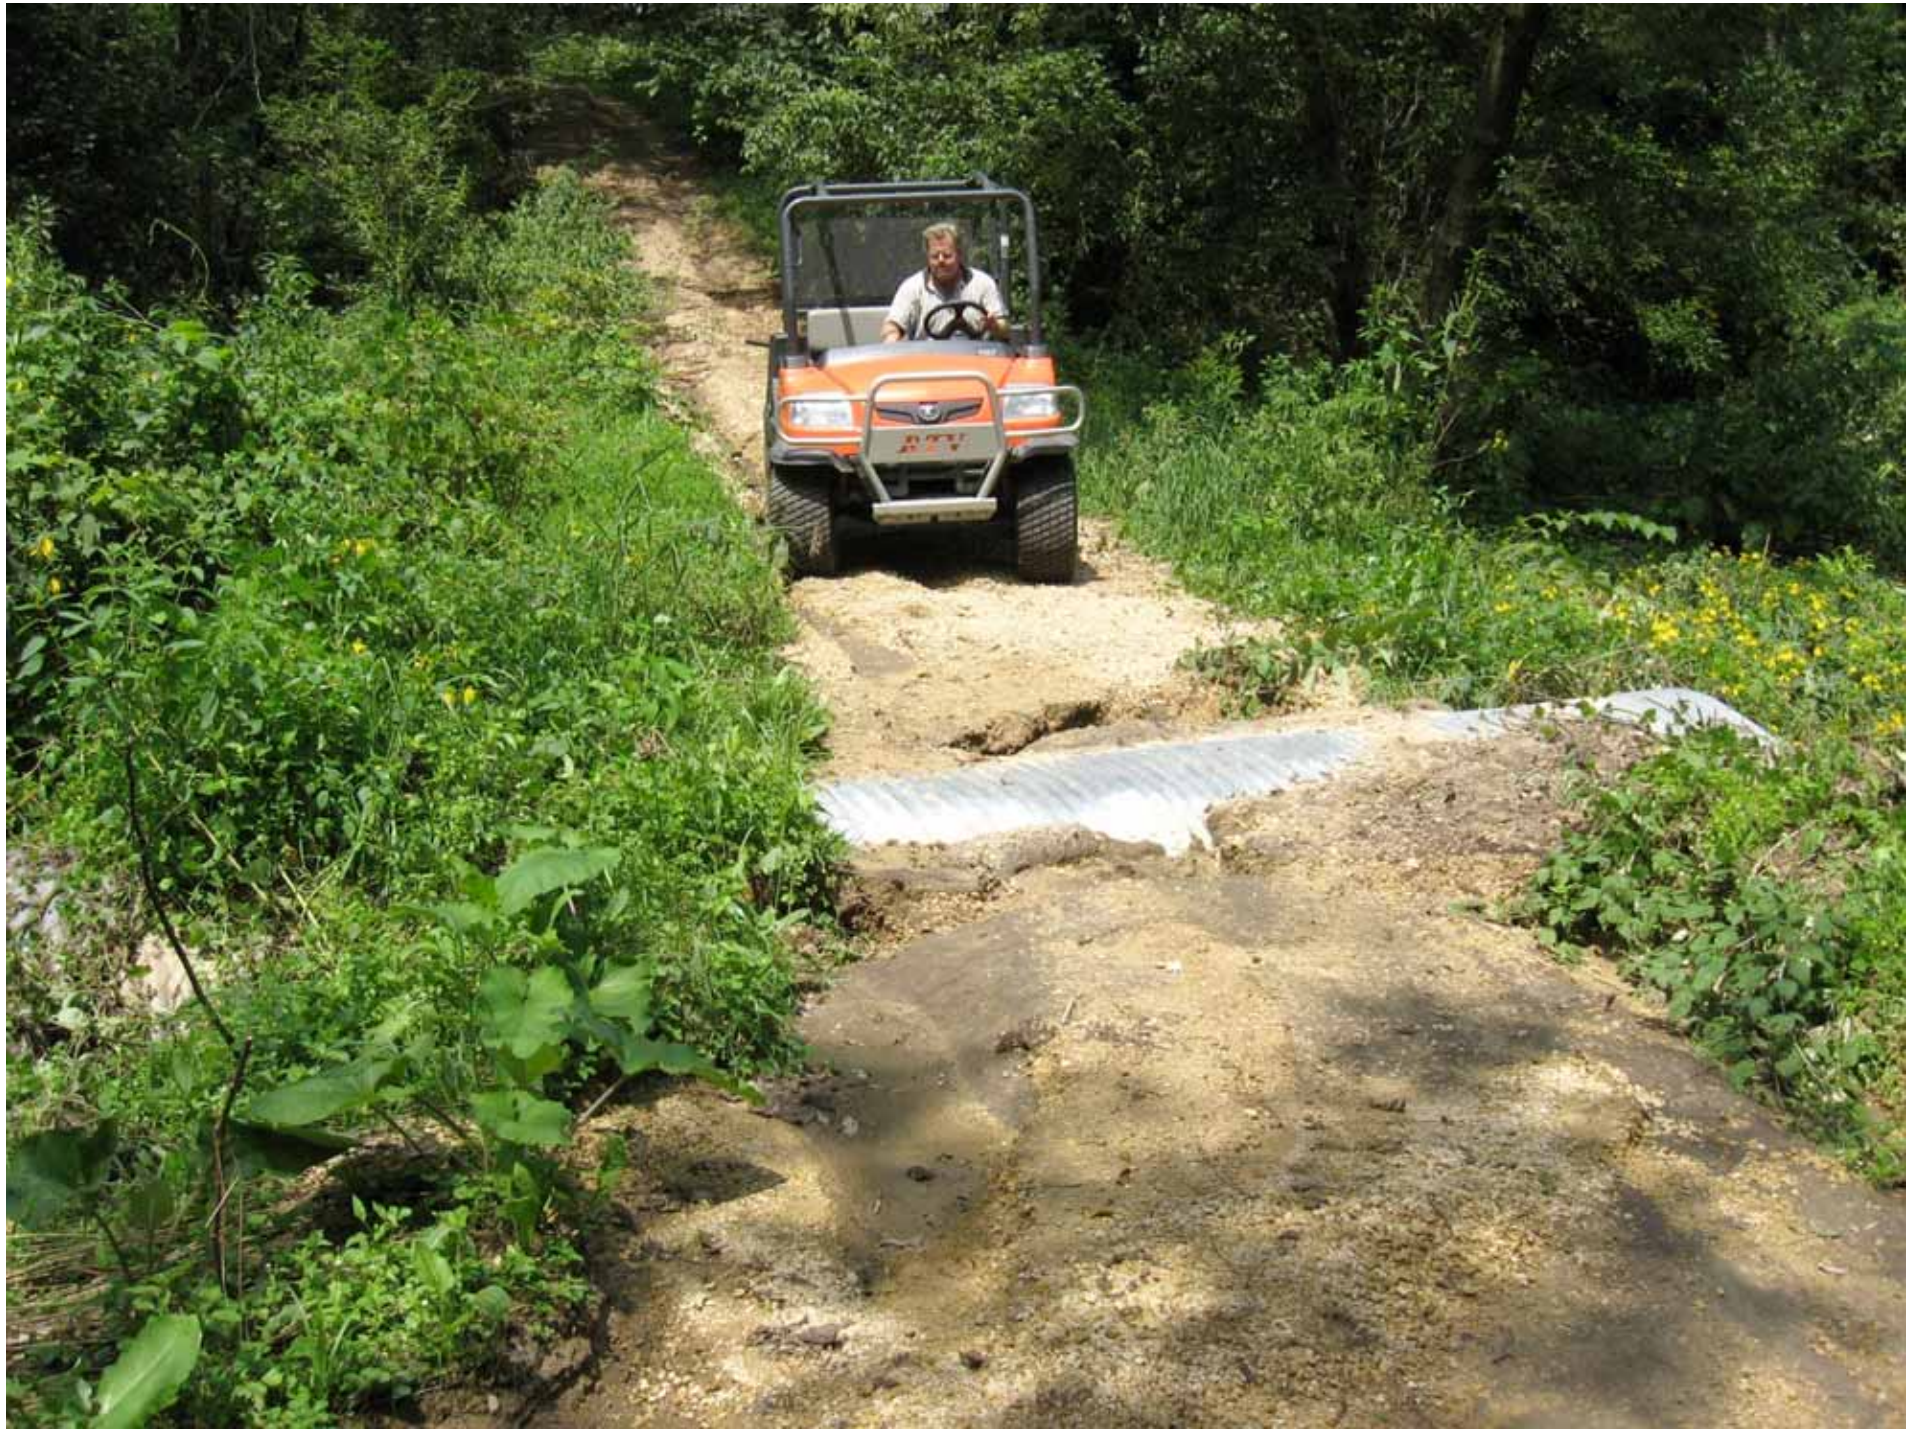
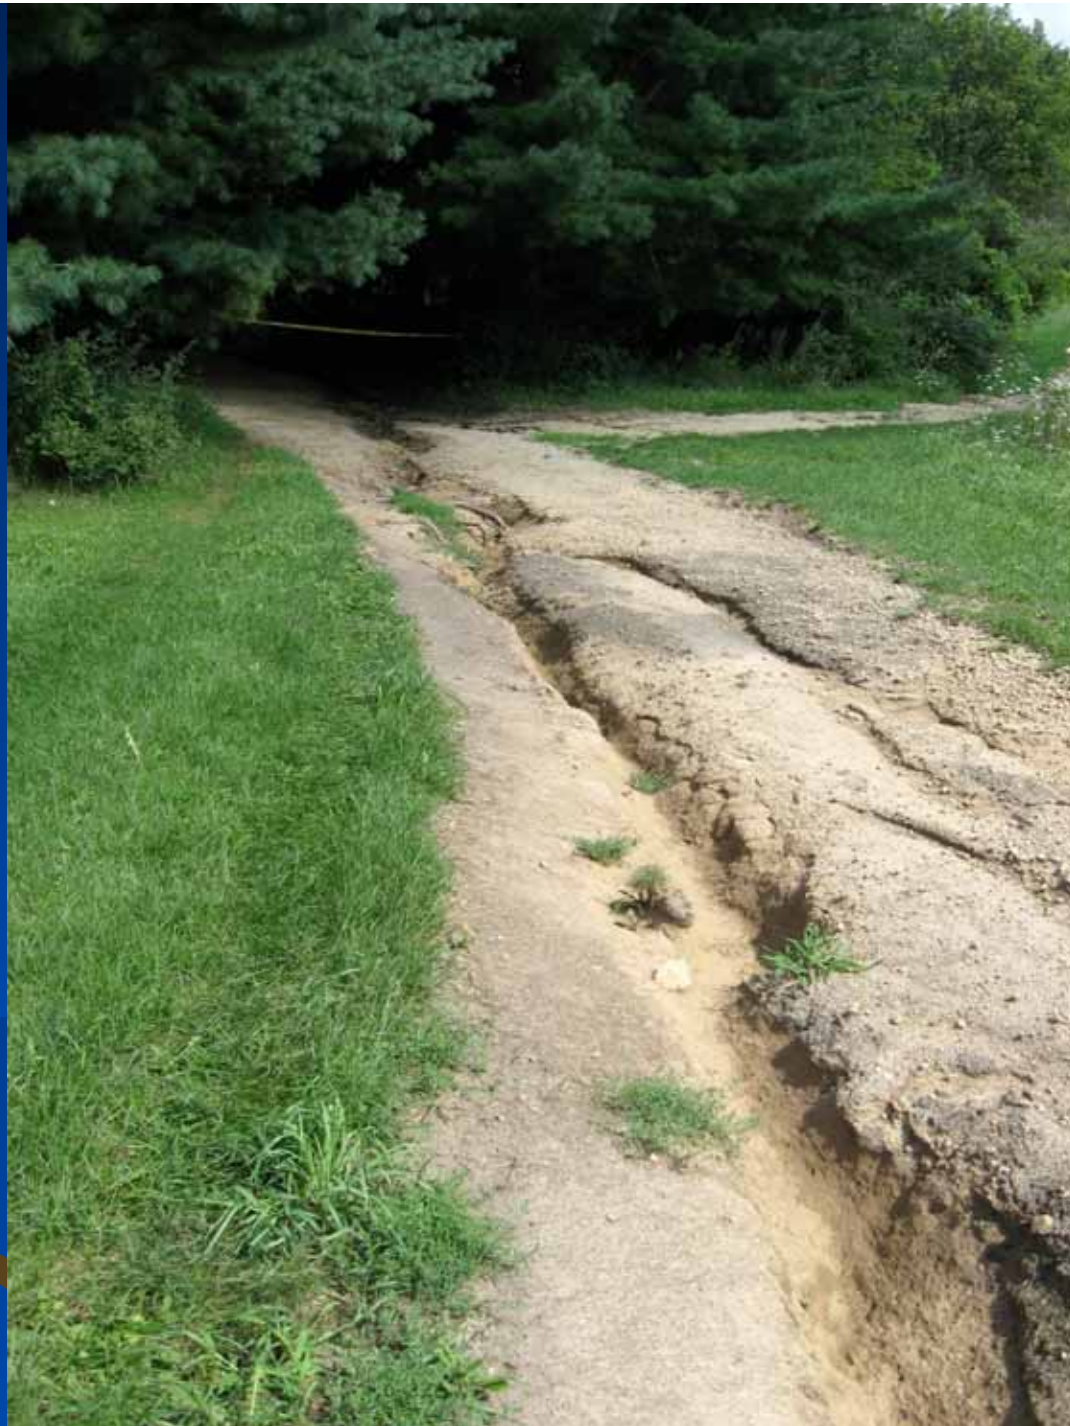
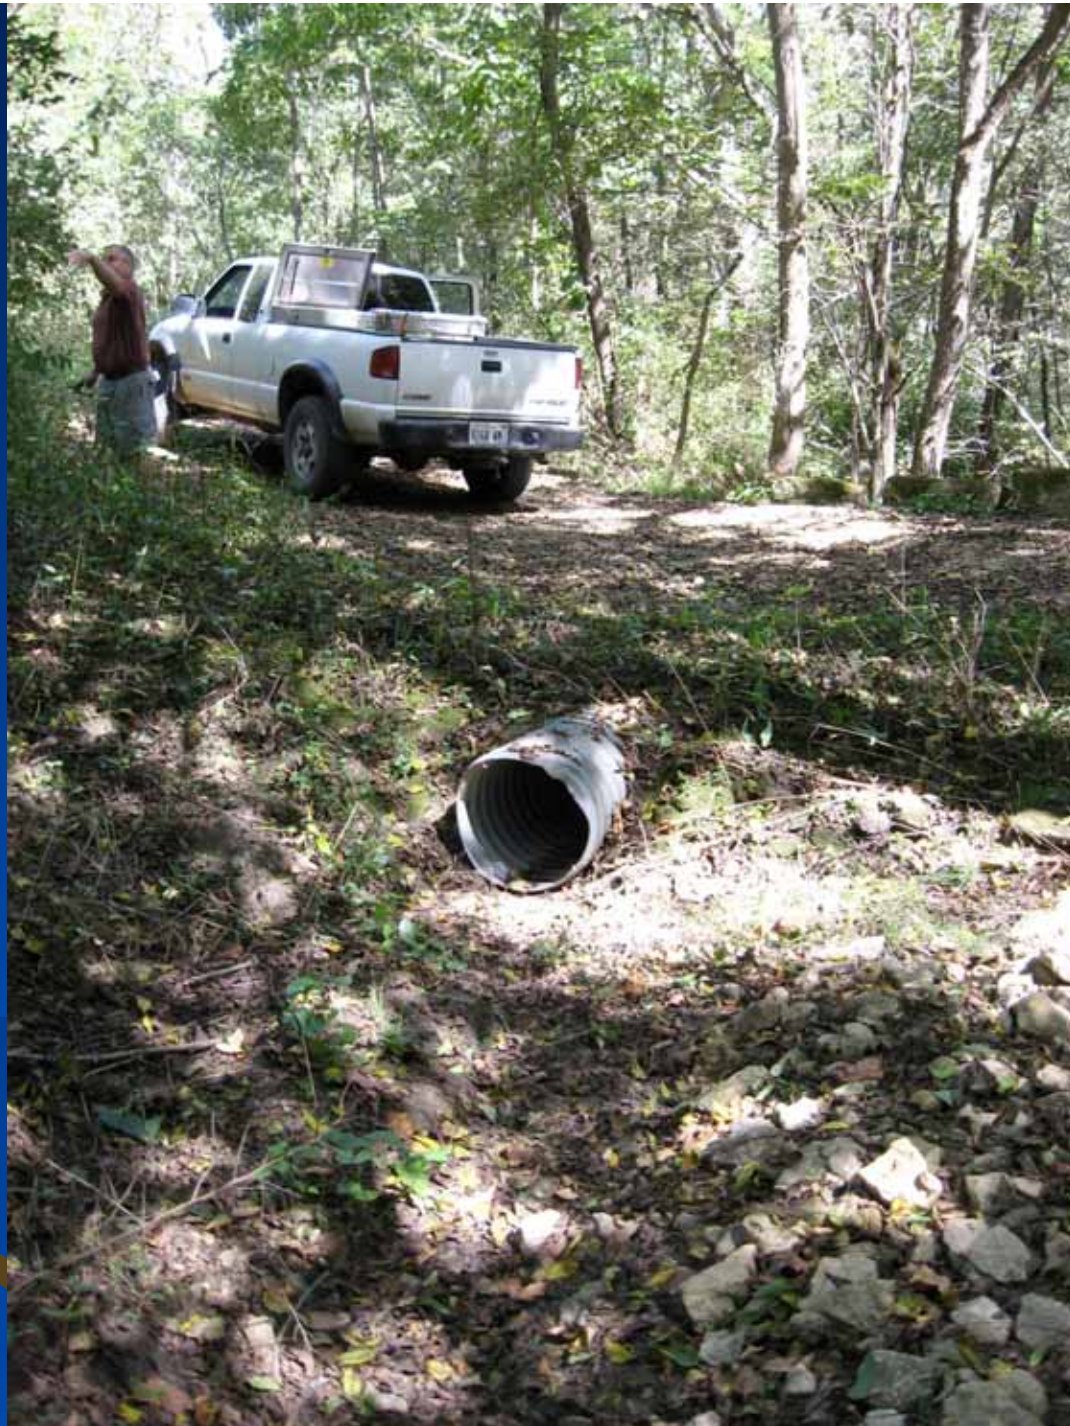
- The trail system circling ACL was particularly hard hit, with trail surfaces washed away or gullied, and the trail itself washed entirely away at locations where drainage ways crossed the trail.
- Significant damage also occurred to the stream channels themselves, with significant erosion, downcutting, and sediment delivery to the lake.
