# FRSG Low Flow Study Collaboration

- Client: Fox River Study Group (FRSG)
- Contractors: Illinois State Water Survey (ISWS) and Deuchler Environmental, Inc. (DEI)
- Time Frame: June 2012
- Location: Fox River from Crystal Lake to Sheridan, IL

- Purpose: Collect dissolved oxygen data and water quality data during “low flow” conditions for model needs
  - > 3 days of data collection
  - > 3 times a day: 4-7 a.m., 11-2 p.m., and 4-7 p.m.
  - > 12 mainstem sites, 11 tributary sites
  - > Sondes and manpower needed
  - > ISWS north half, DEI south half
  - > Other aspects – benthic algae, stage and discharge measurements, SOD measurements, surveying

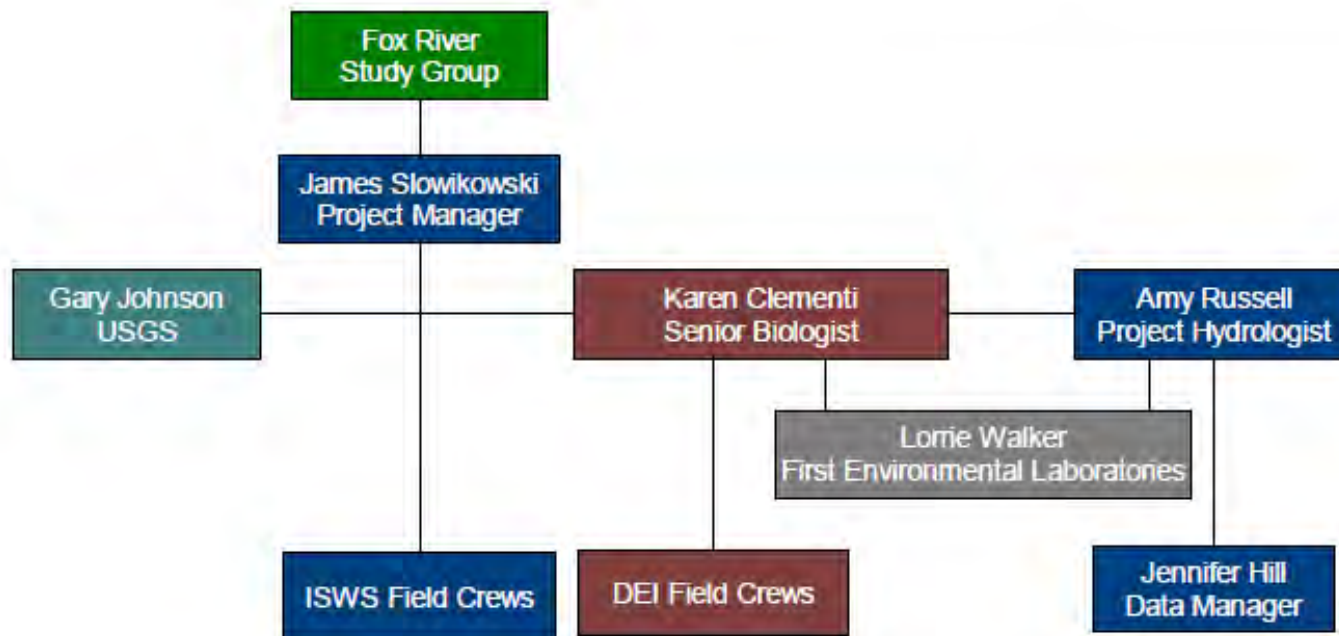
Figure 1-1. Organizational chart of the FRSG DO monitoring project

- 4 ISWS teams, 4 DEI teams of 2 people collecting the WQ data
- Additional DEI team collecting algae data
- DEI staff member collecting samples at Geneva for all DEI and ISWS teams and taking to lab
- Waiting since 2006 so timing was crucial

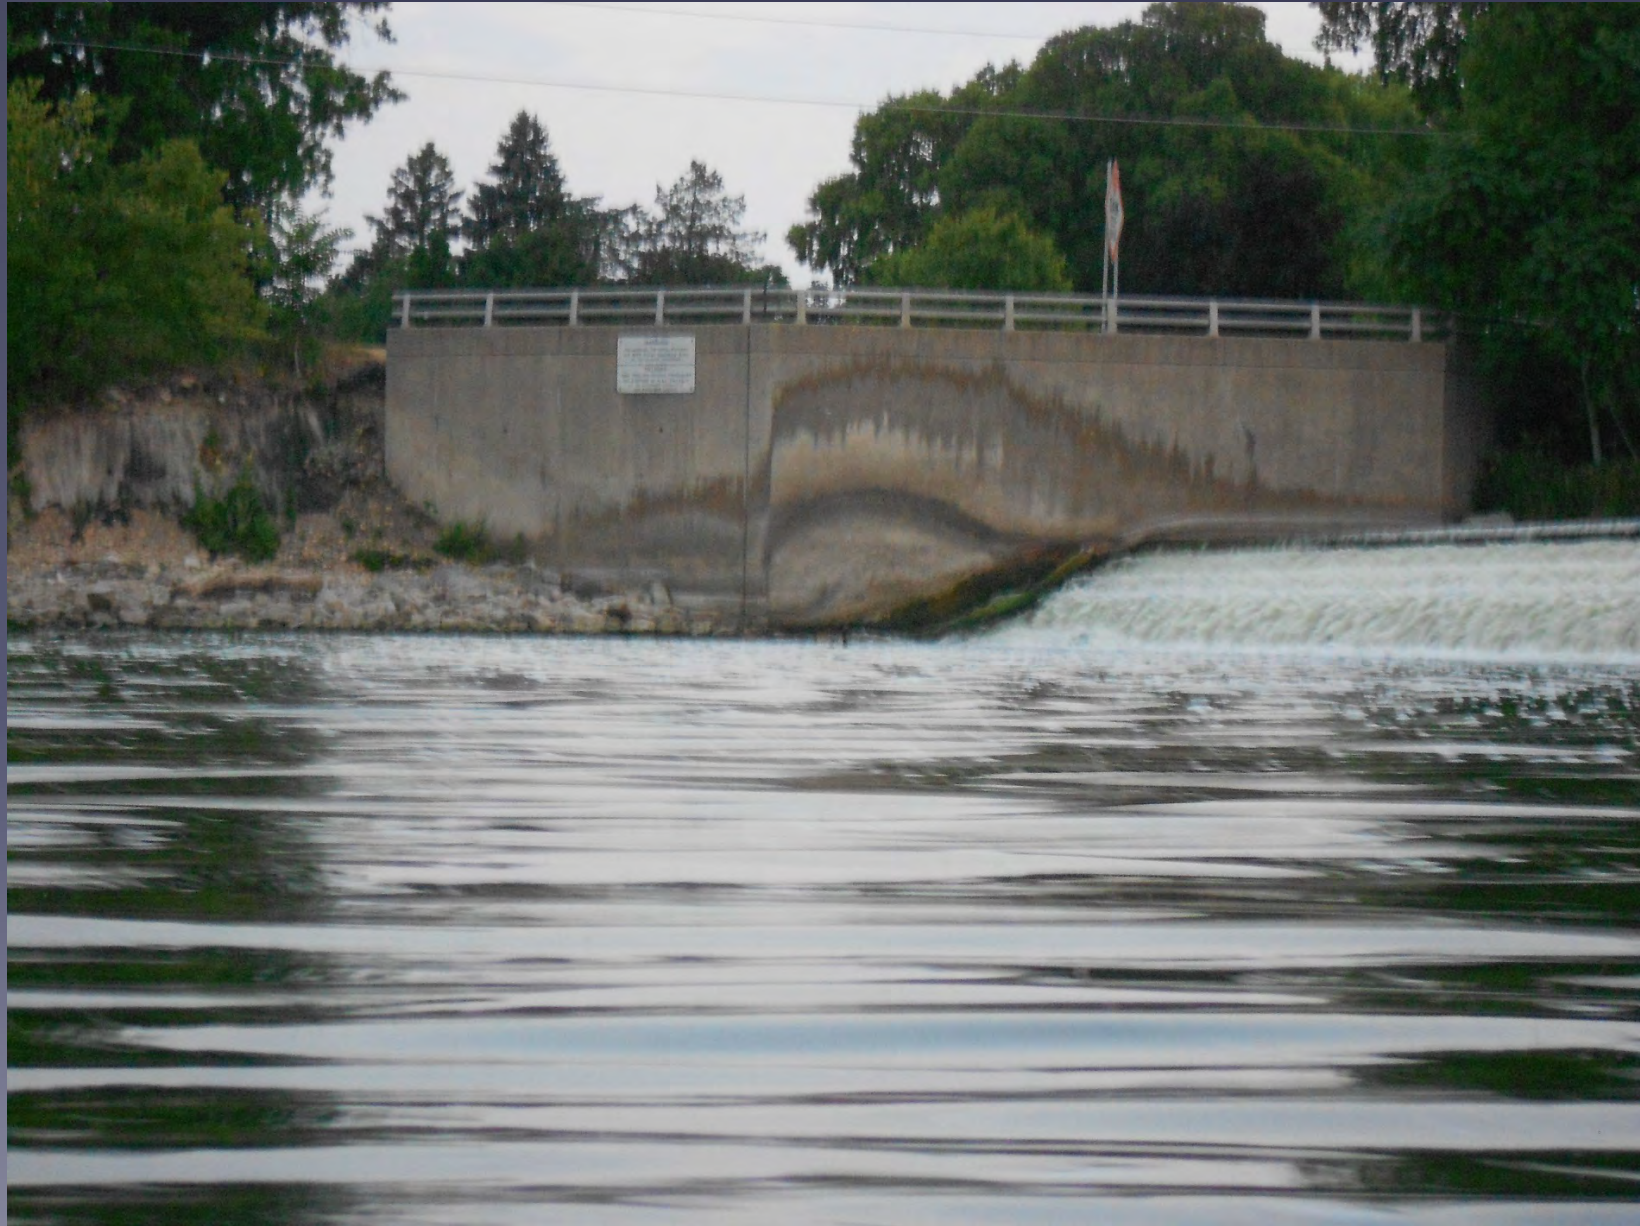
# Watermarks on Montgomery dam retaining wall

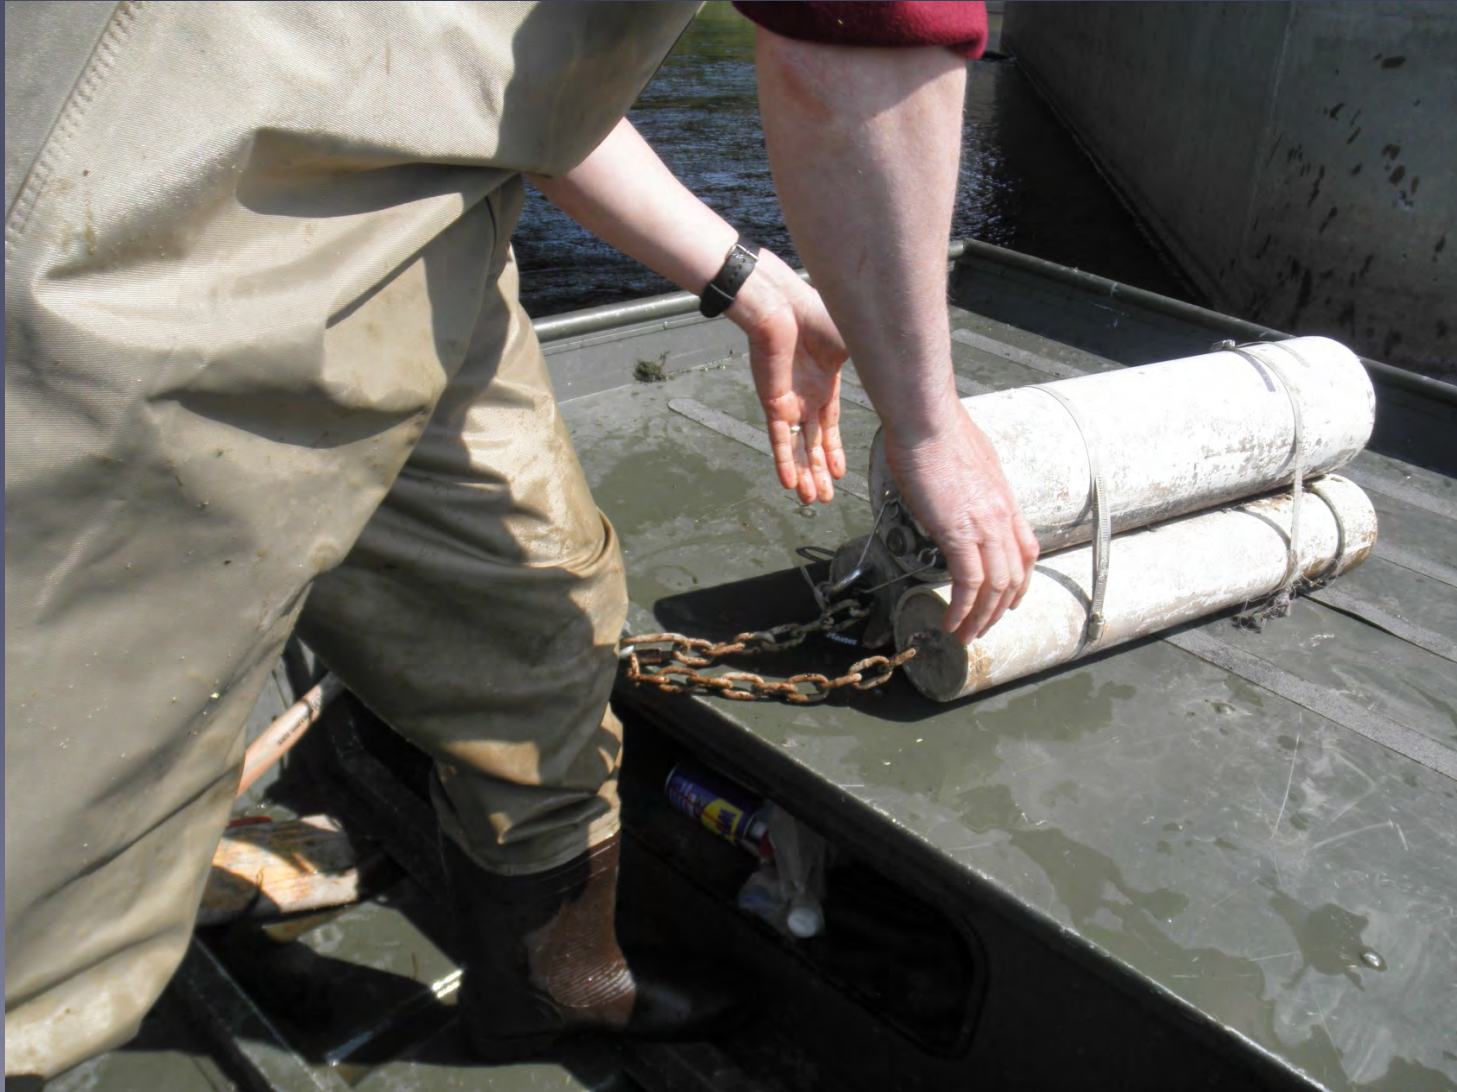
# Sonde deployment

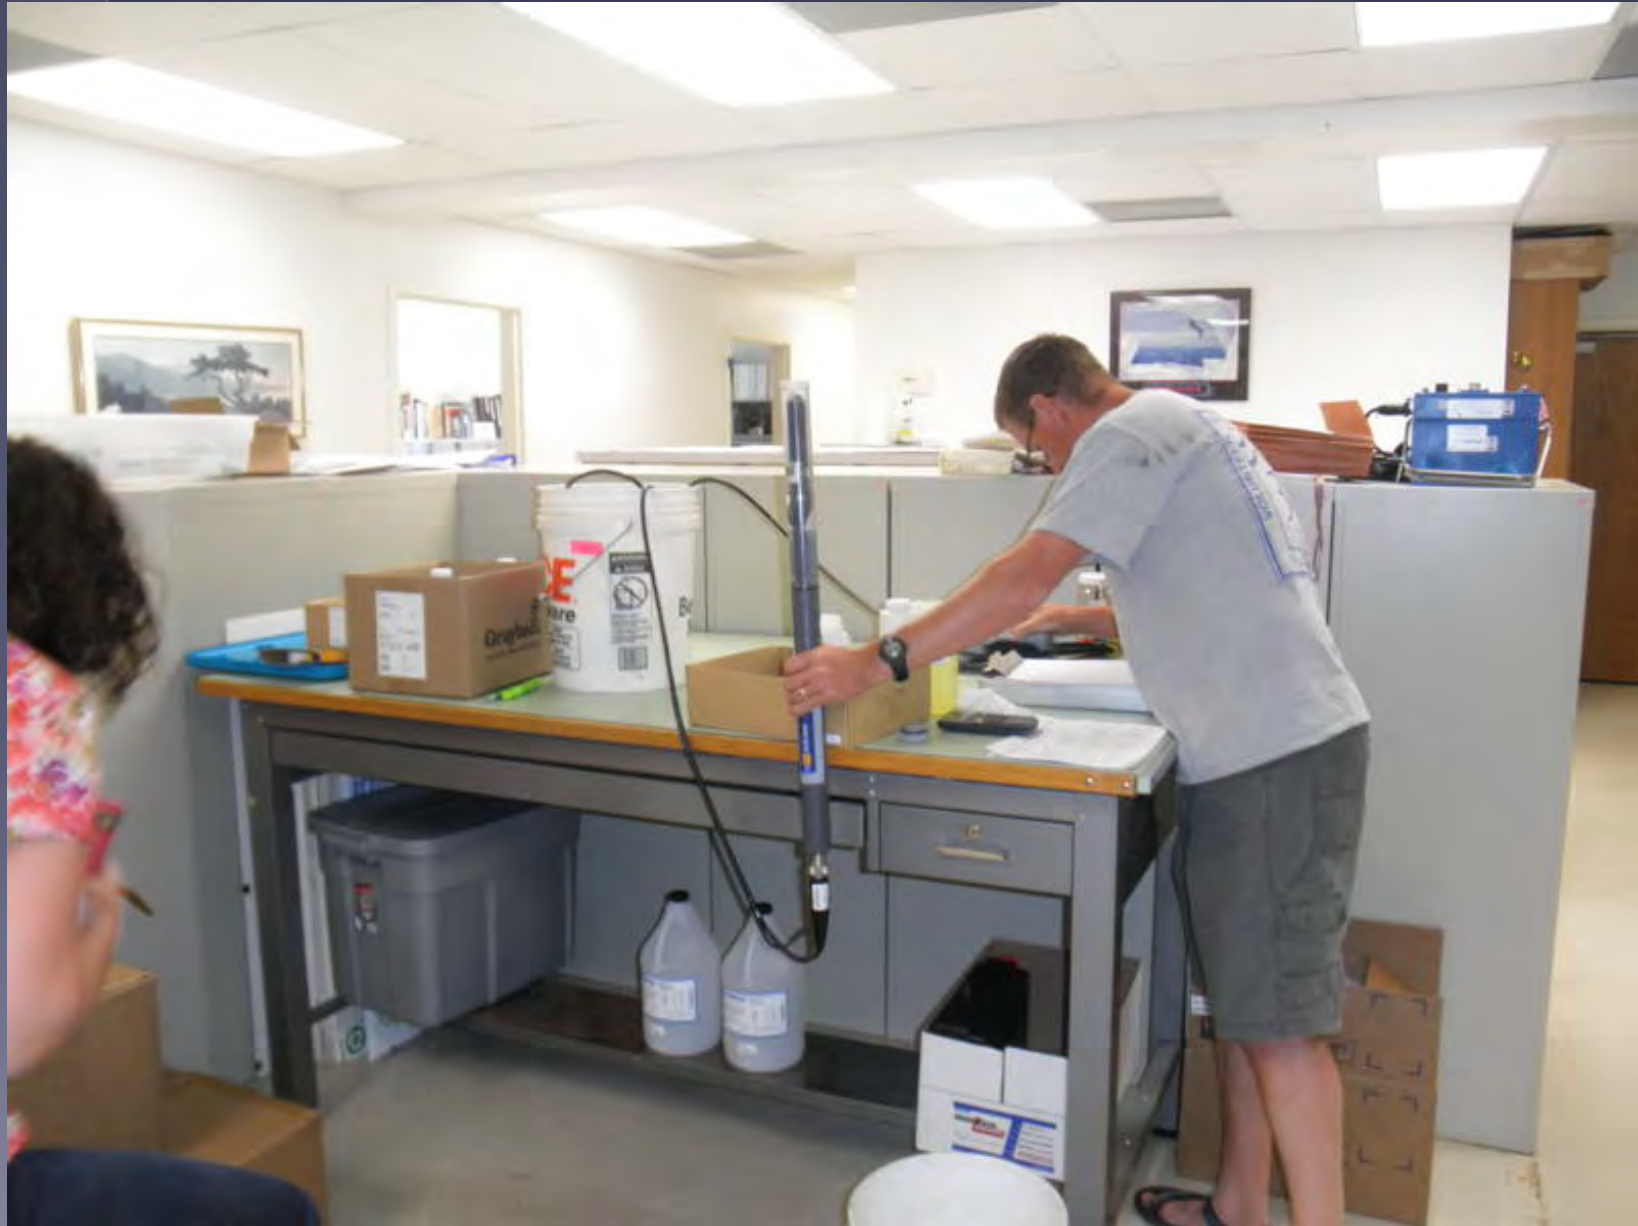
# Calibrating equipment

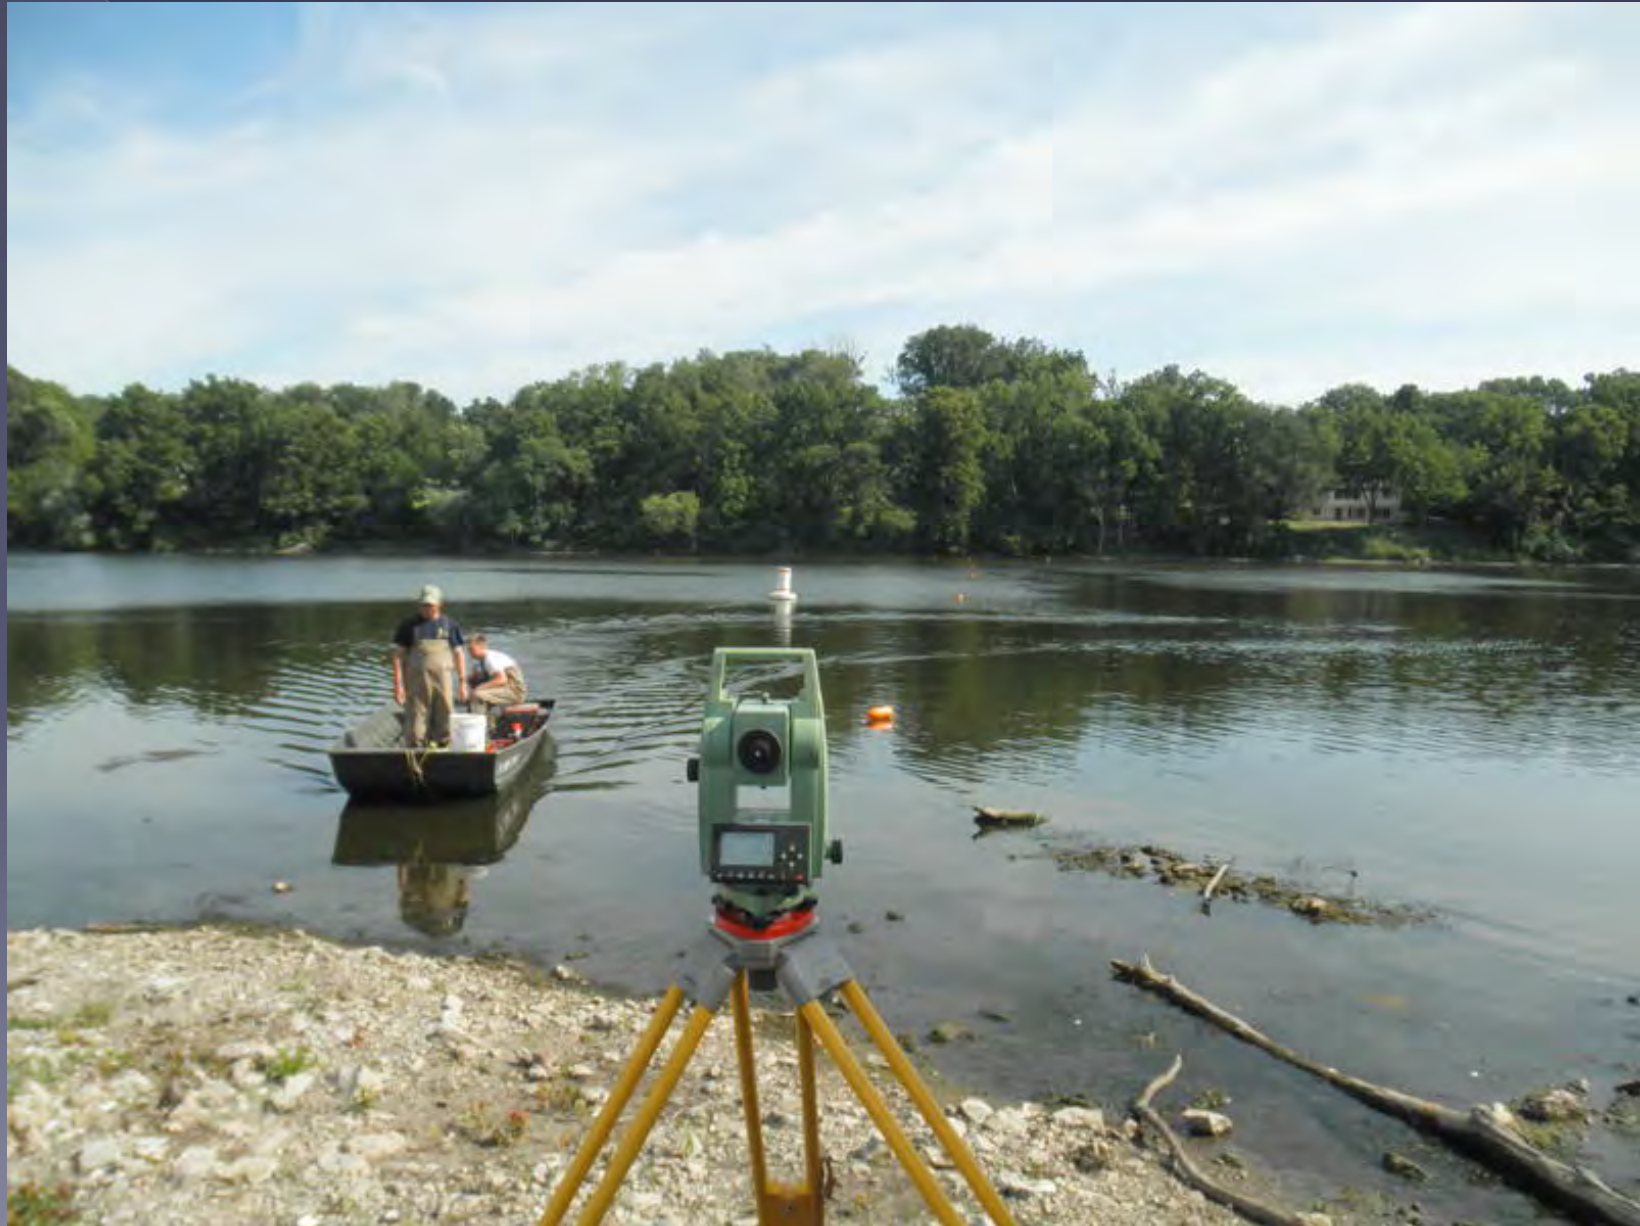
# Equal width transect on mainstem

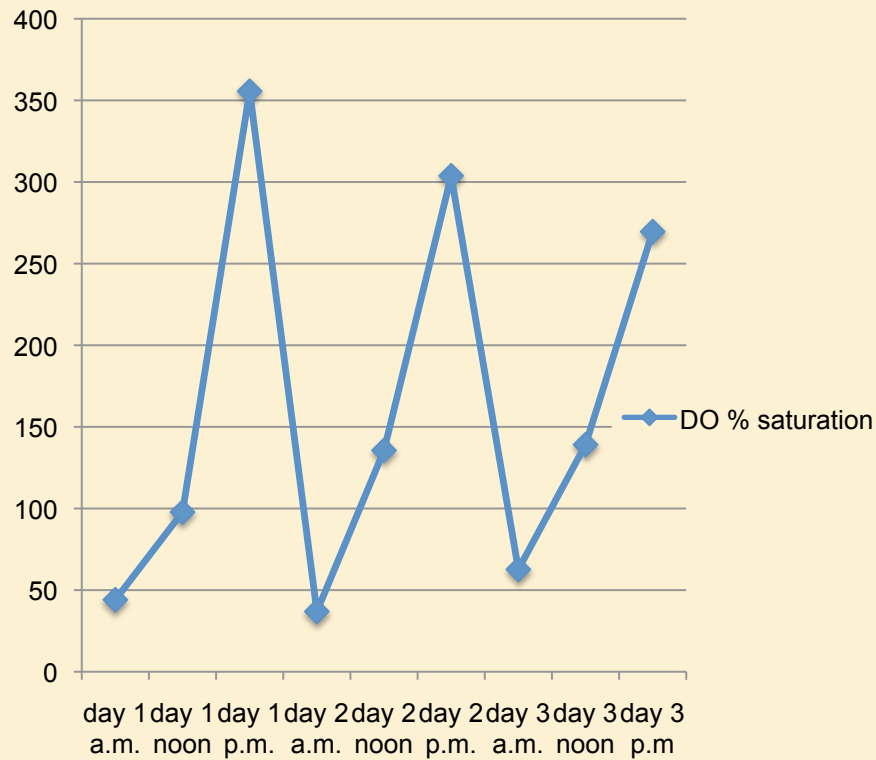
## DO % saturation at Yorkville Dam

# In-situ measurements -- wide DO fluctuations
