**Evaluation of fish community response to dam removals
and fish passage
in Northeastern Illinois**

Steve Pescitelli and Bob Rung, Division of Fisheries

Dam Projects in Illinois - Update

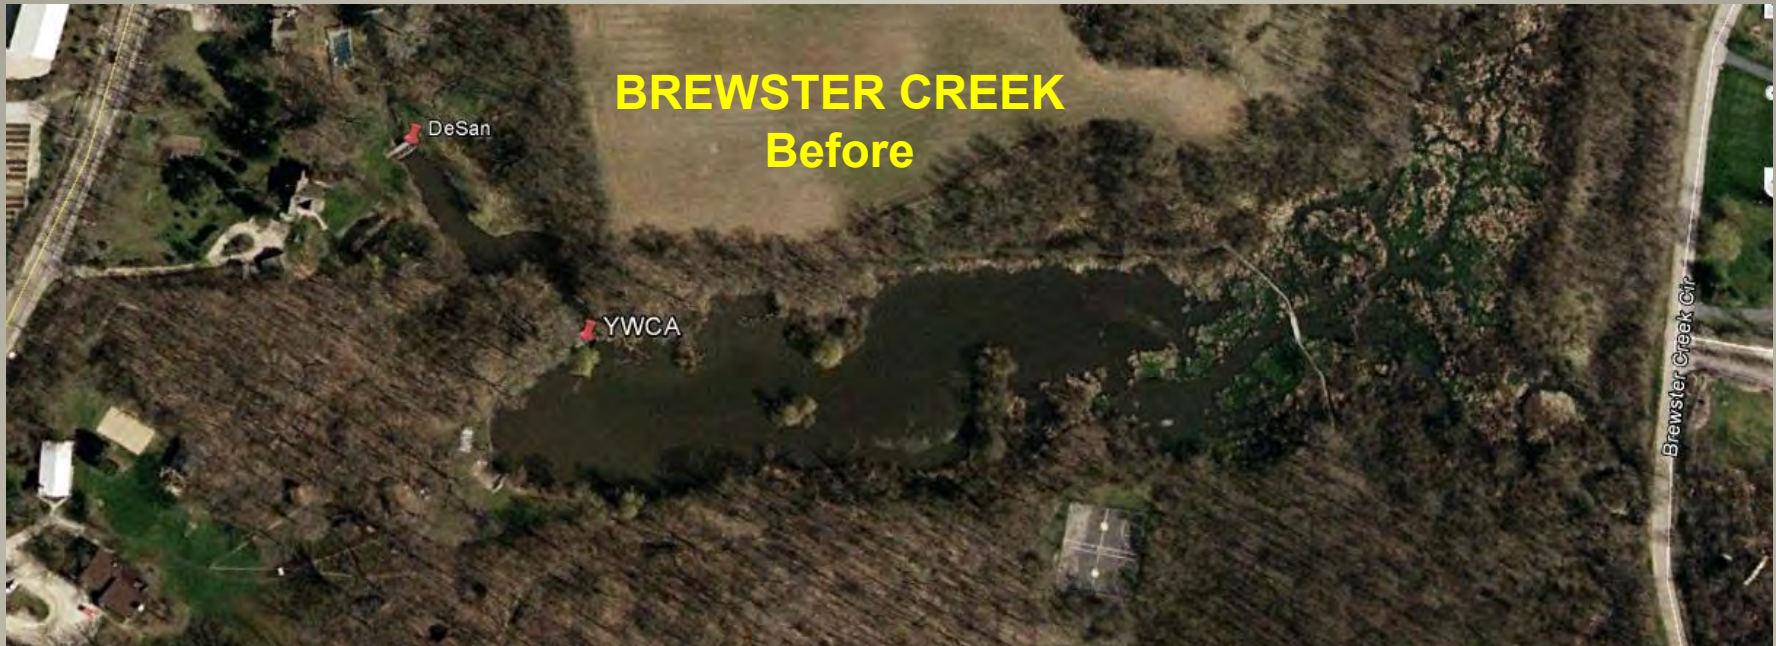
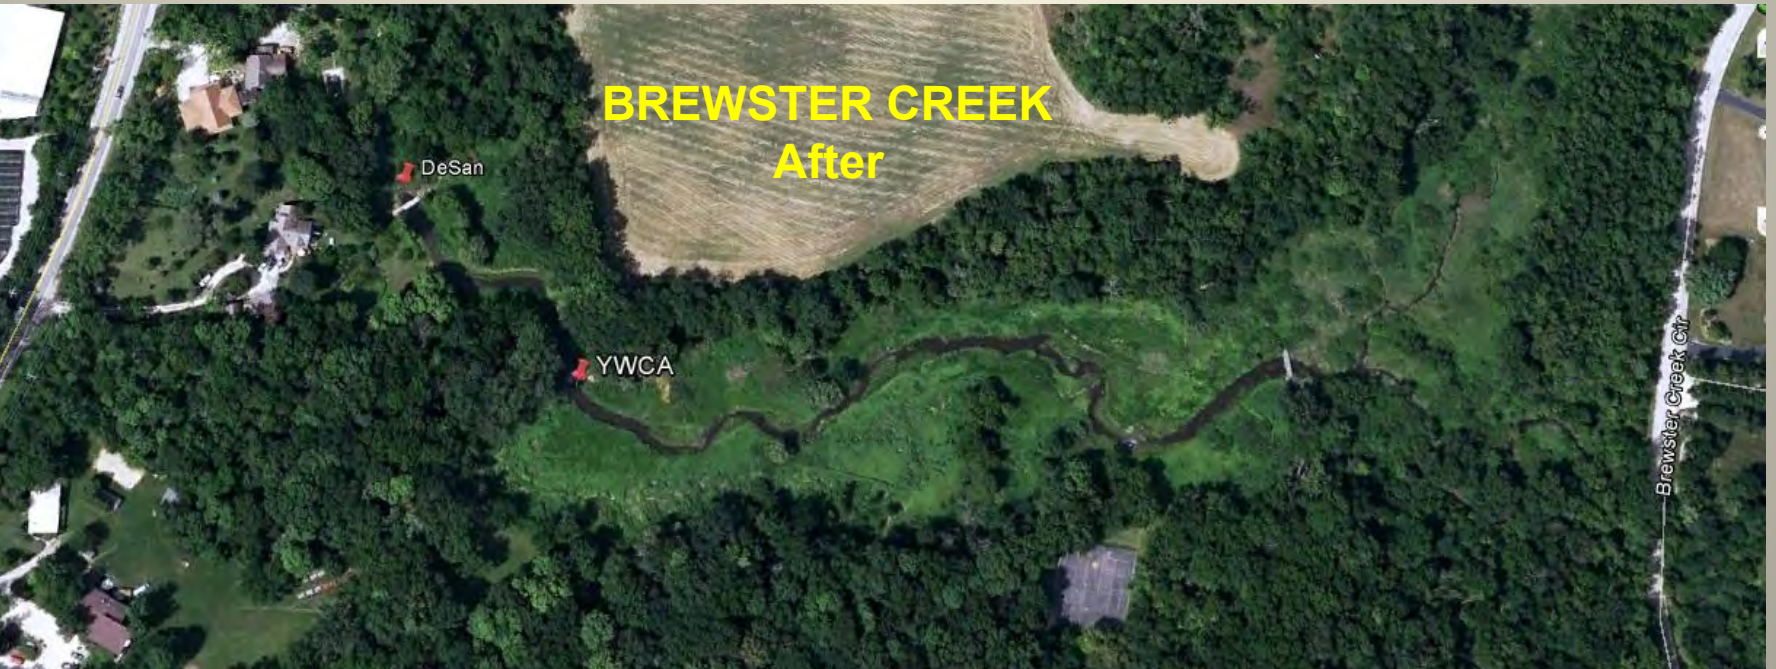
Brewster Creek

- 18 sq. mi. watershed
- YWCA dam removed 2004 (8 X 25 ft)
- DeSantos dam removed 2006 (3 X 20 ft)
- 1 mi. upstream Fox River

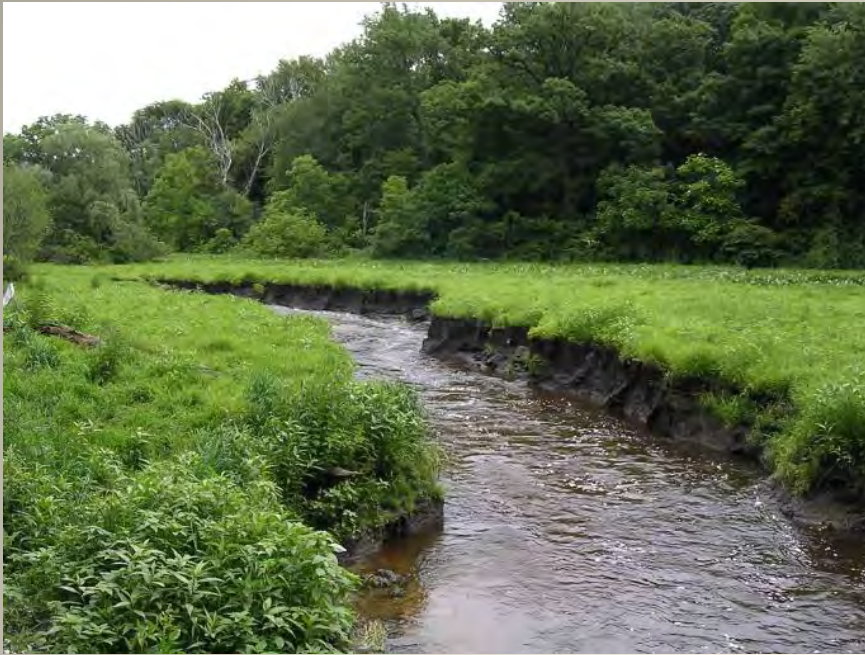
**New channel in former lake bed
2004 - 4 months post removal**

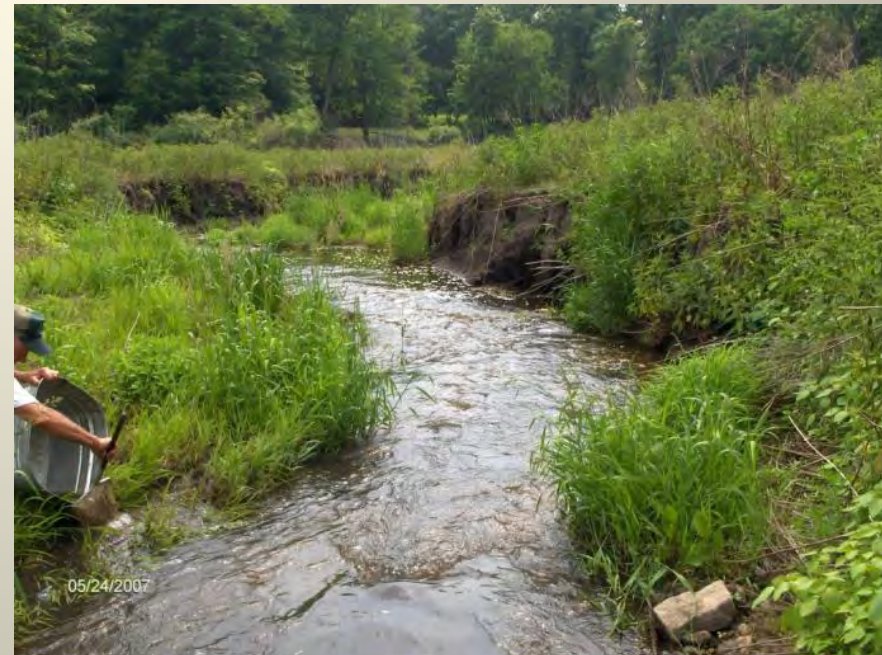
**New channel in former lake bed
2008 - 4 years post removal**

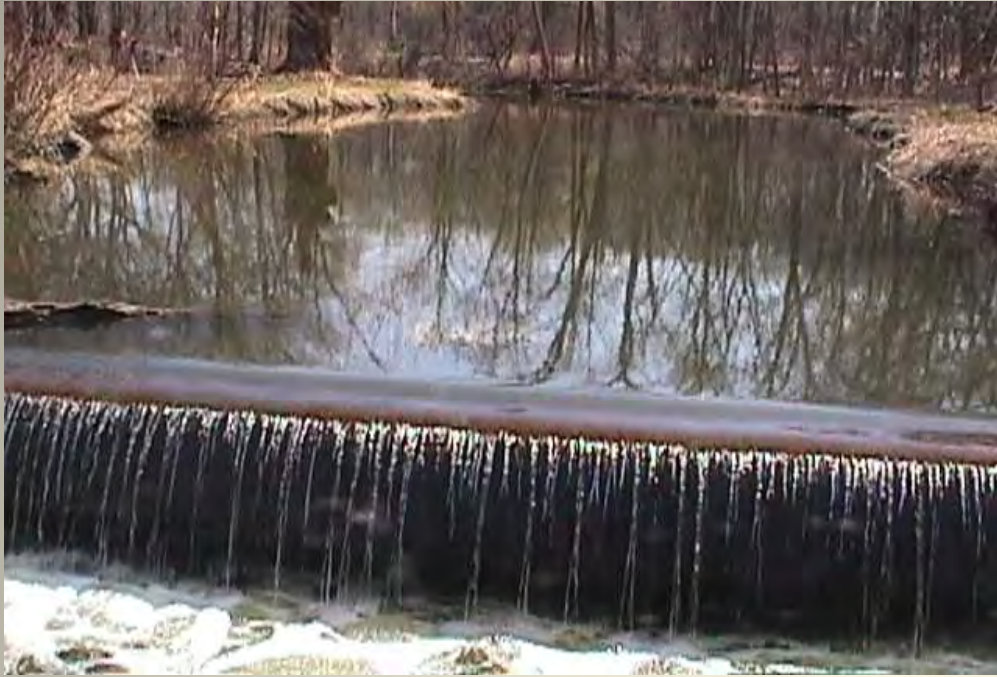
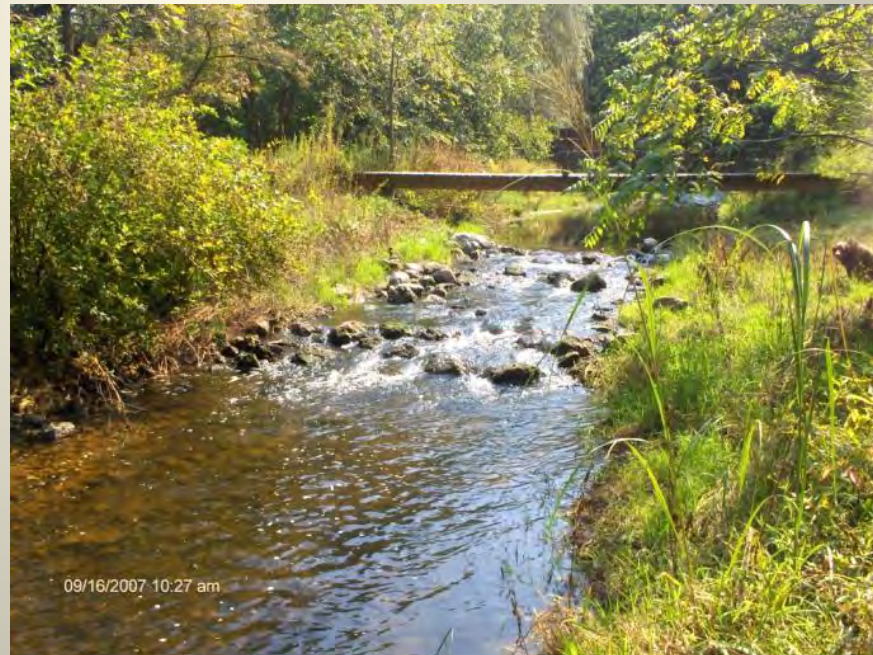
BREWSTER CREEK DeSantos Dam

BEFORE REMOVAL

AFTER 2006 REMOVAL

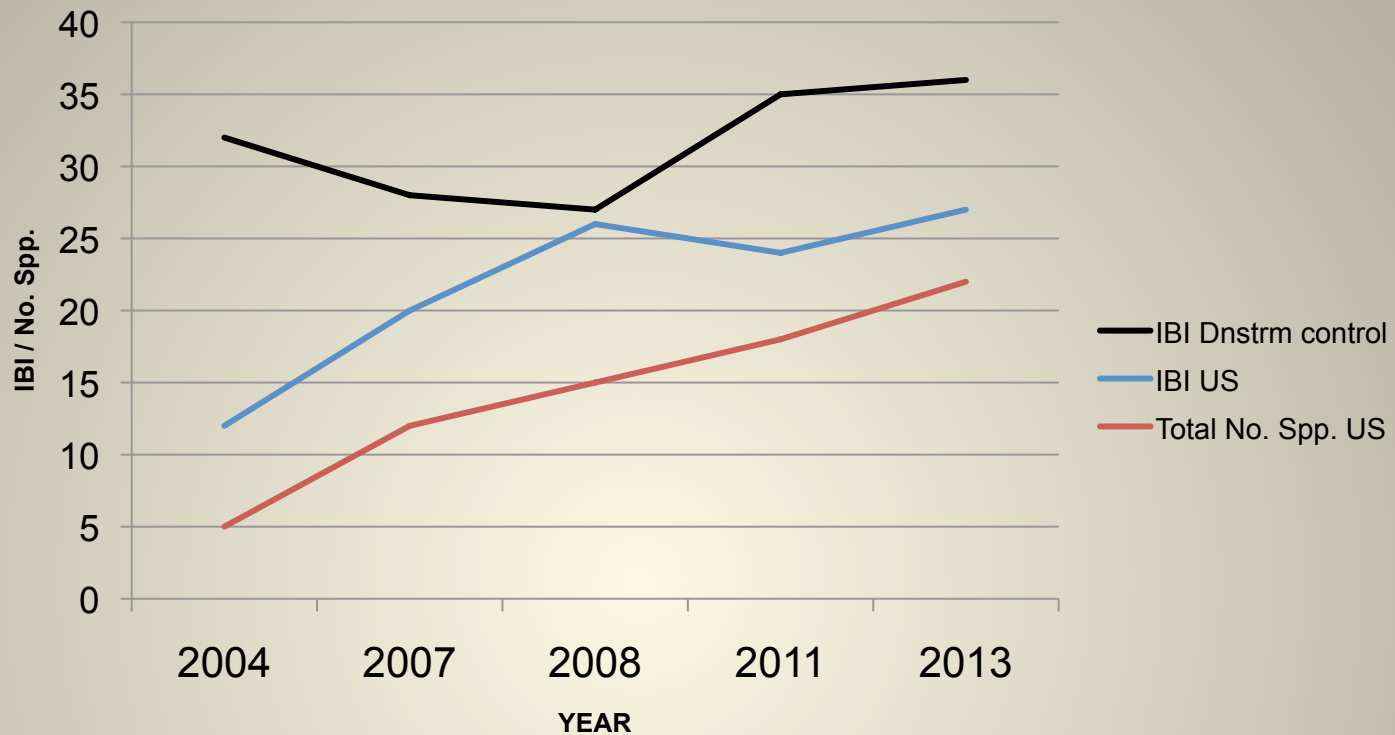
Brewster Creek Dam Removal

Year	IBI Dnstrm control	IBI Upstrm	Total No. Spp. US
2004	32	12	5
2007	28	20	12
2008	27	26	15
2011	35	24	18
2013	36	27	22

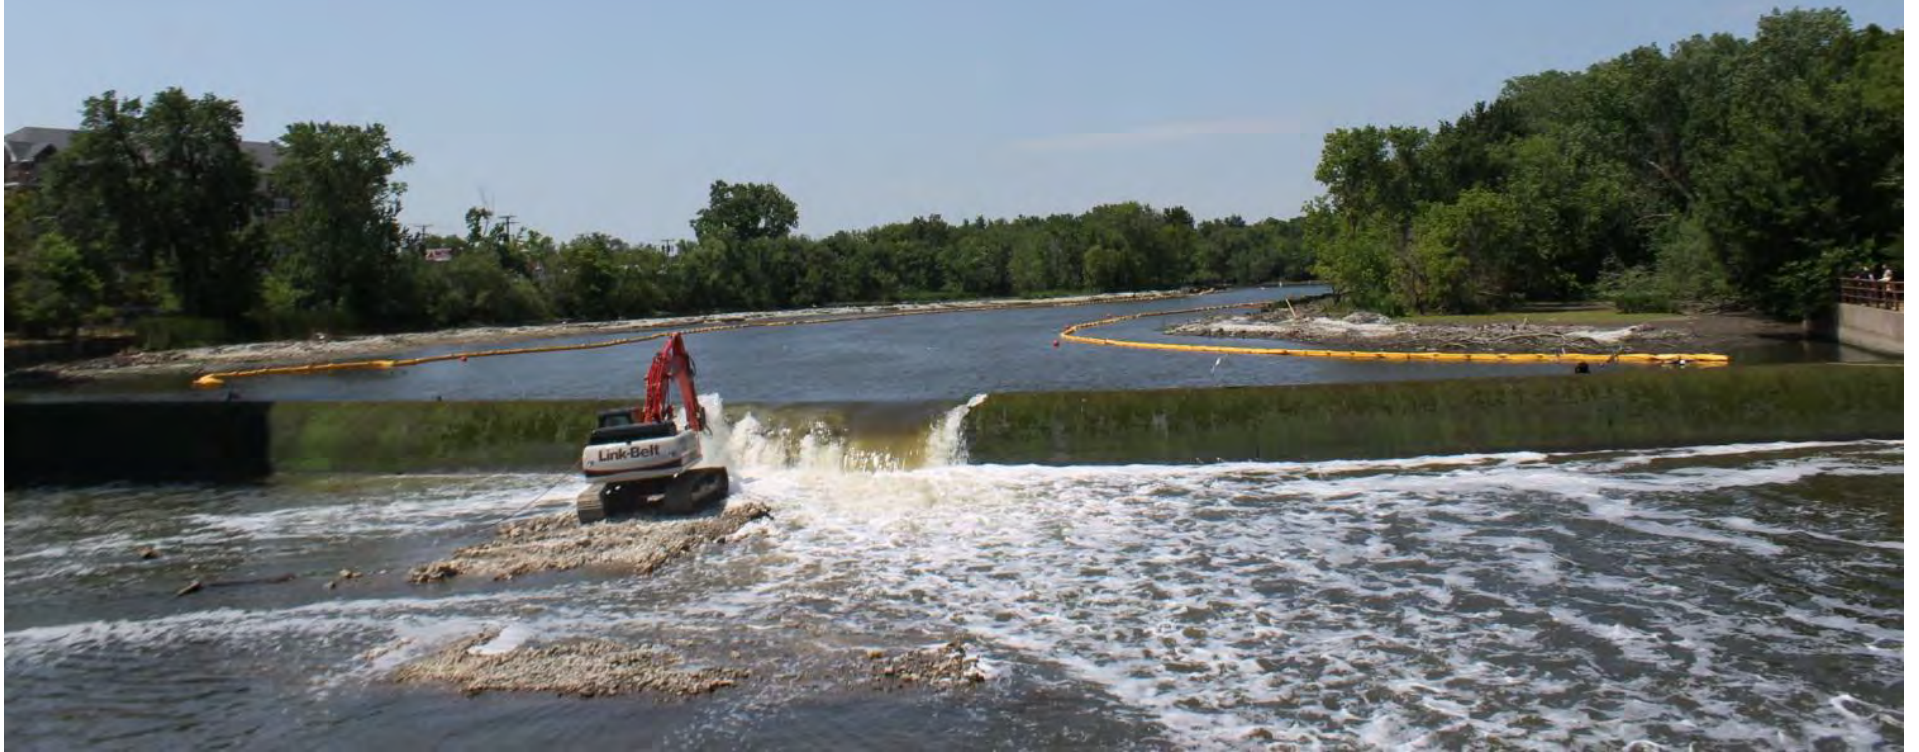
Hoffman Dam removal

Day One
6/19/12

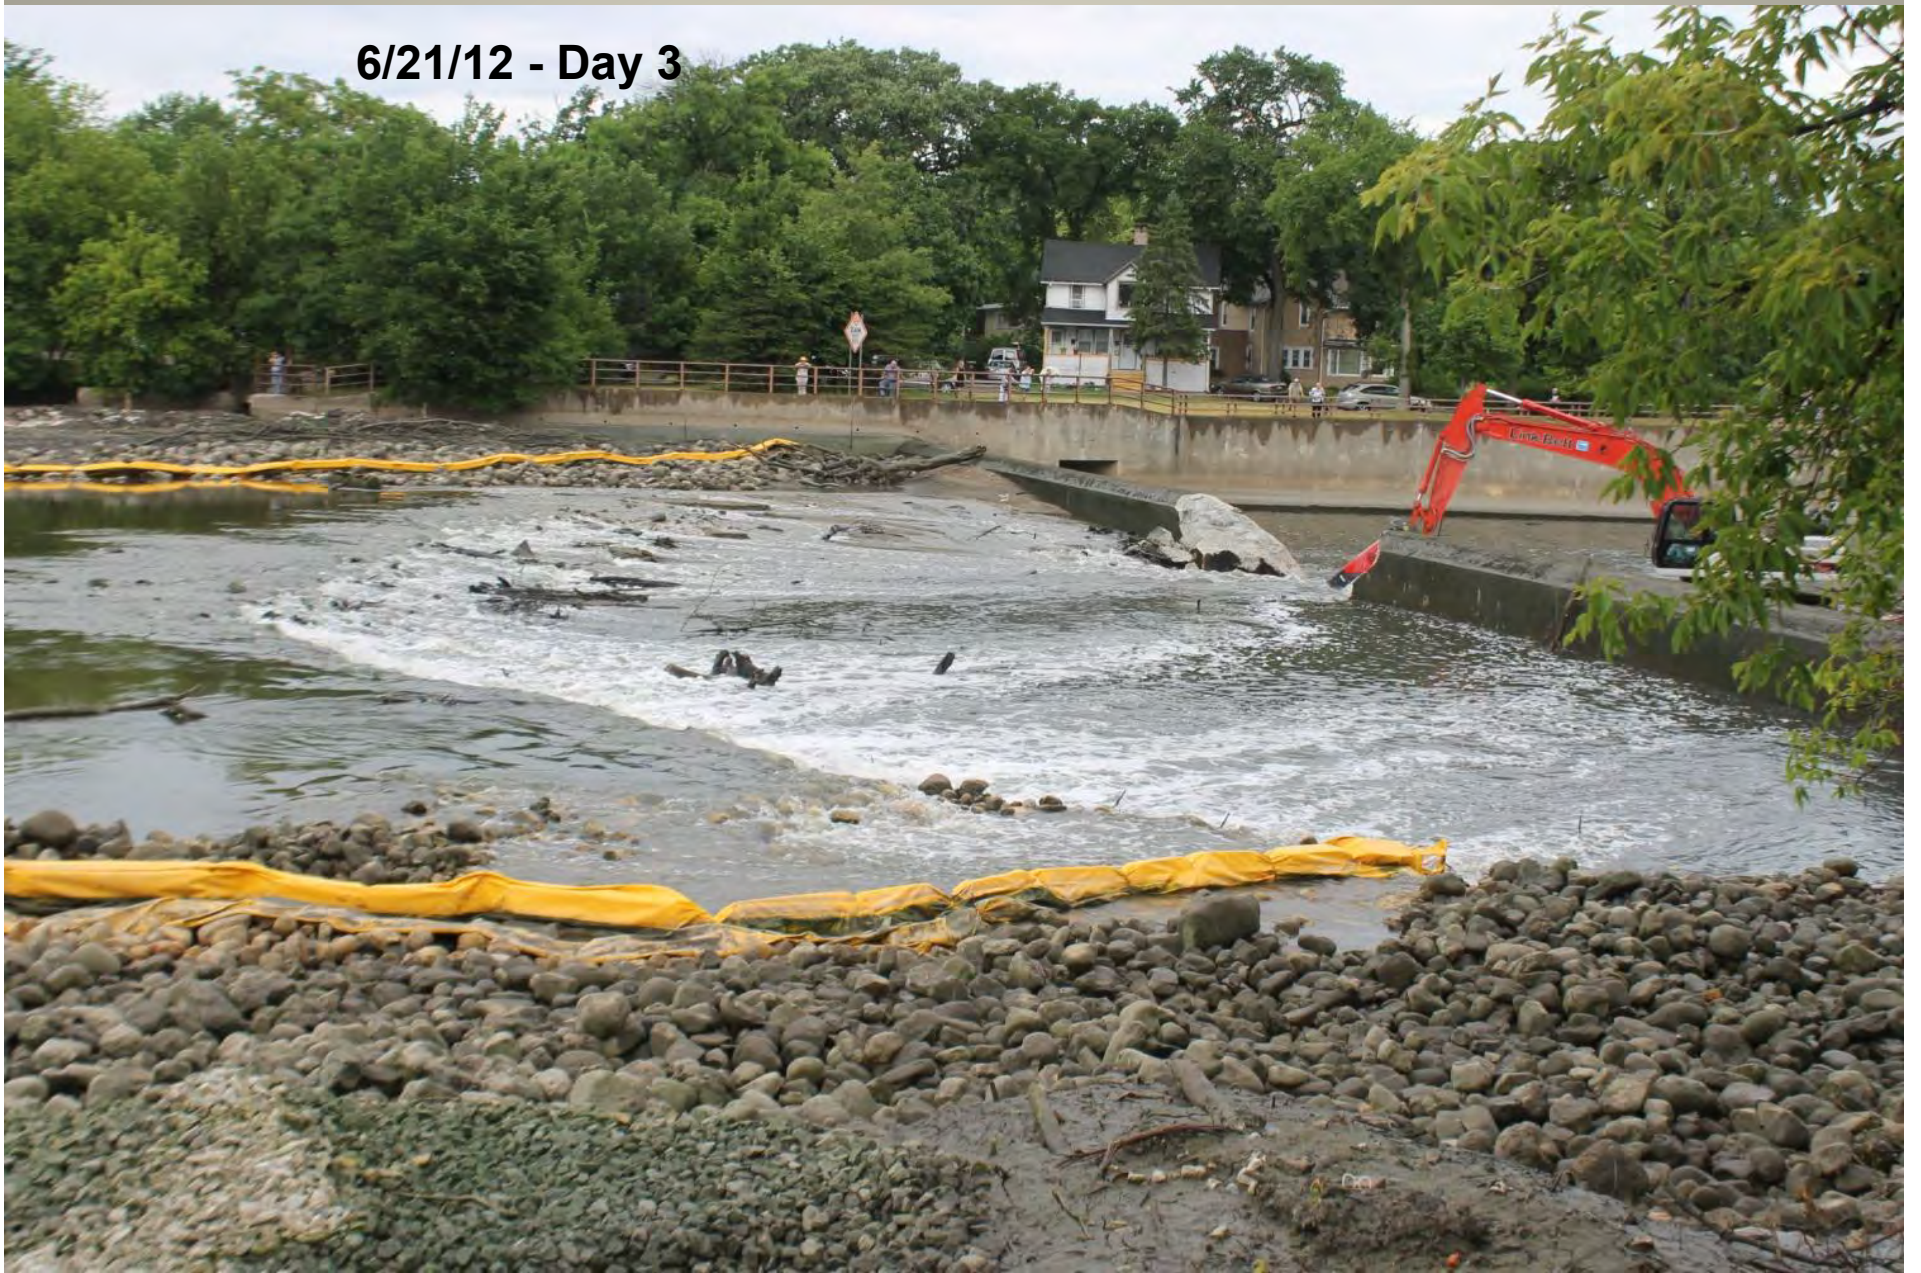
6/21/12 - Day 3

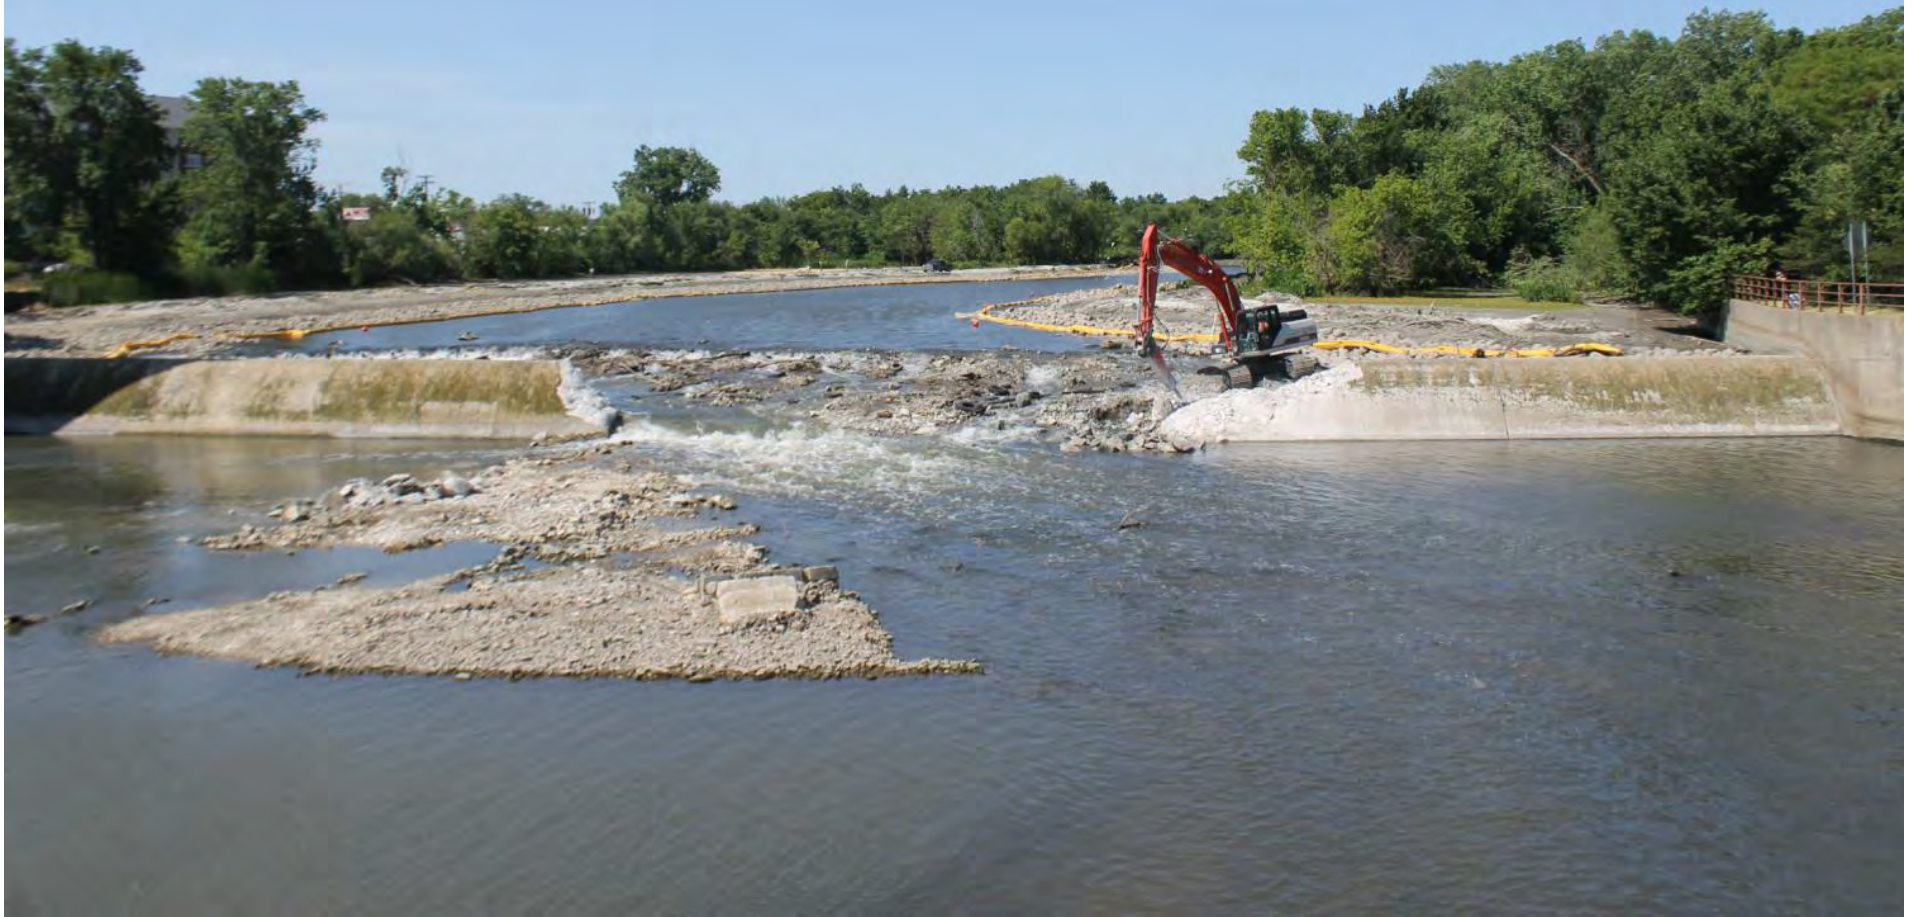
6/26/12 – Day 8

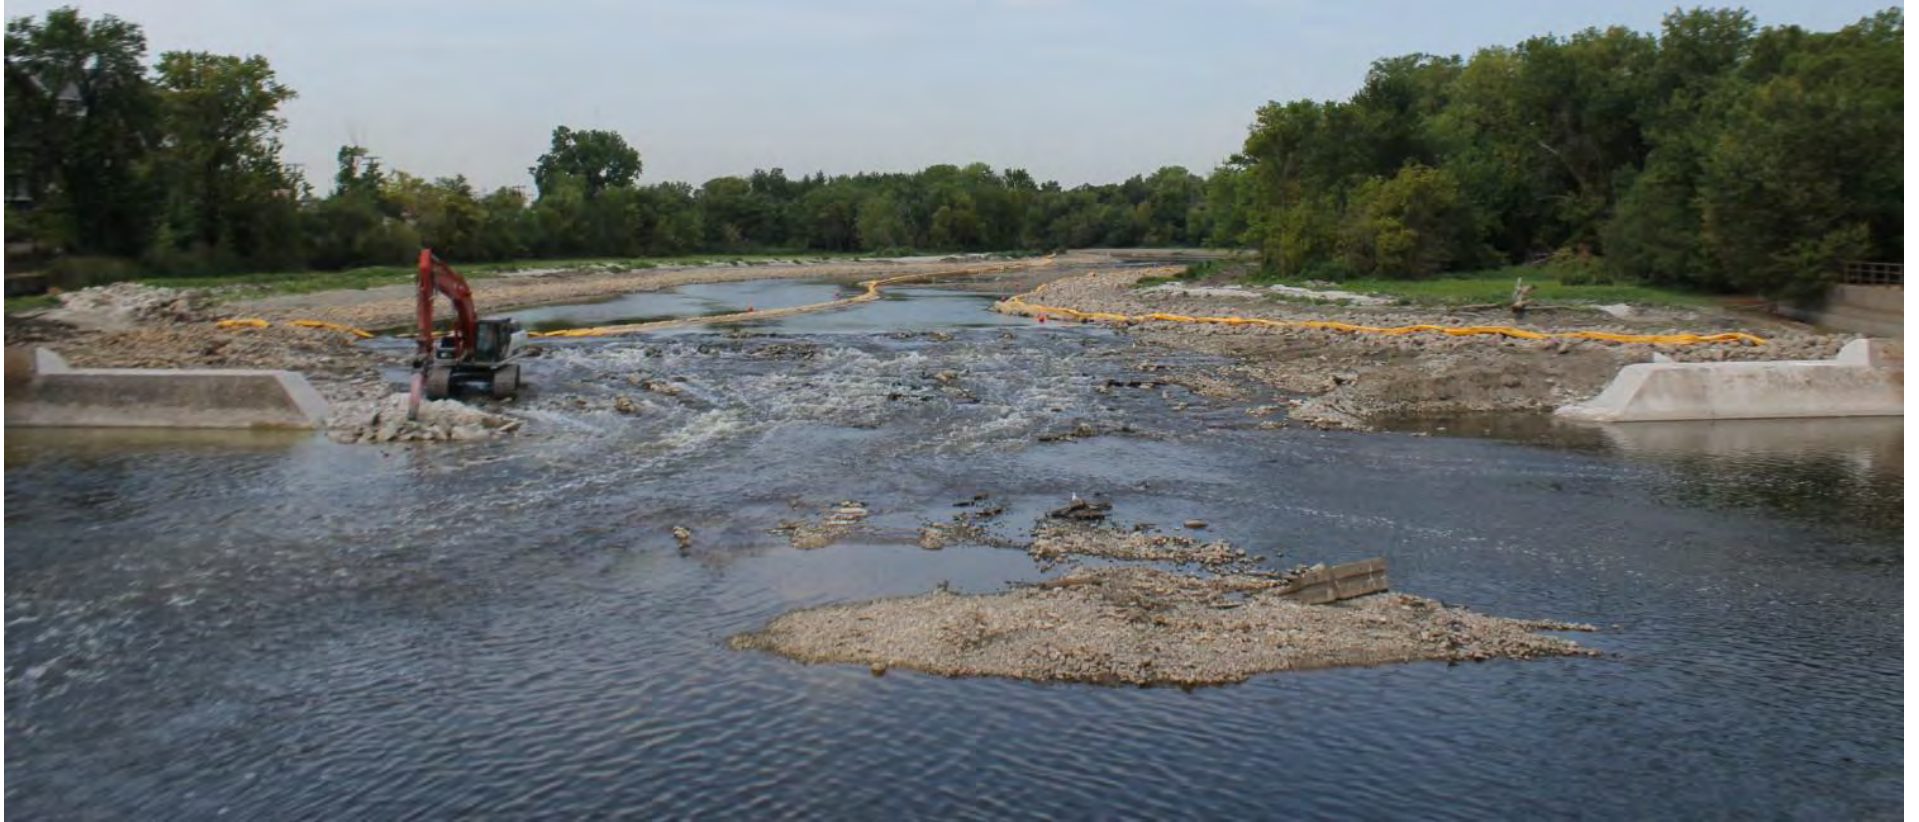
7/17/12 – day 29

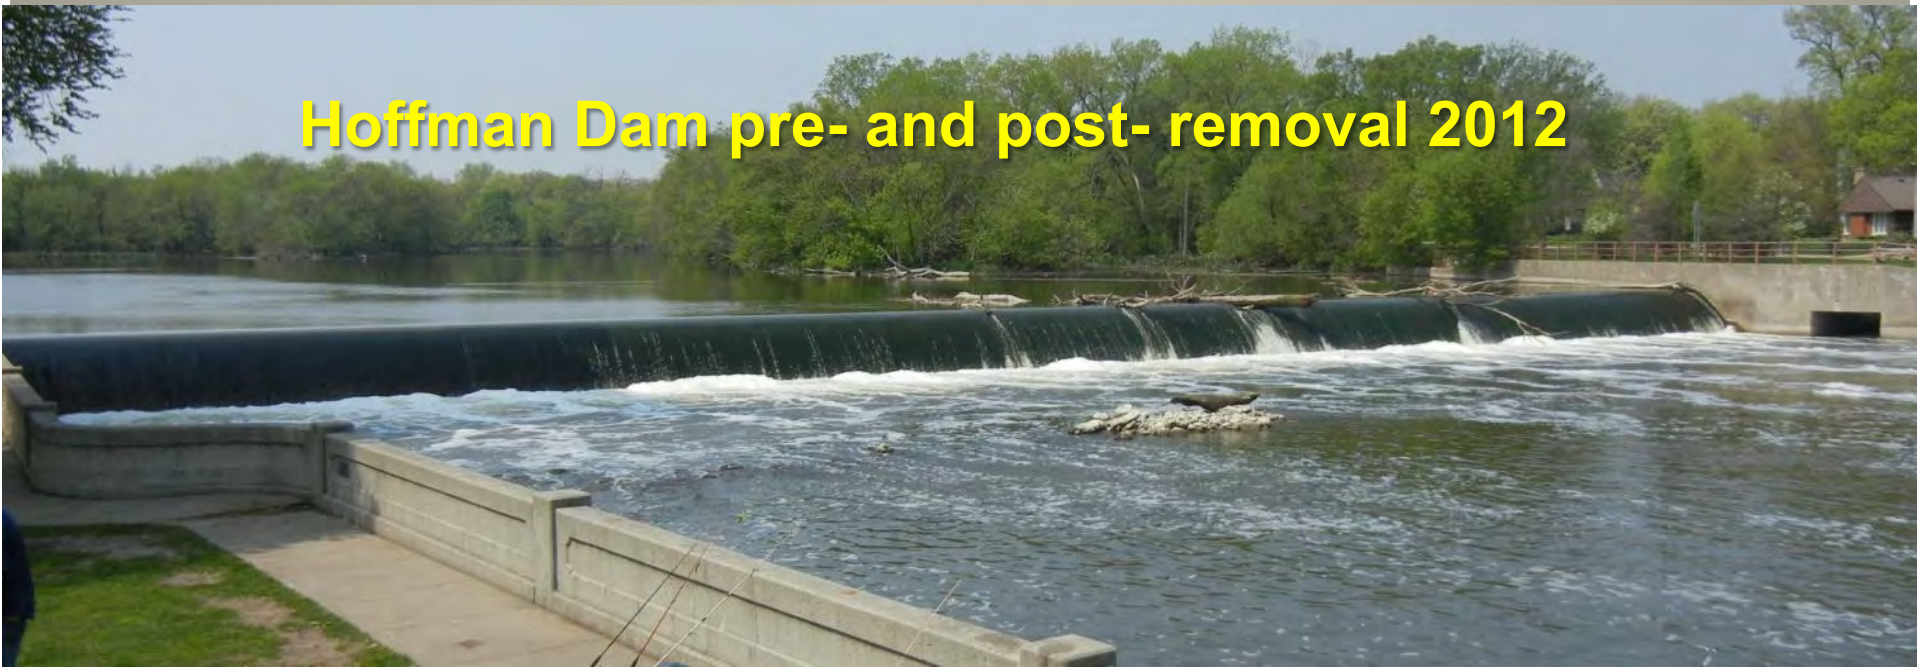
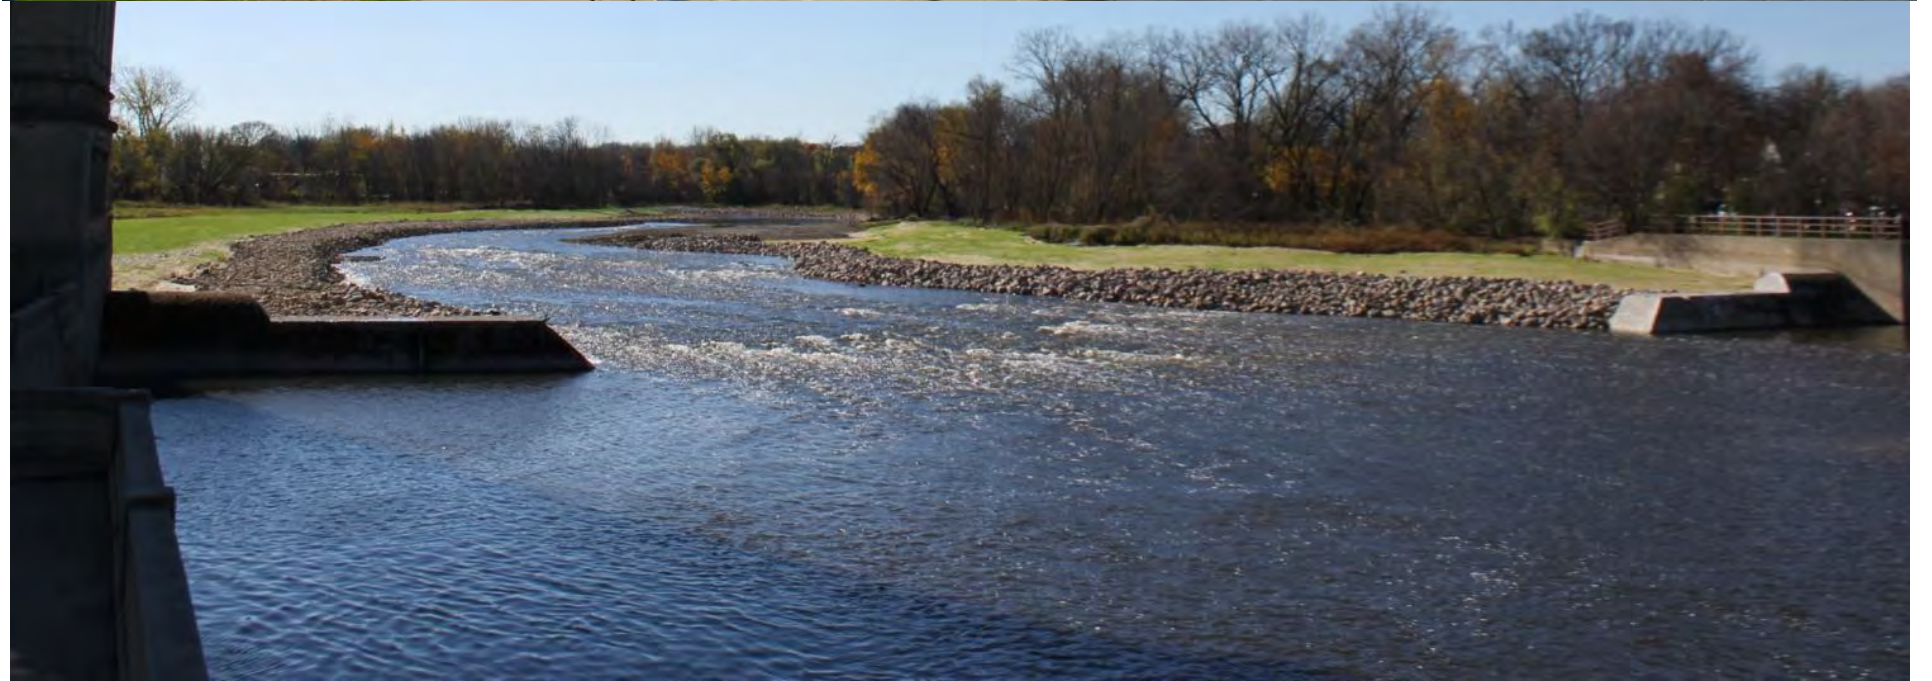
Hoffman Dam pre- and post- removal 2012

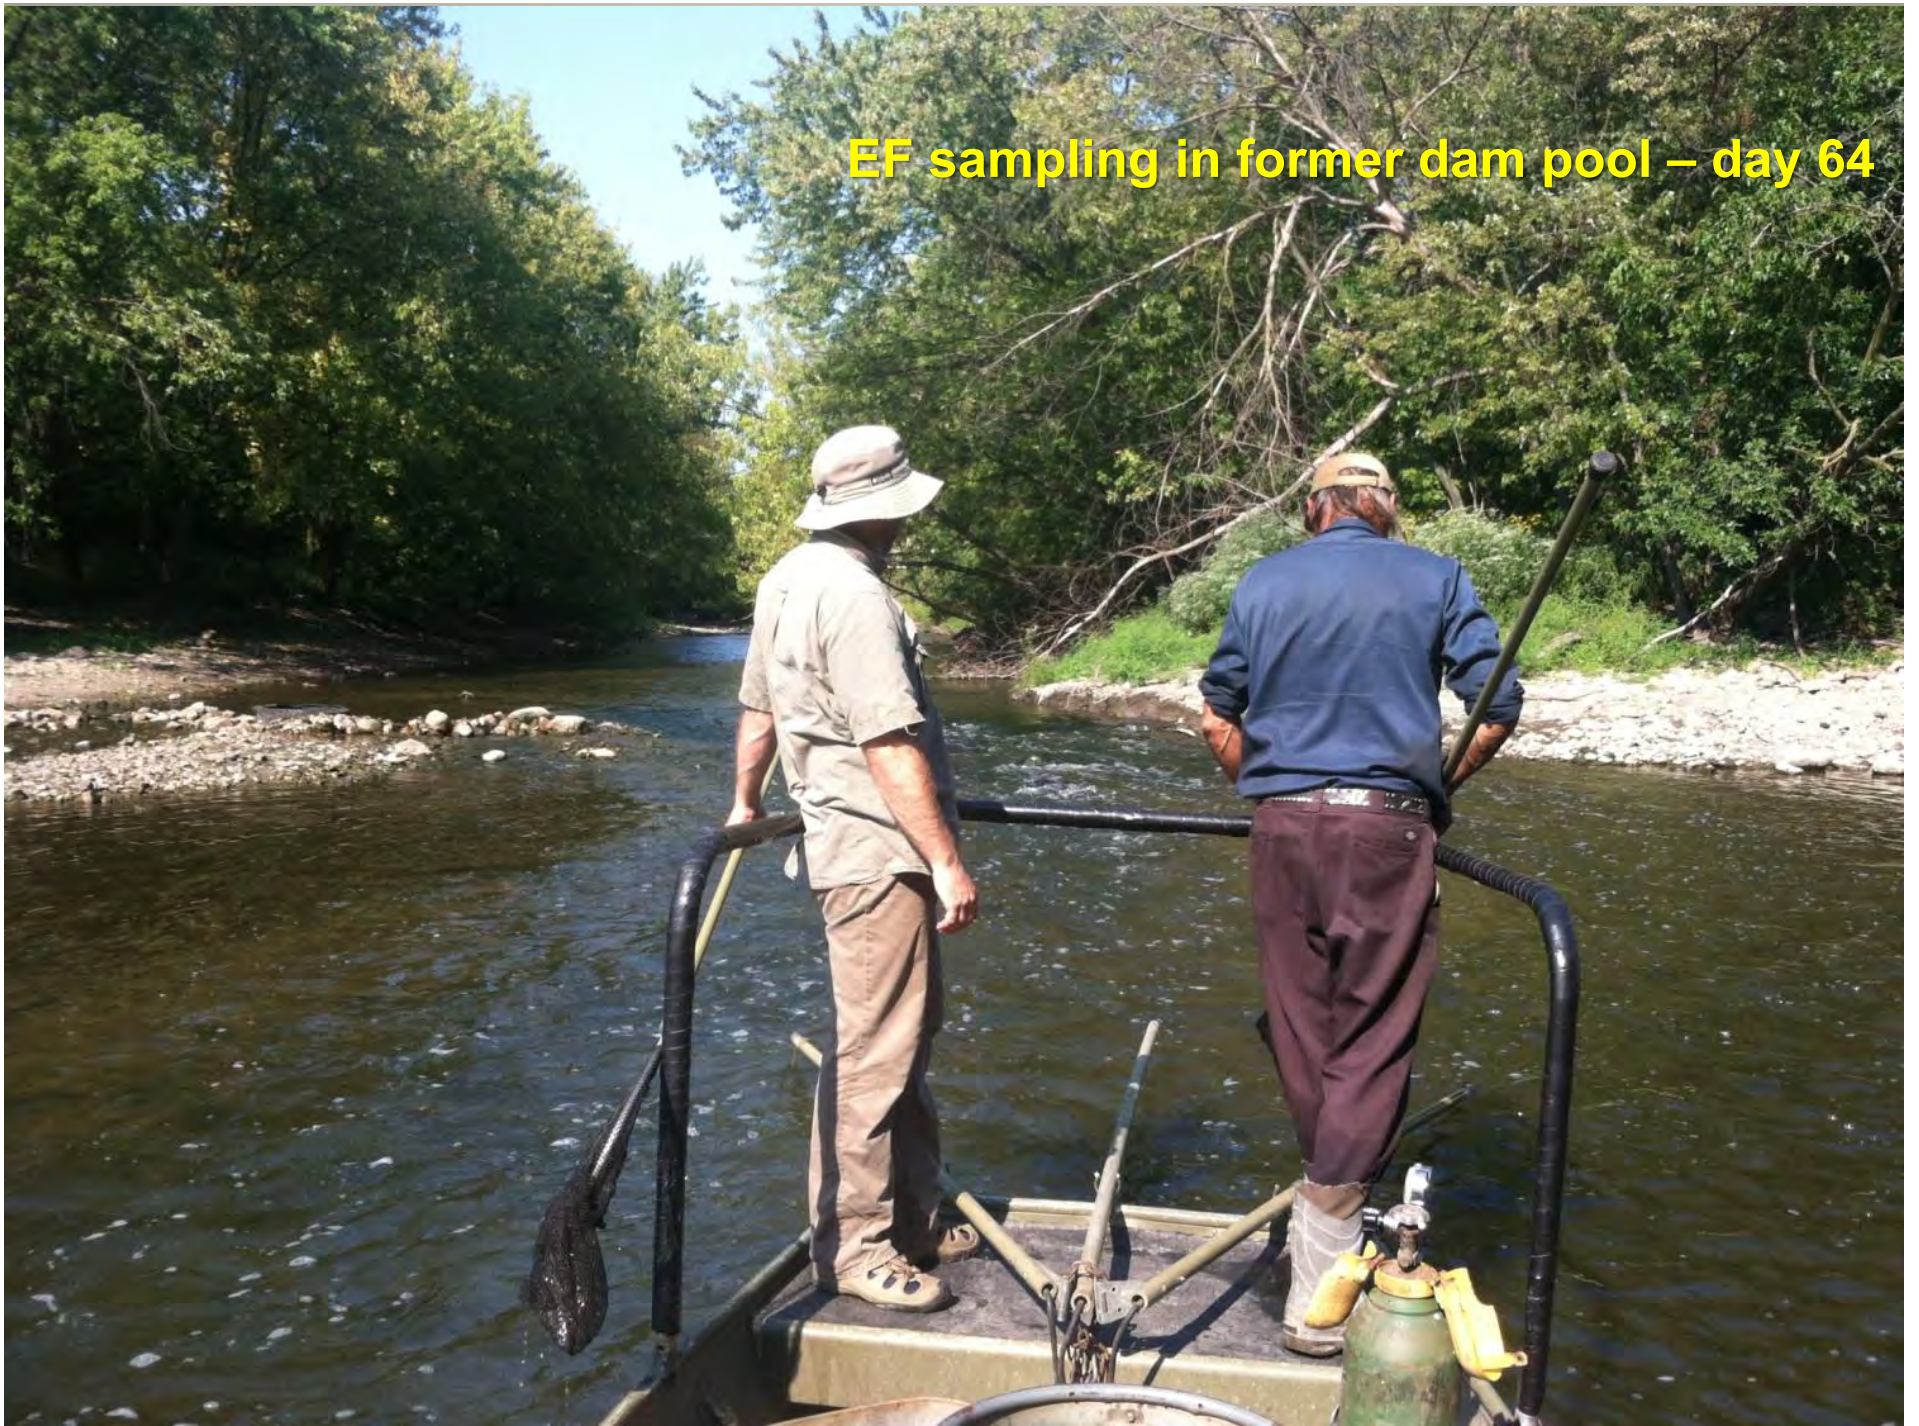
EF sampling in former dam pool – day 64

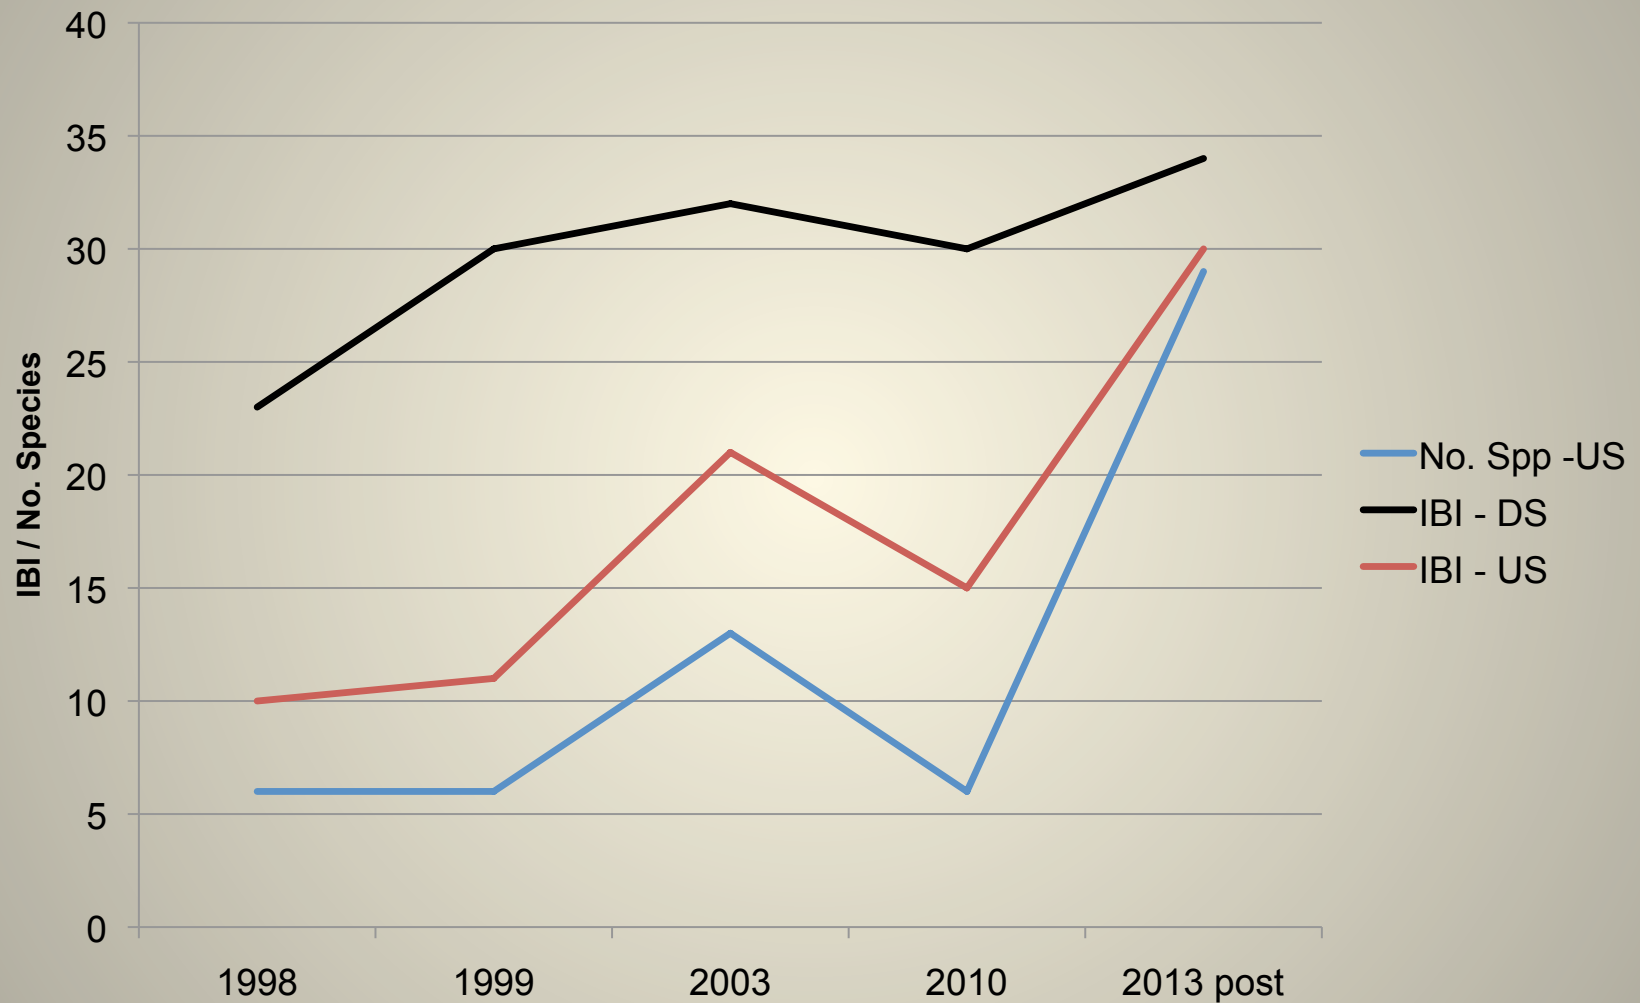
Hoffman Dam Removal Evaluation

IBI and No. species Downstream (DS) v. Upstream (US)

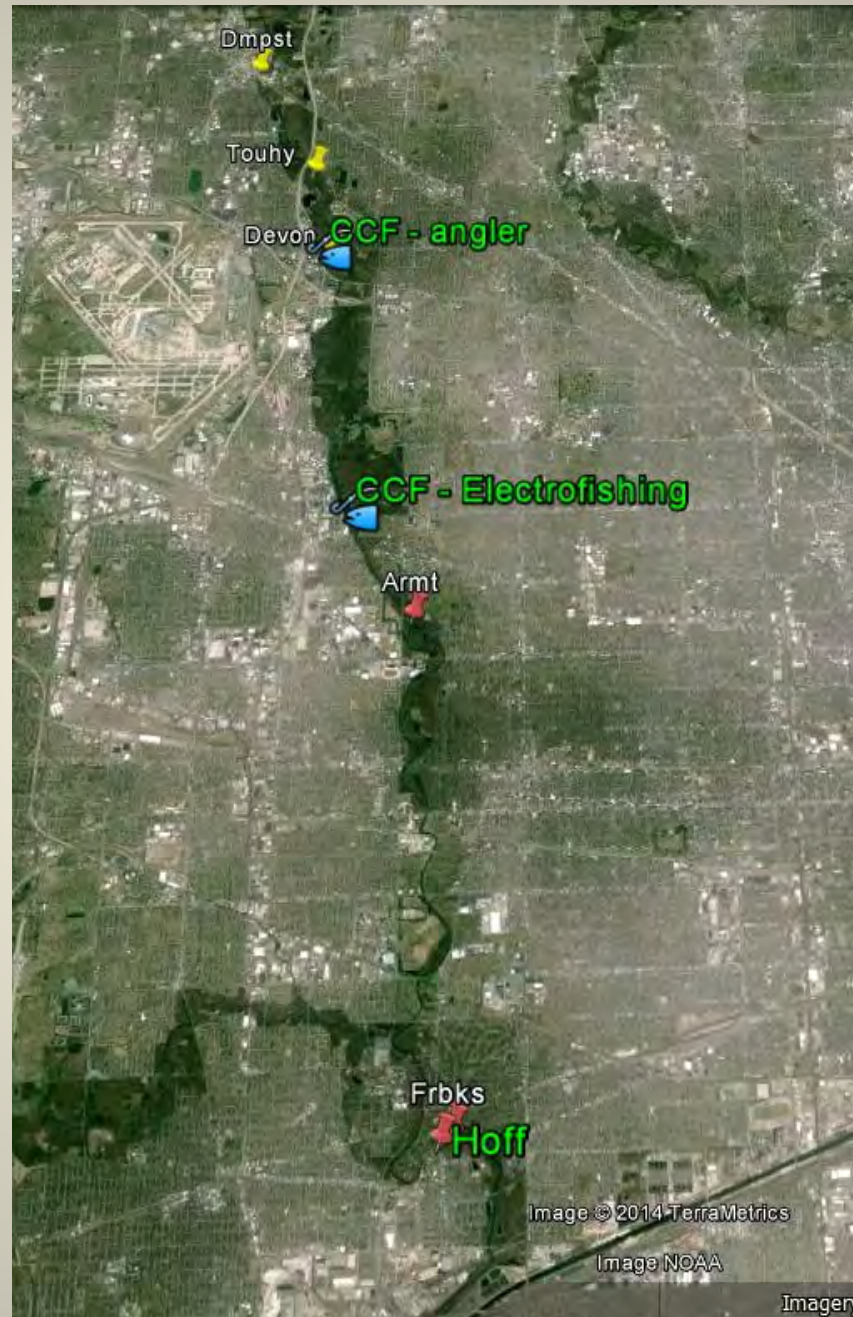
Channel catfish (CCF)
Post Hofmann removal
migration 10 miles upstream

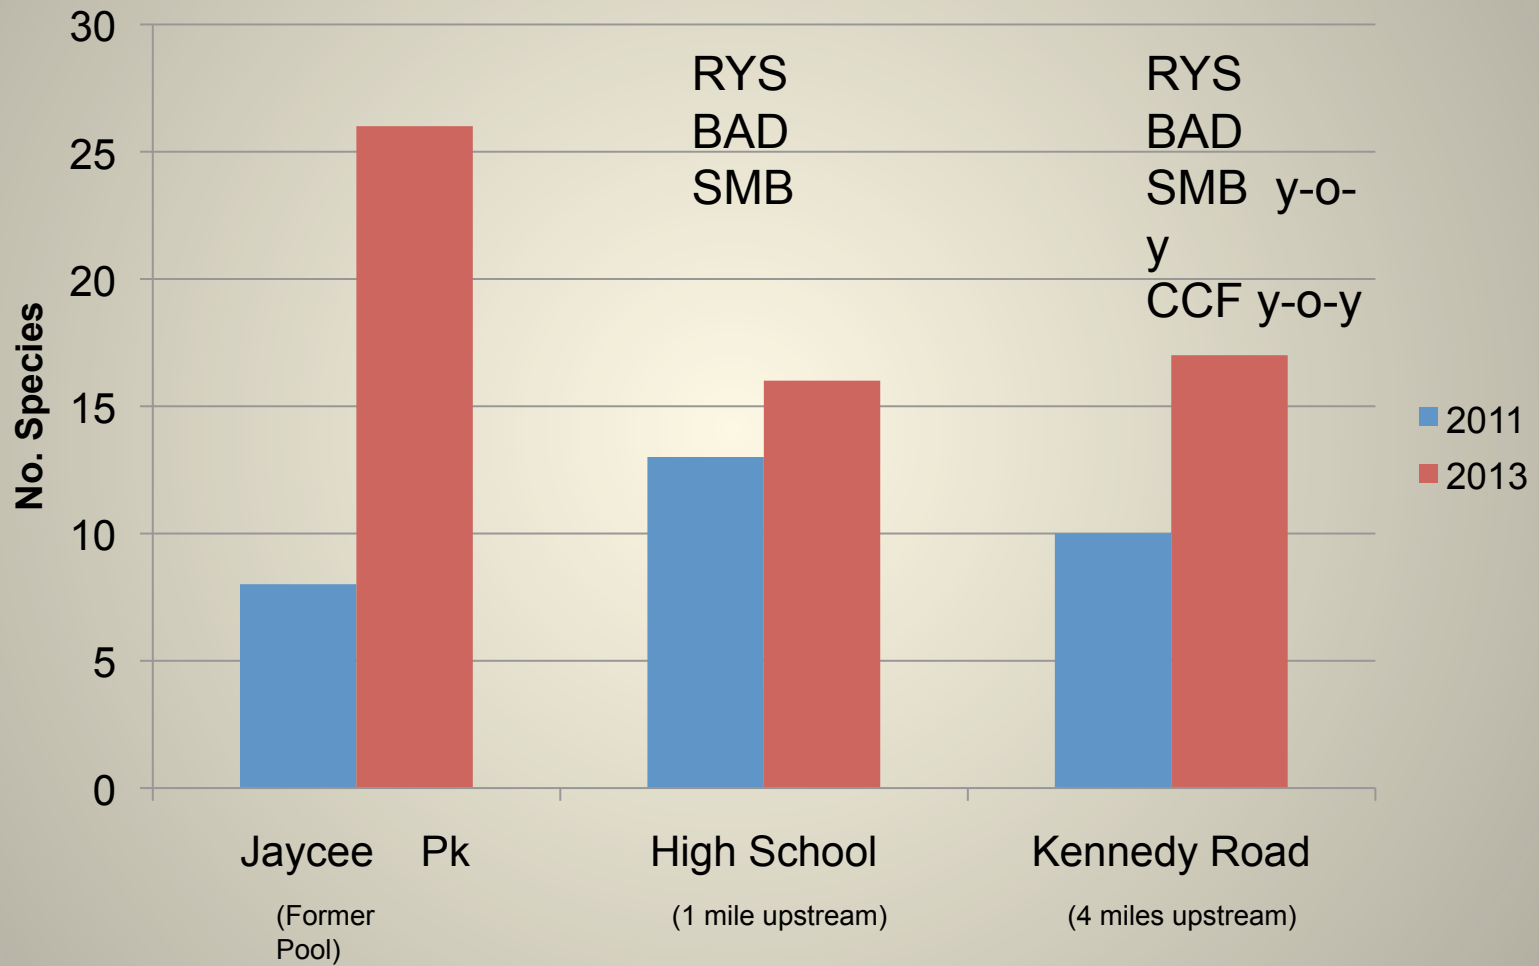
Blackberry Creek Dam Evaluation

No. species pre (2011) vs. post (2013)

Blackberry Creek Dam Pool Area			
	2011 pre	2013 post	
No. Species	8	26	24
Total No. Fish	74	898	3039
