**Evaluation of fish community response to dam removals
and fish passage
in Northeastern Illinois**

Steve Pescitelli and Bob Rung, Division of Fisheries

Dam Projects in Illinois - Update

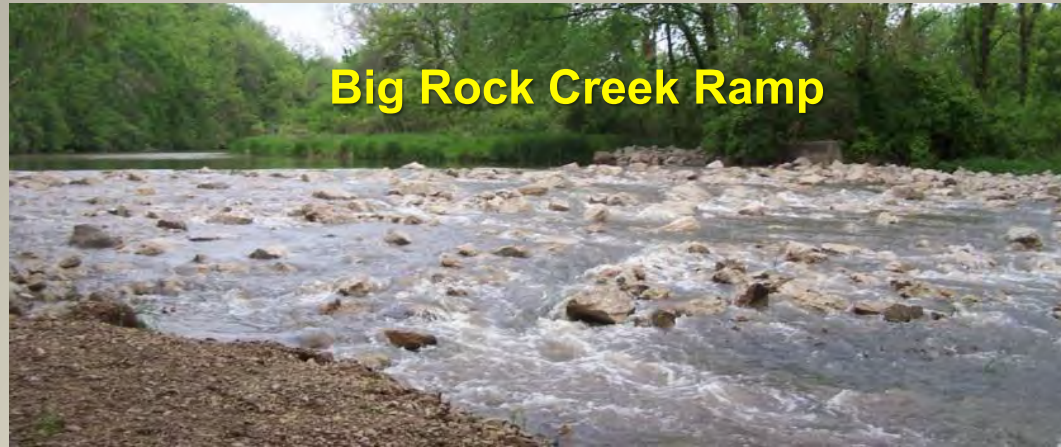
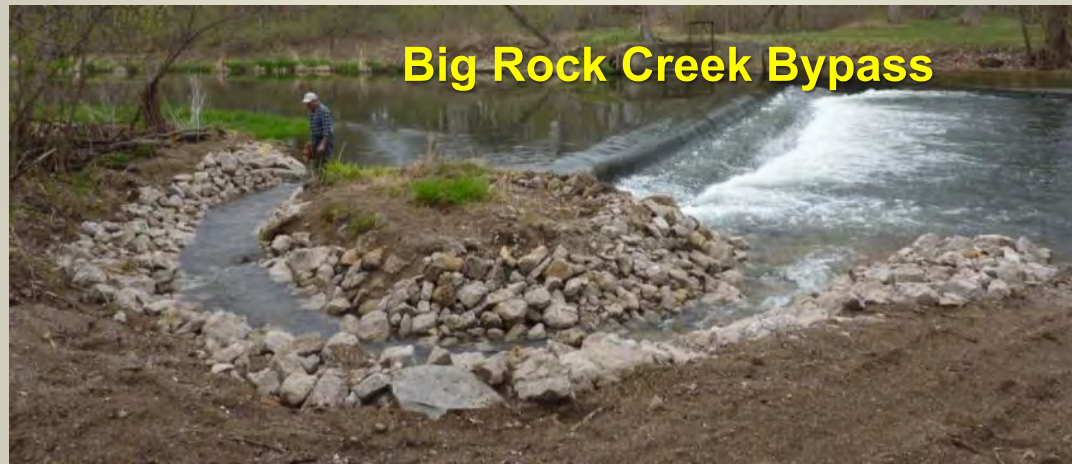
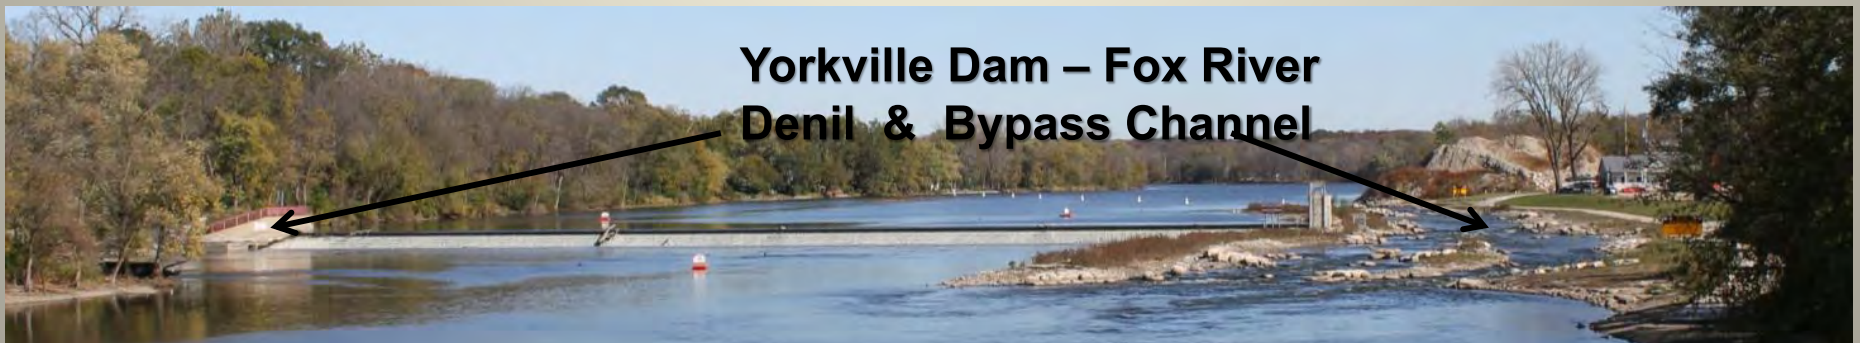
**Fish
Passage
Projects**

**Denil Fish Ladder
Completed March 2008**

**Watercraft and Fish
Bypass Channel
Completed Sept 2010**

**Steps and Denil: \$2.7
million
Bypass: \$5.0 million
Bridge: \$0.4 million**

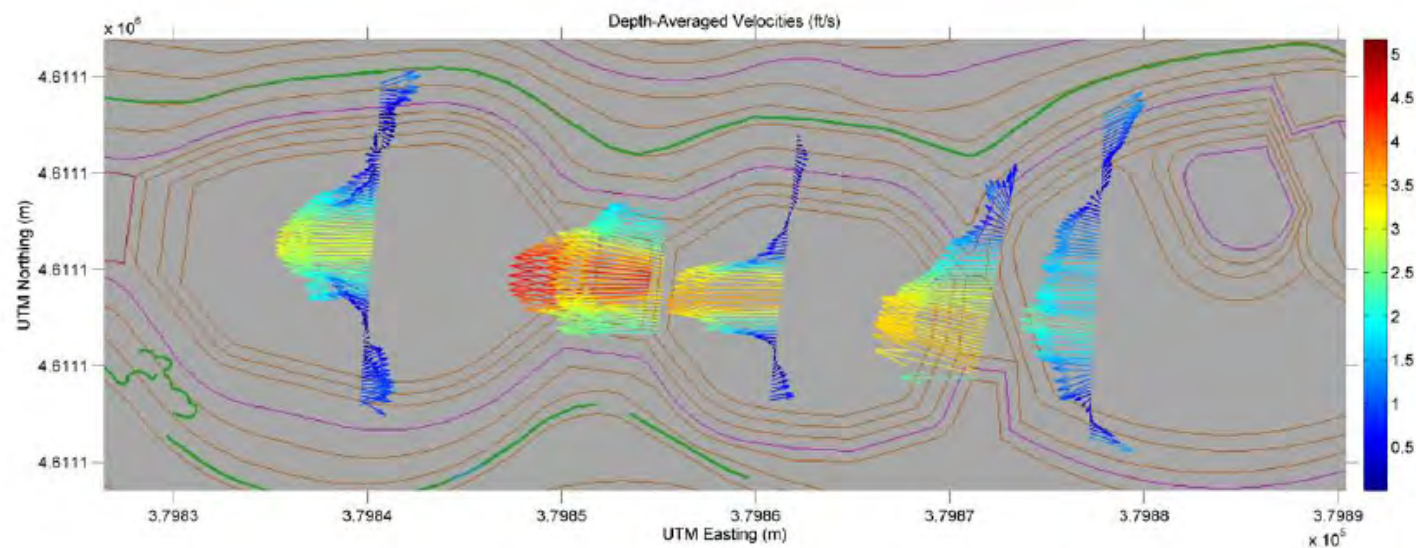
Sites F to K – plan view

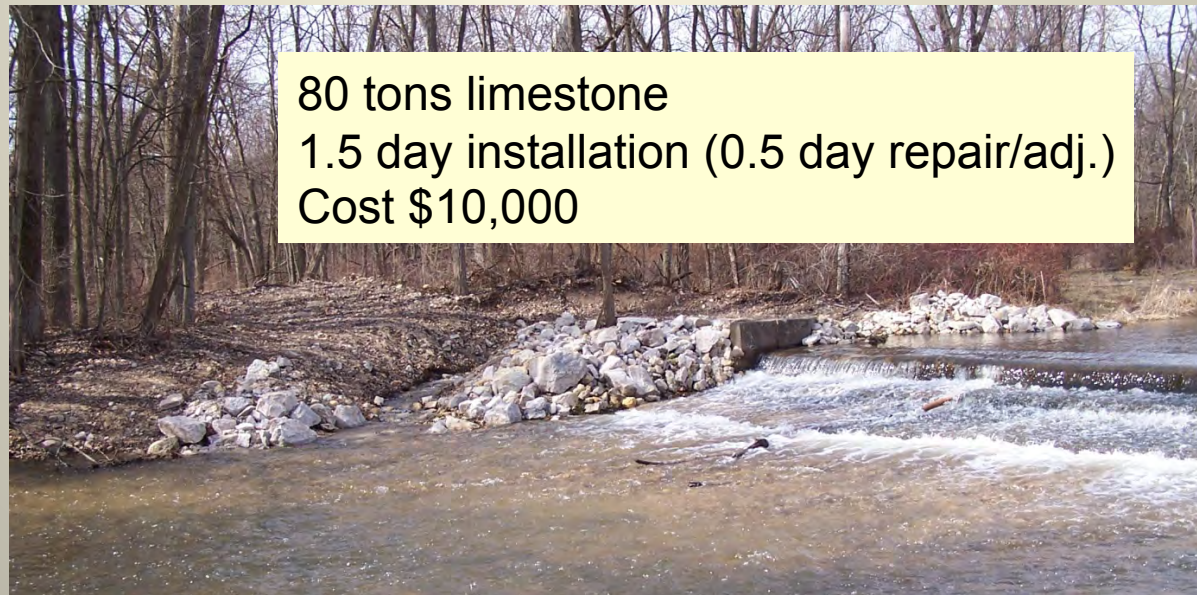
Big Rock Creek Fish Passage Project – Harrington Dam

80 tons limestone
1.5 day installation (0.5 day repair/adj.)
Cost \$10,000

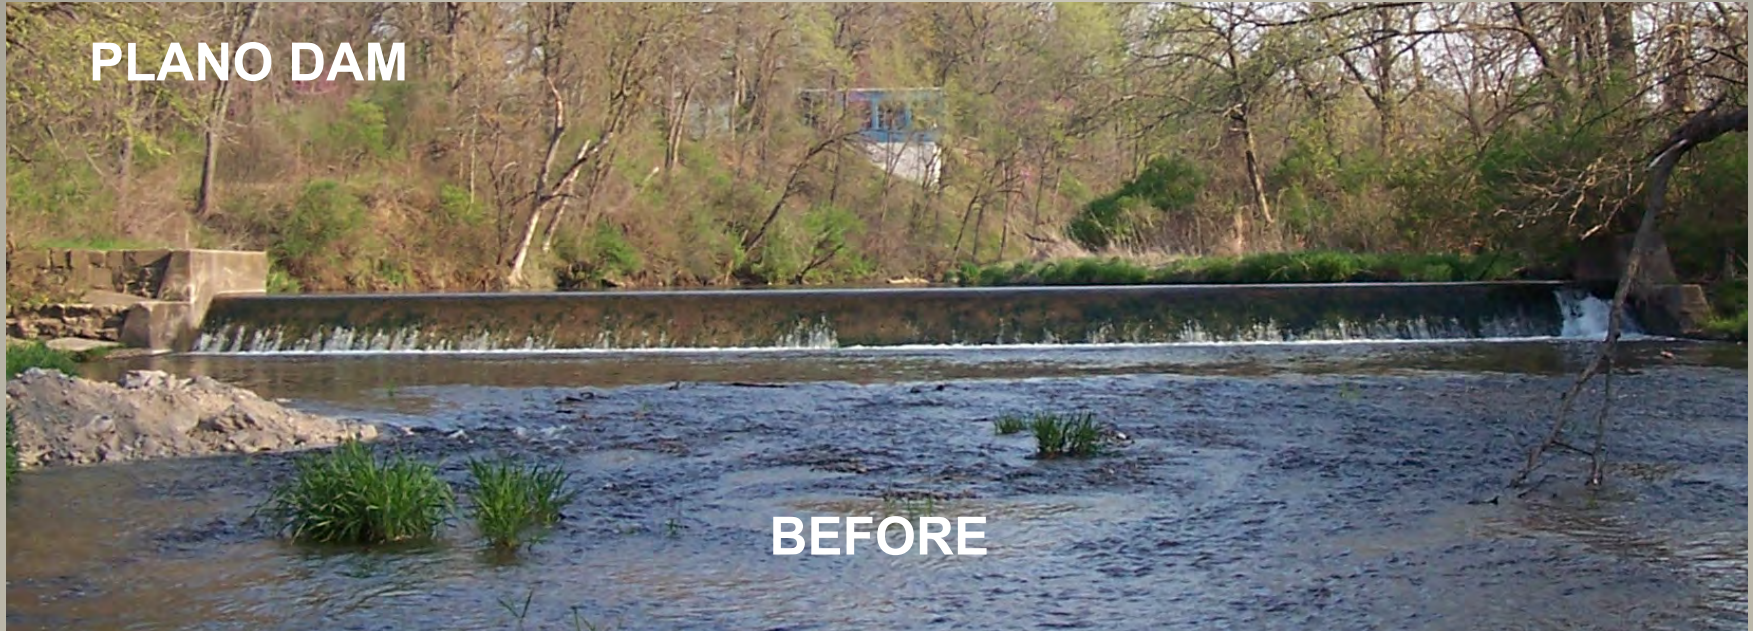
PLANO DAM

BEFORE

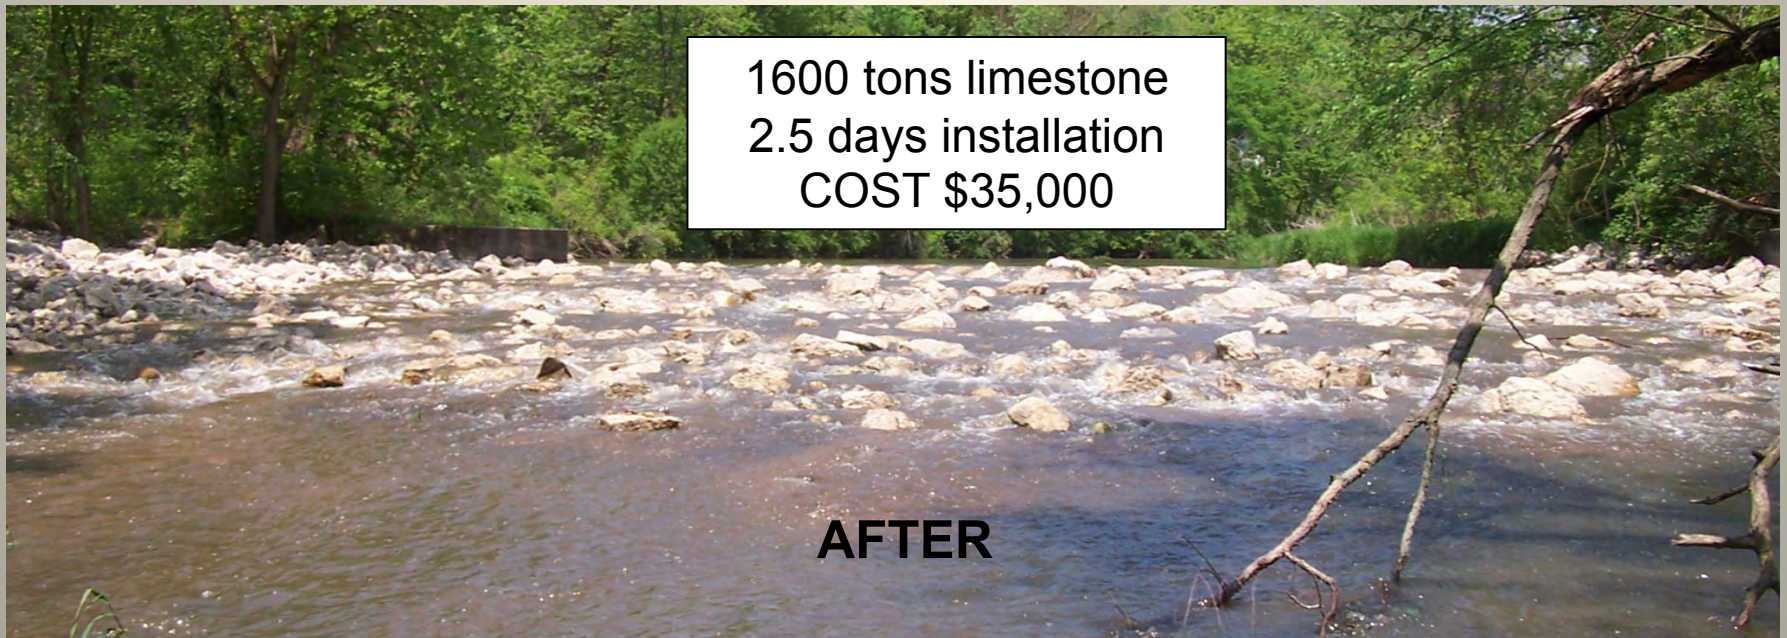
1600 tons limestone
2.5 days installation
COST \$35,000

AFTER

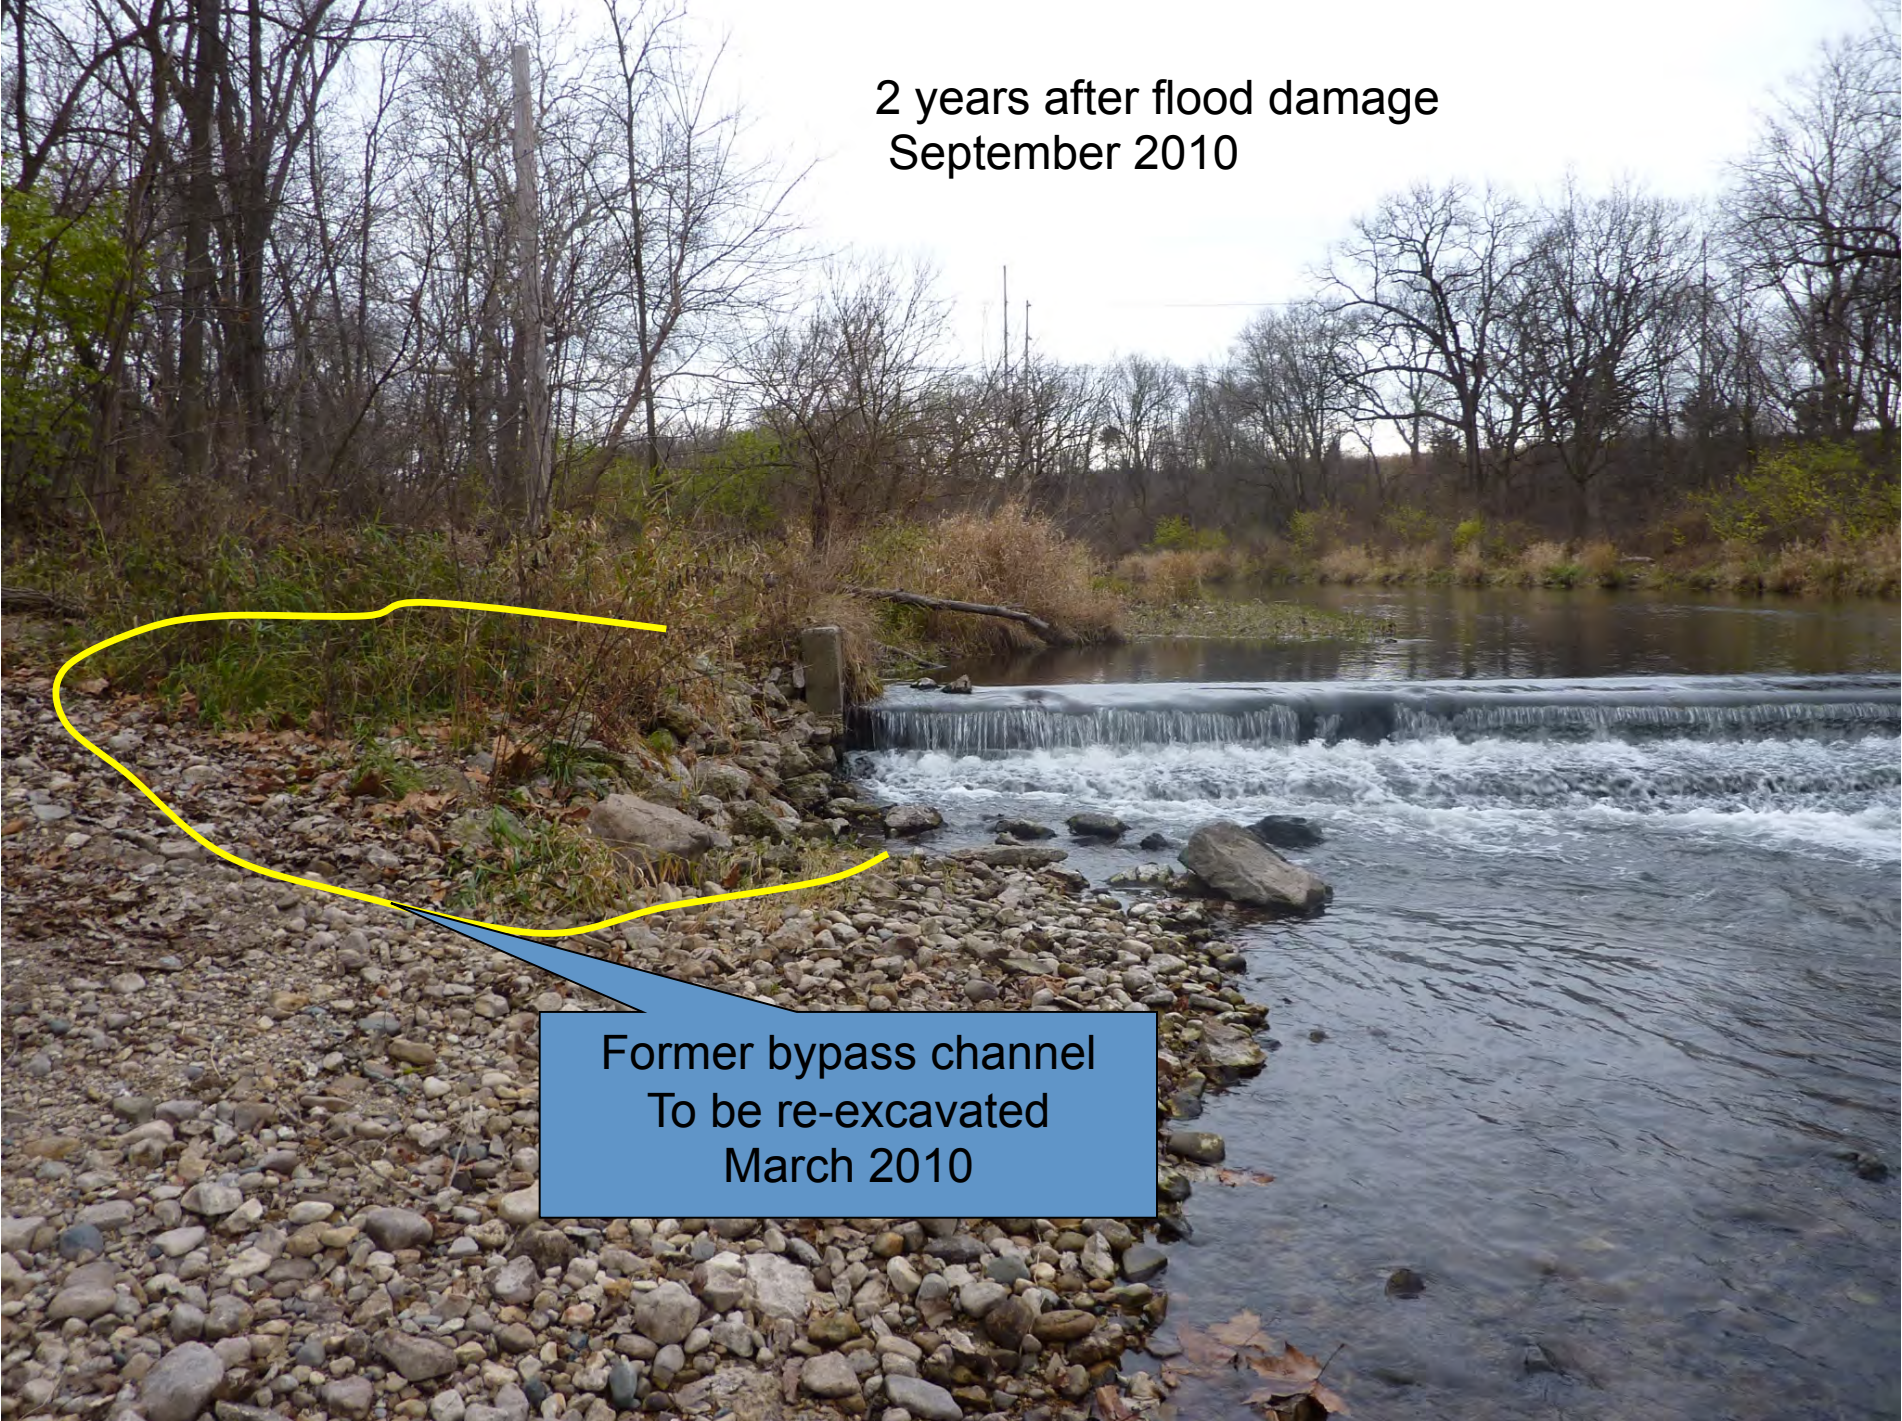
2 years after flood damage
September 2010

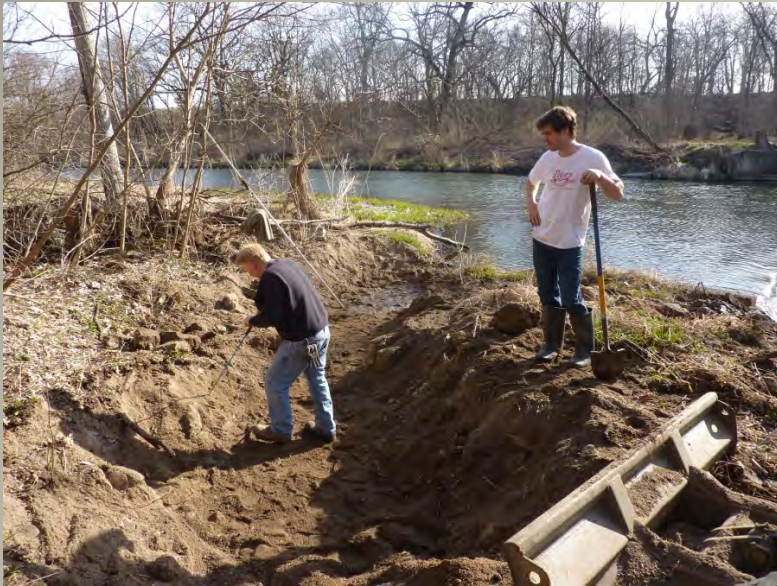
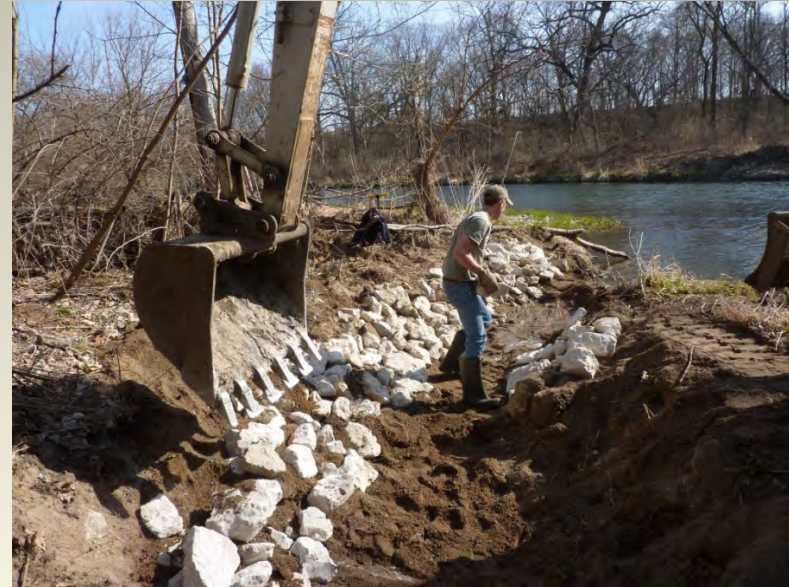
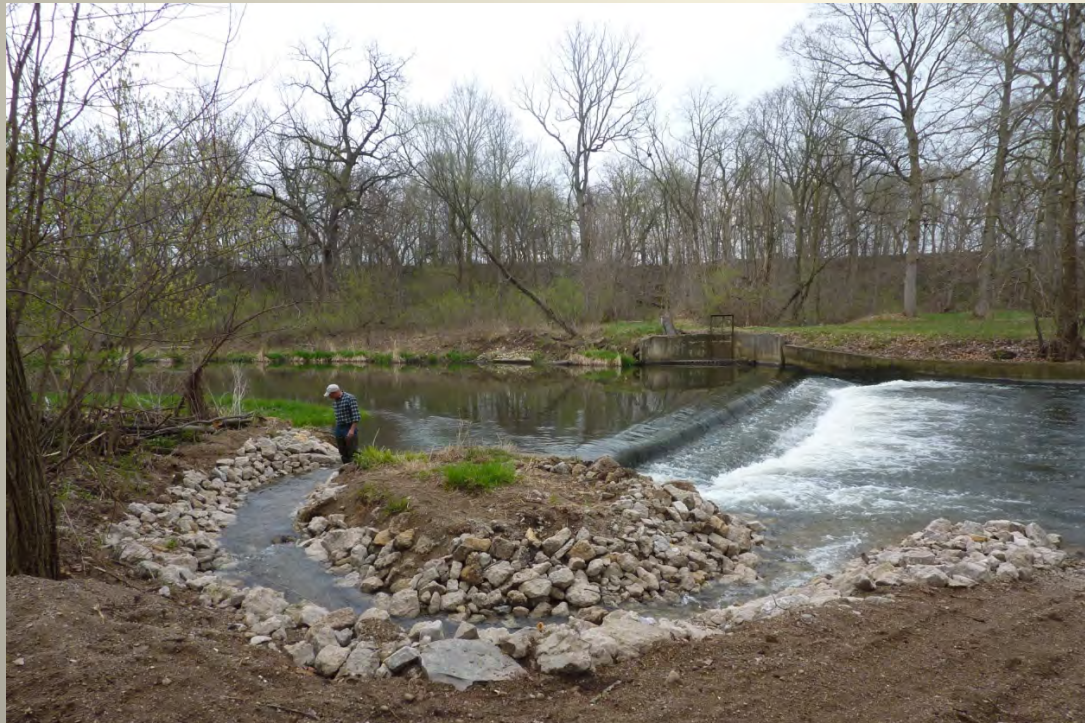
Former bypass channel
To be re-excavated
March 2010

\$2000 Repairs
funded by
