What is Alum?

A Case Study on Lake Barrington for Improving Water Quality

Alana Bartolai, MS
Water Quality Specialist
Lake County Health Department

ILMA; Crystal Lake, IL
March 14, 2019

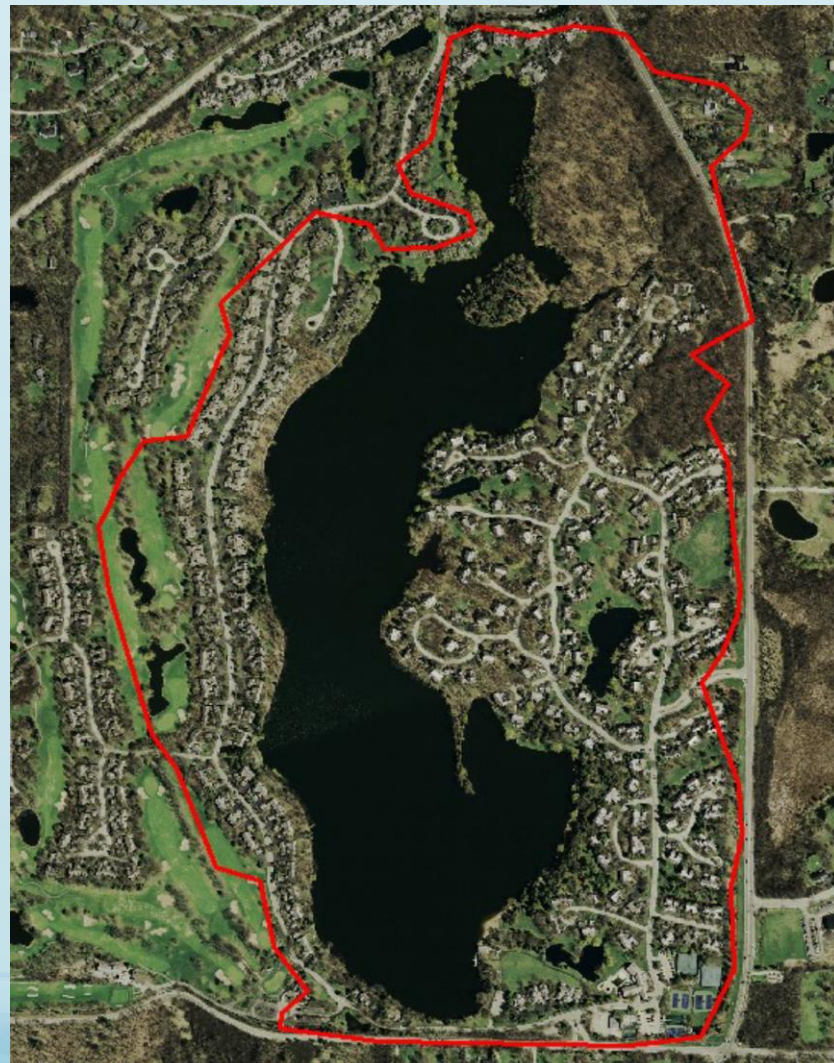
Lake Barrington, IL

- 91-ac in the Village of Barrington
- Mean depth = 5 ft; Max. depth = 20 ft
- Watershed = 291-ac; WS:L area = 3.2:1
- Retention time = 3.5 yrs

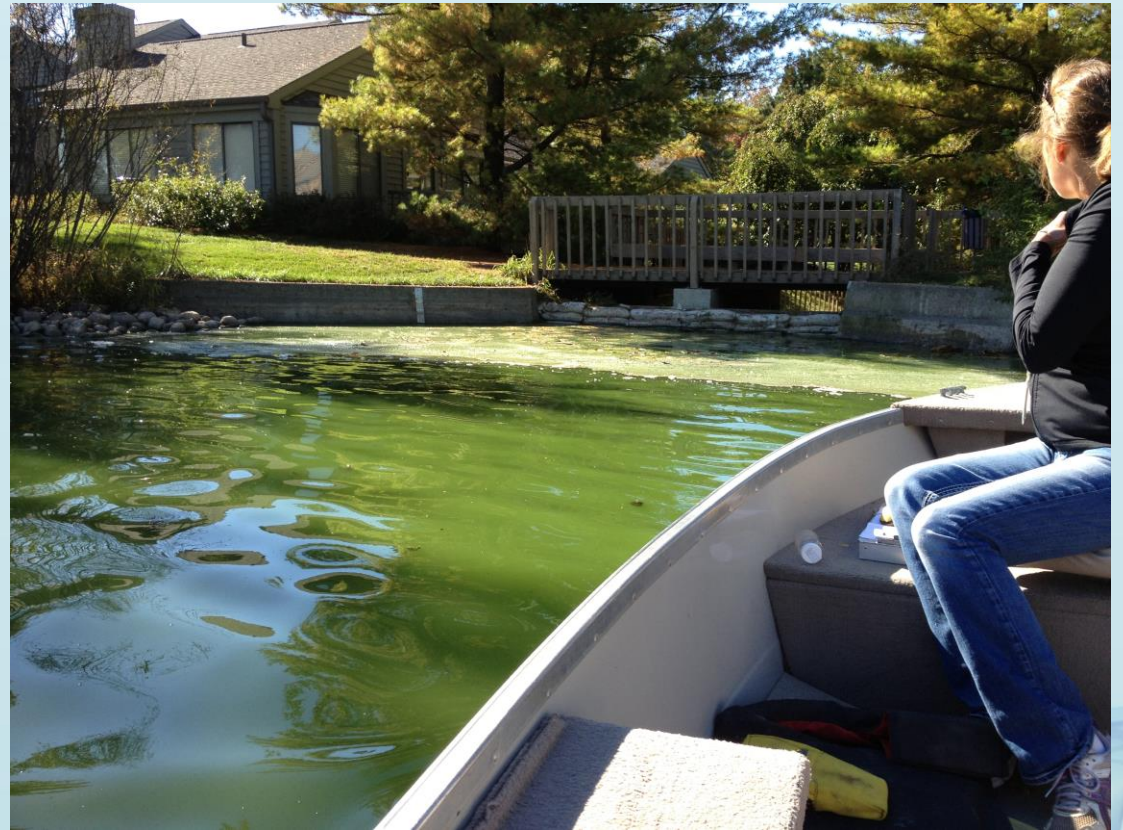
Historic Water Quality

- Poor water quality & Phosphorus impairments
- Algae problems; lake closed in 2013 for toxins (microcystin 635 ug/L)
- Total-P = 60 ug/L (2013), 105 ug/L (2007)
- Secchi disk depth = 5.8 ft (2013)
- Anoxic below 8 ft in late summer

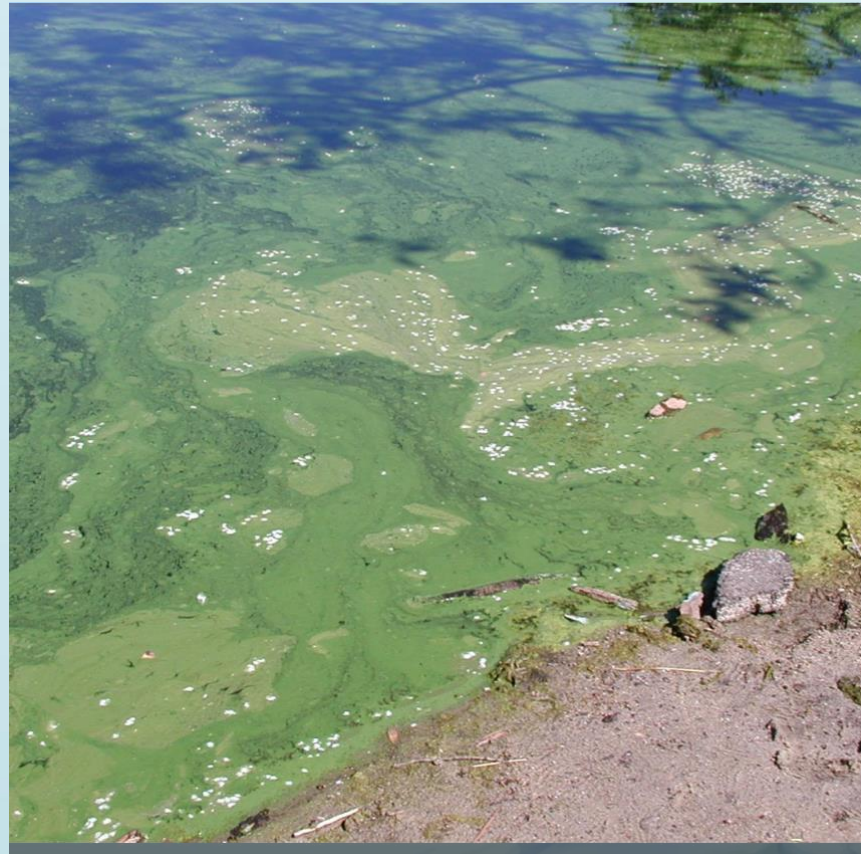
Phosphorus Management Plan (2014)

- Phosphorus identified as the driver of poor water quality & algae blooms
- Internal loading of P from lake sediments identified as a primary source of P
- Aron & Associates recommend an alum dose of 345 gal/ac to reduce internal loading

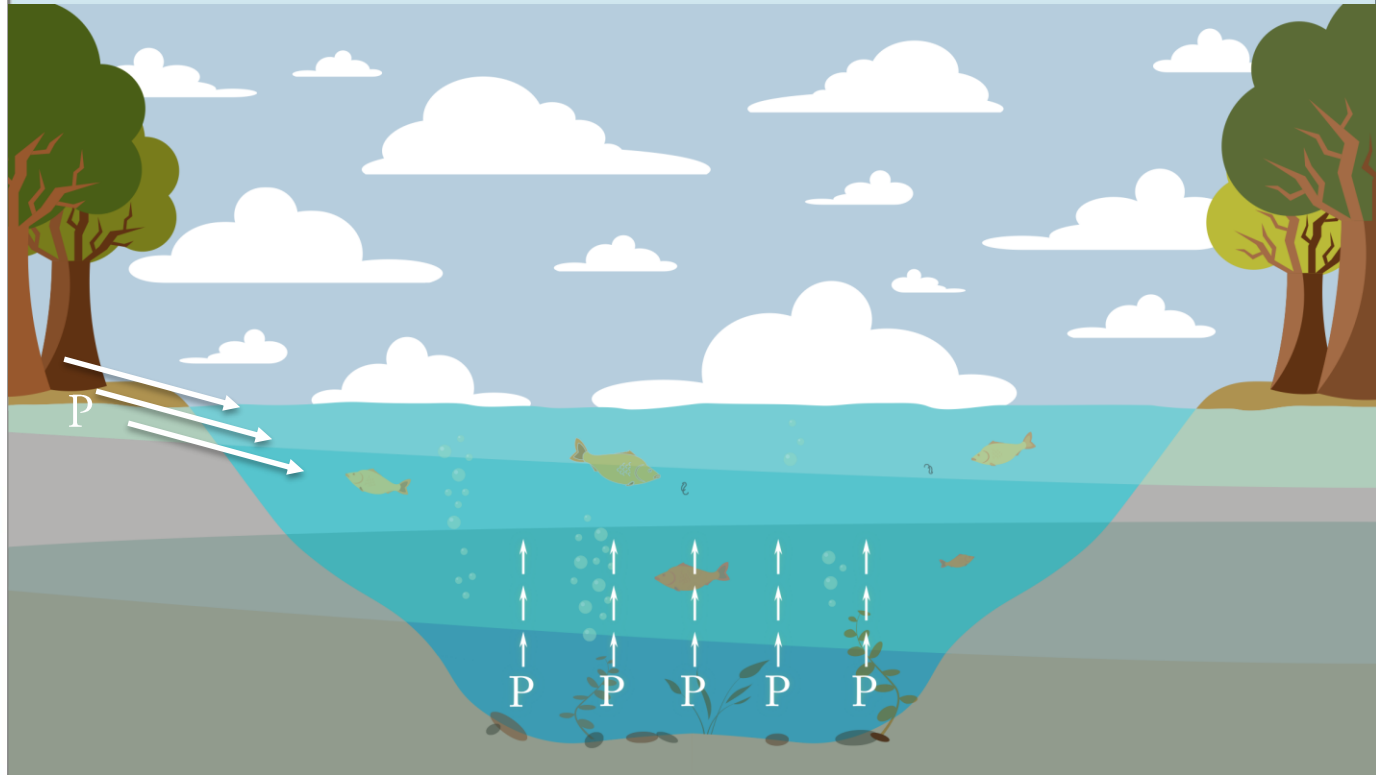
Sources of Phosphorus in Lakes

- Recognized the role of internal P loading and the cost effectiveness of alum applications

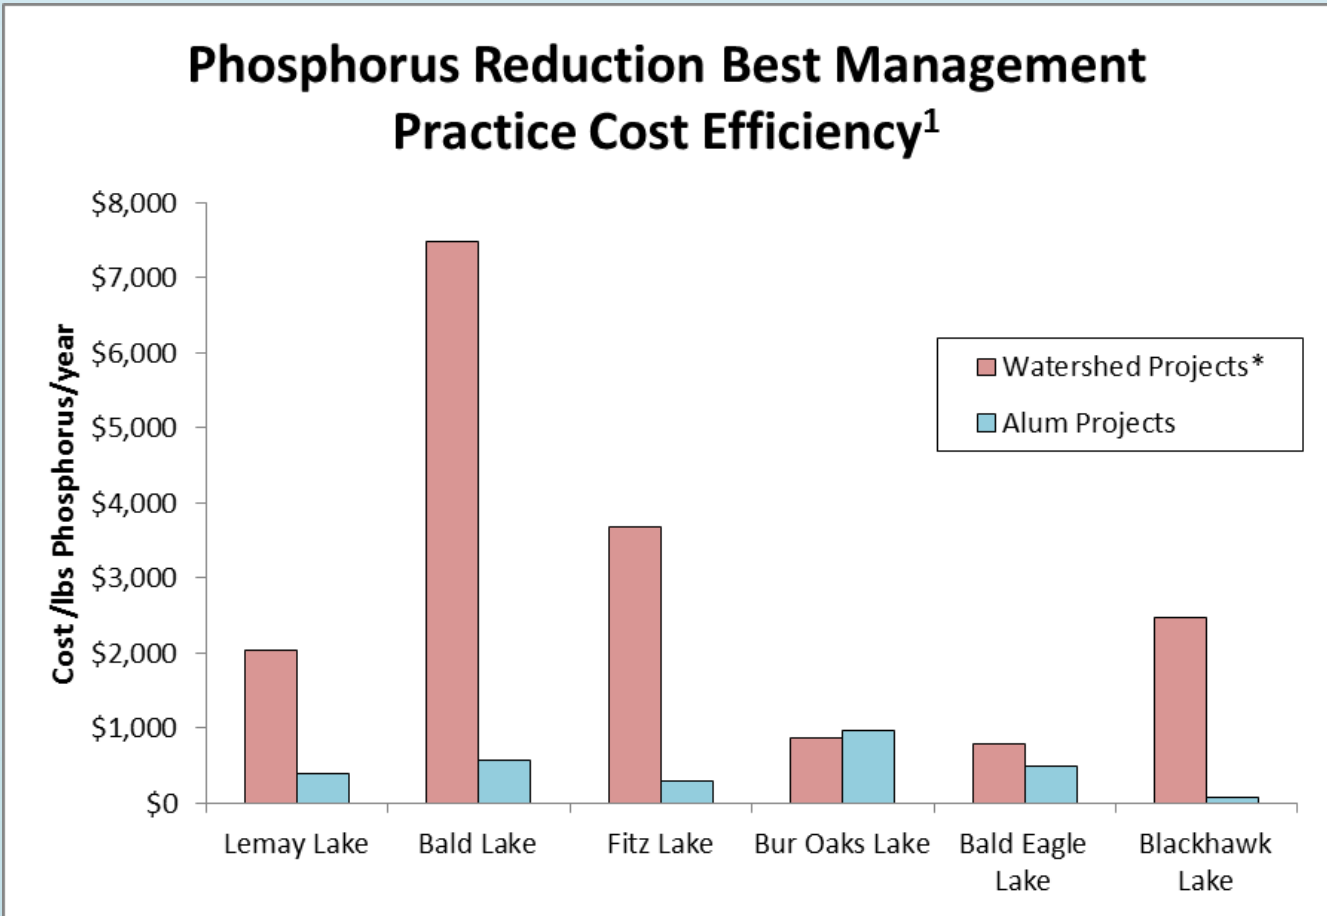
Management Cost Efficiency

*Average cost of all potential watershed projects
¹Cost Efficiency = cost per pound/year

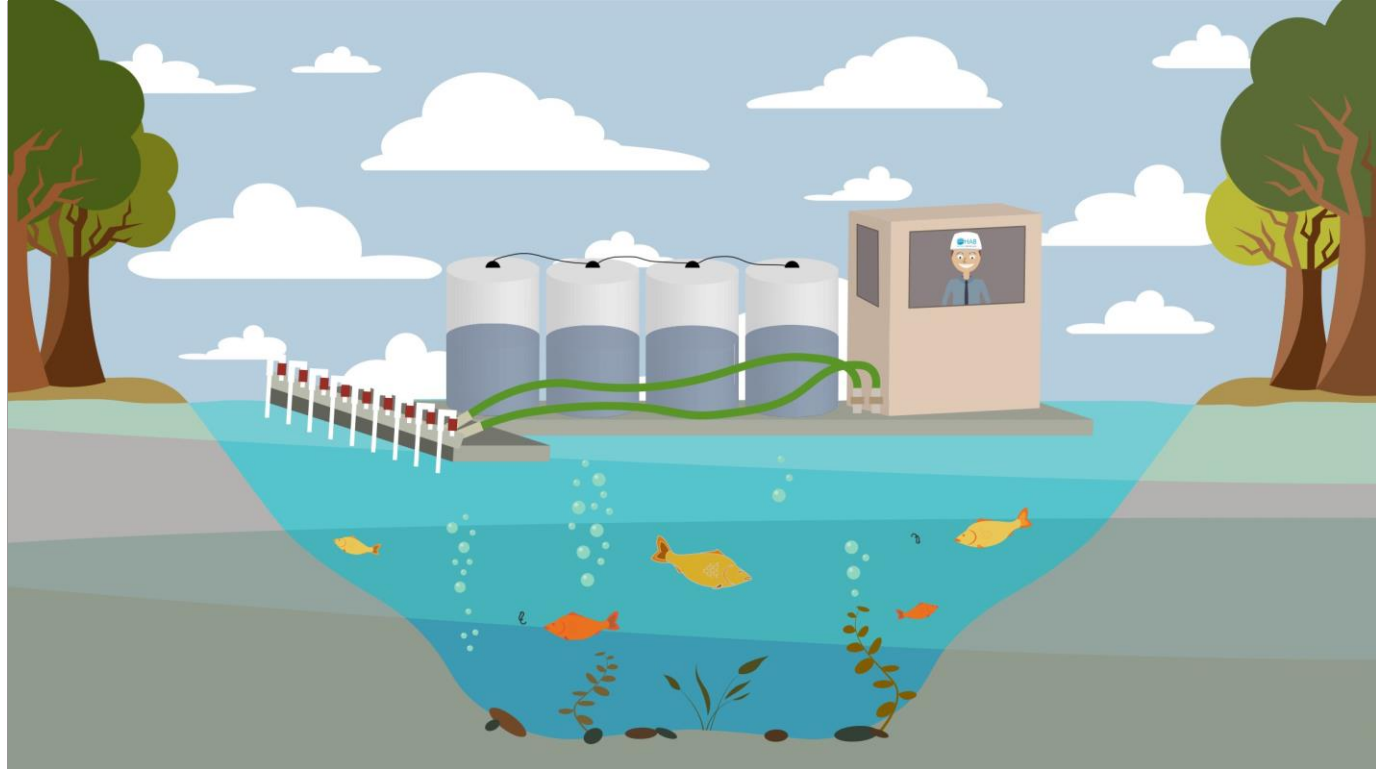
Lake Barrington Alum Application

- HAB Aquatic Solutions applied 31,424 gal of alum over two days in April of 2015

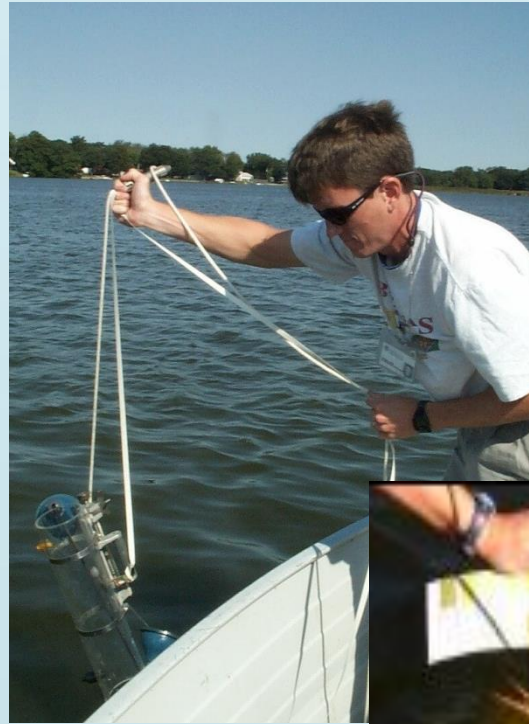
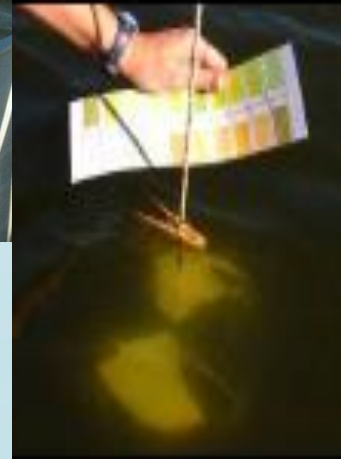
Water Quality Monitoring

- LCHD monitored 2013 pre-alum treatment, 2015 during/post alum treatment
- Lake Barrington volunteers monitored in 2018, through the Volunteer Lake Monitoring Program

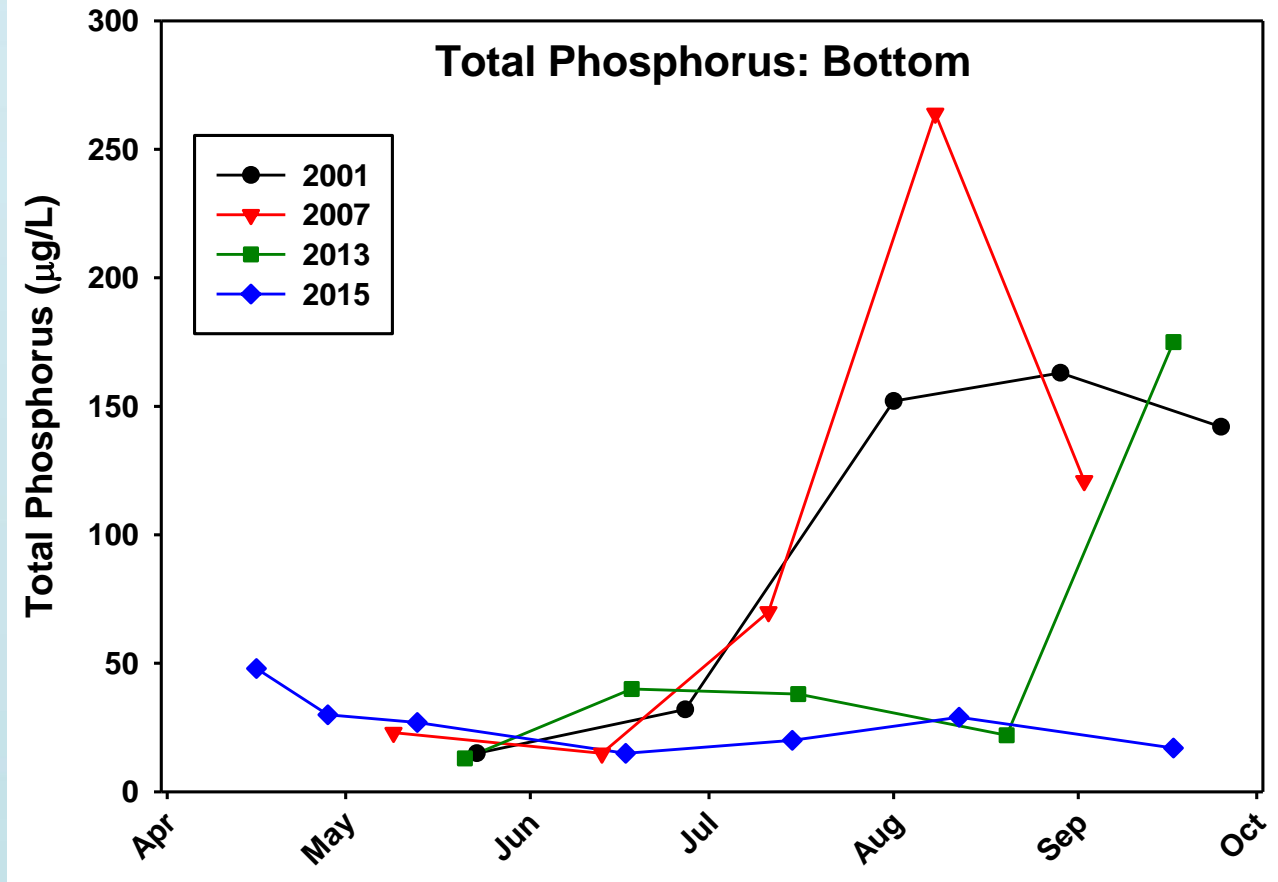
Water Quality Results: Total-P

● There were large internal loading events prior to the alum application

● Alum reduced mean TP near the bottom from 97 ug/L (2013) to 22 ug/L in 2015 (77% reduction)

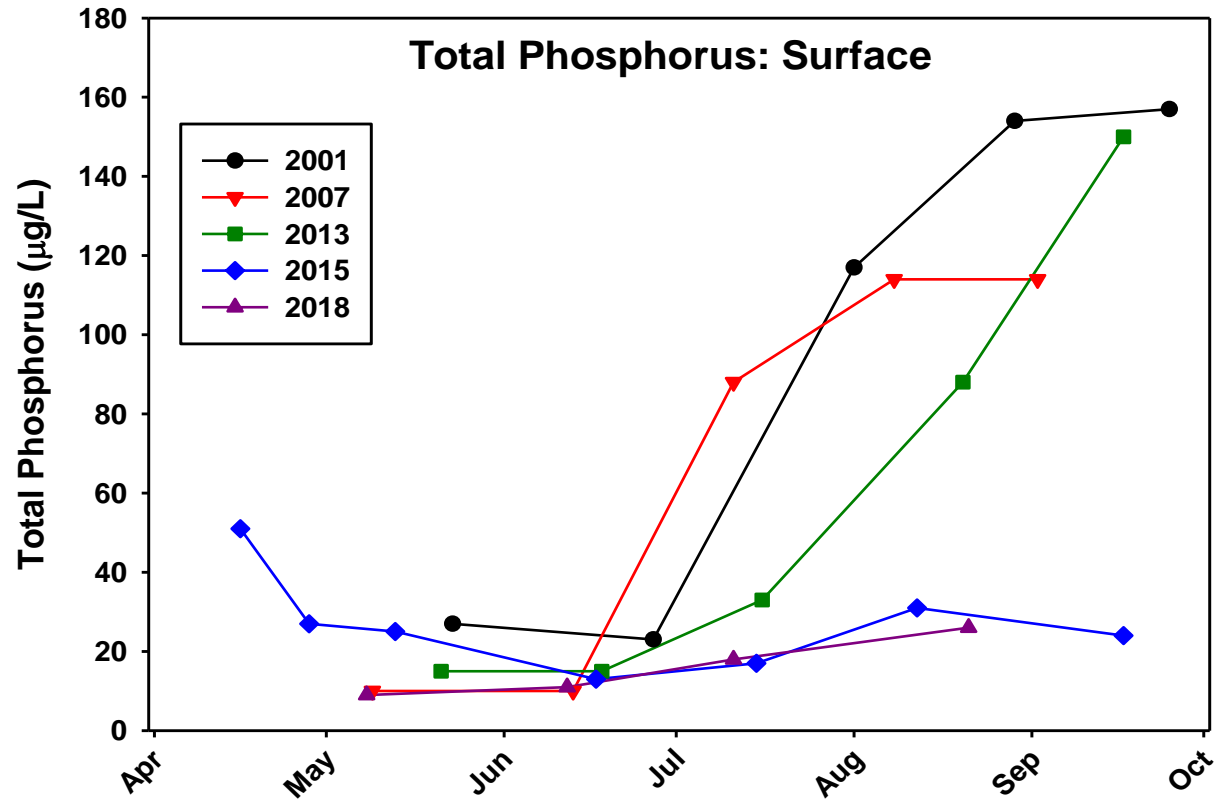
Water Quality Results: Total-P

- Reduced internal P loading reduced water column TP by 63% (2013 to 2015)
- Mean TP was 60 ug/L prior to alum (2013) and 22 ug/L post alum
- Average (2001-2013) 87 ug/L to 22 ug/L post alum
IEPA TP standard = 50 ug/L

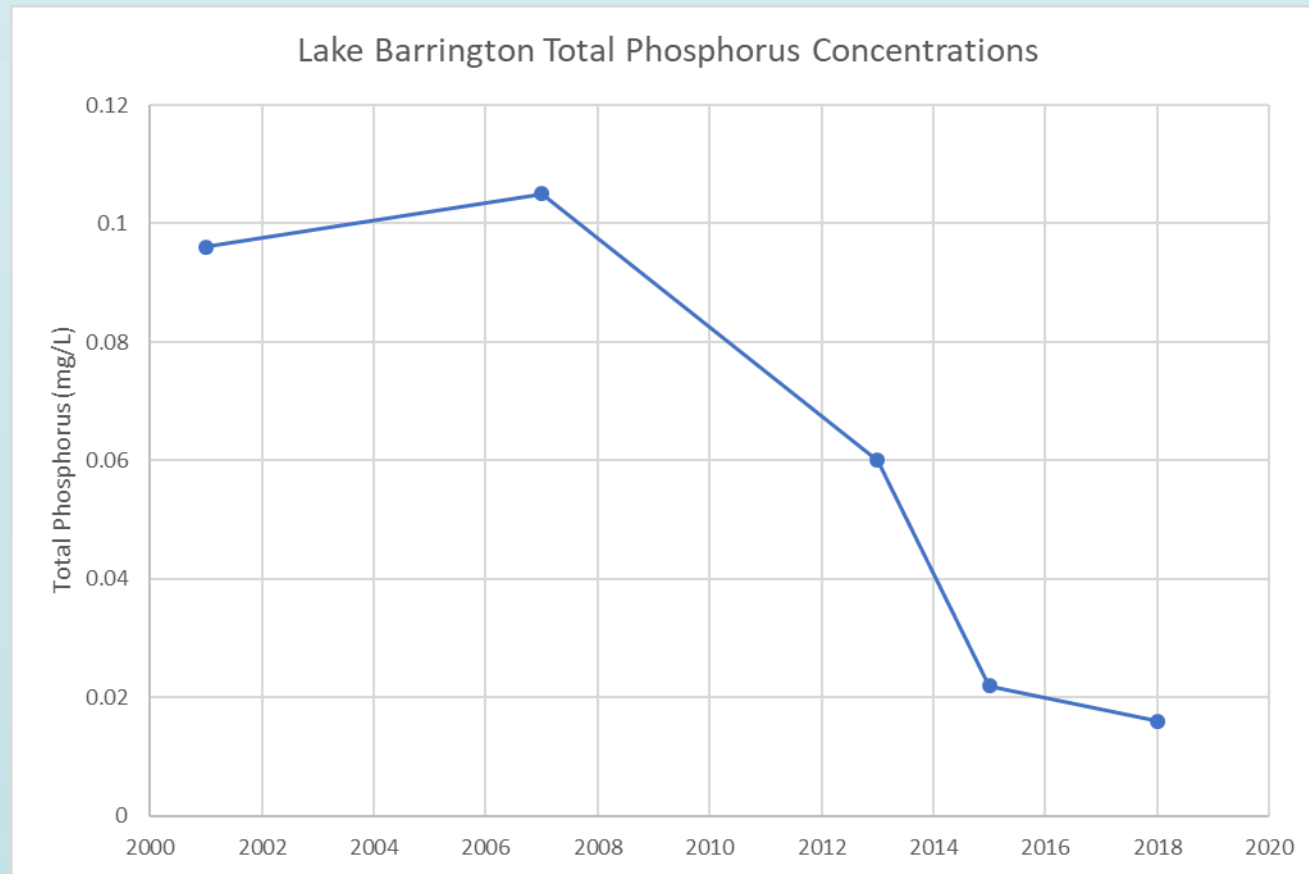
Water Quality Results: Total-P

● Surface total phosphorus remains low, 3 years post treatment

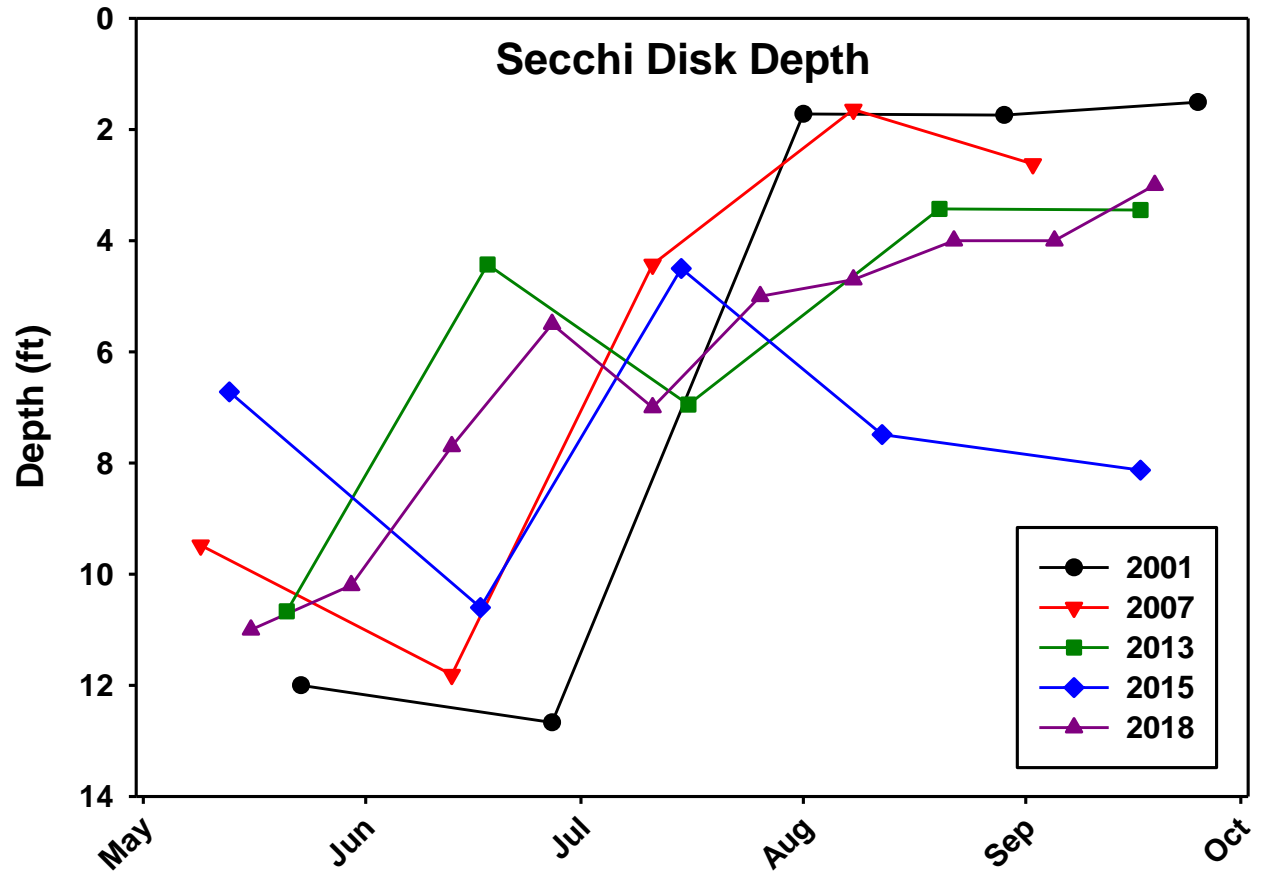
Water Quality Results: Clarity

Water clarity increased by over 1 ft (29%) from 5.8 ft to 7.5 ft after the alum application

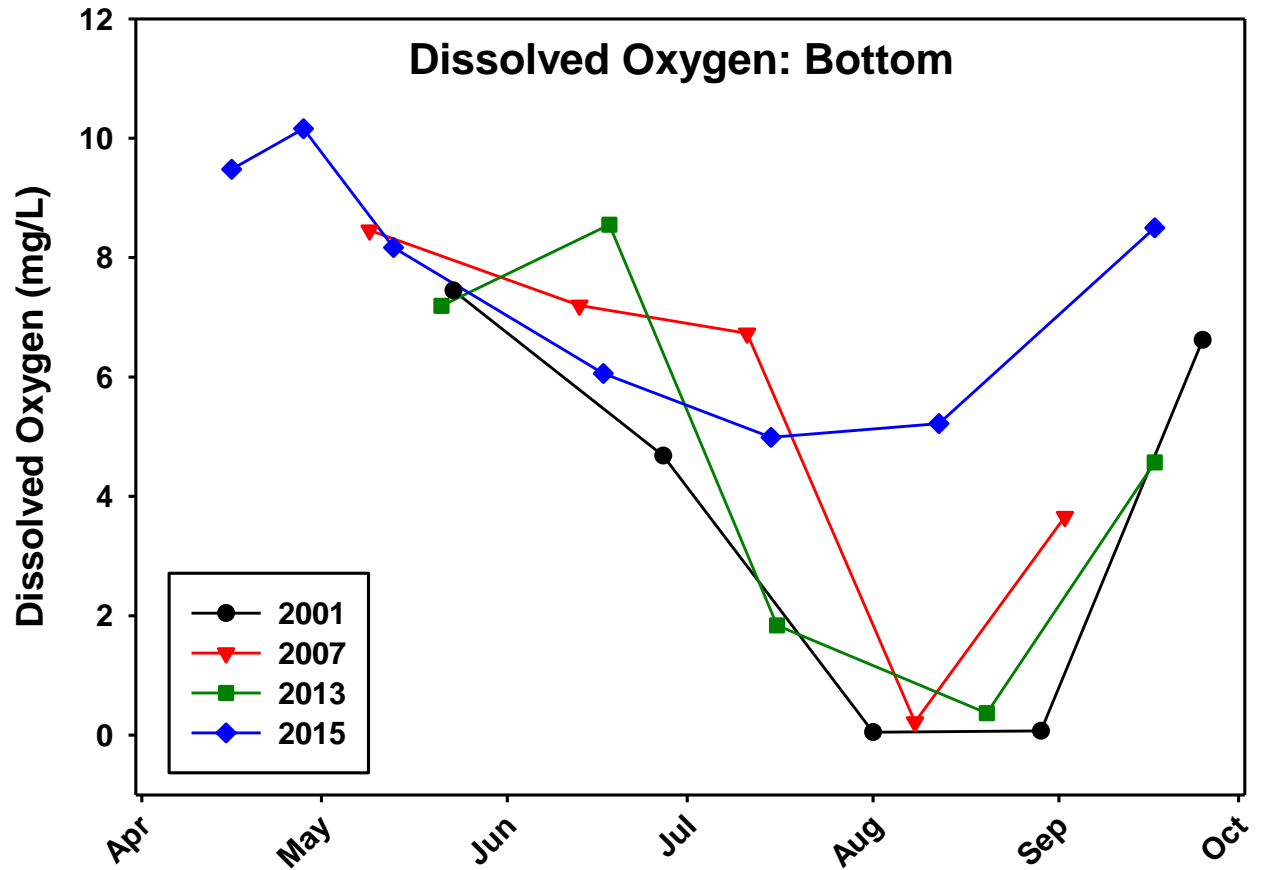
Water Quality Results: Dissolved Oxygen

- Mean dissolved oxygen near the bottom increased by 2.8 mg/L (60%) from 4.4 to 7.2 mg/L after the alum application

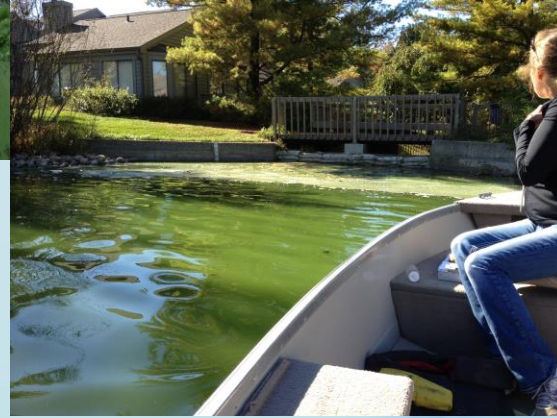
Water Quality Results: Algae

- The toxic cyanobacteria blooms that closed the lake in 2013 have not occurred after the alum application reduced TP

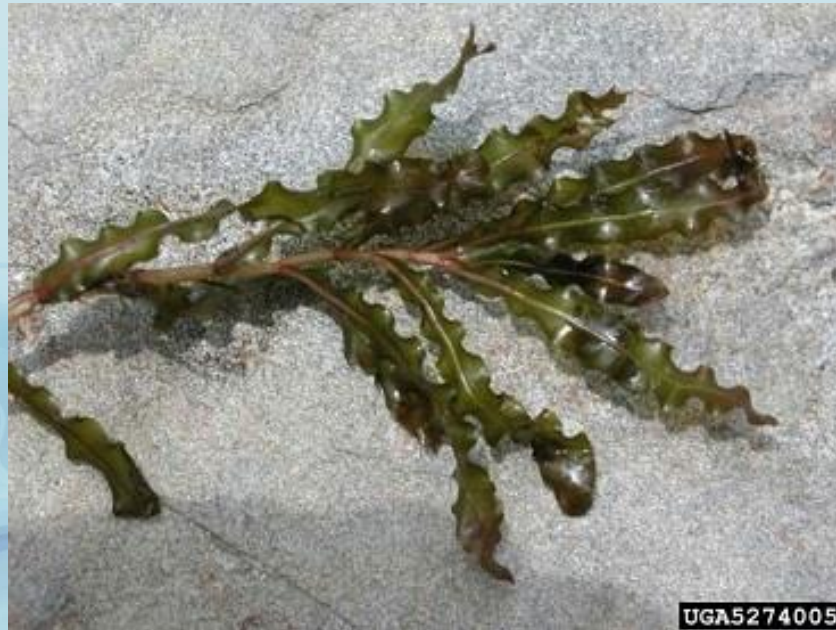
Water Quality Results: Aquatic Vegetation

- Curlyleaf Pondweed has increased in the lake post alum treatment. This was expected and the lake association knew they might have had to increase lake treatments for this
- 2018 native pondweeds found growing including 10-14 foot depths
