Using Citizen Science to Tackle a Blue Green Algae Problem in Long Lake

Laura Risser

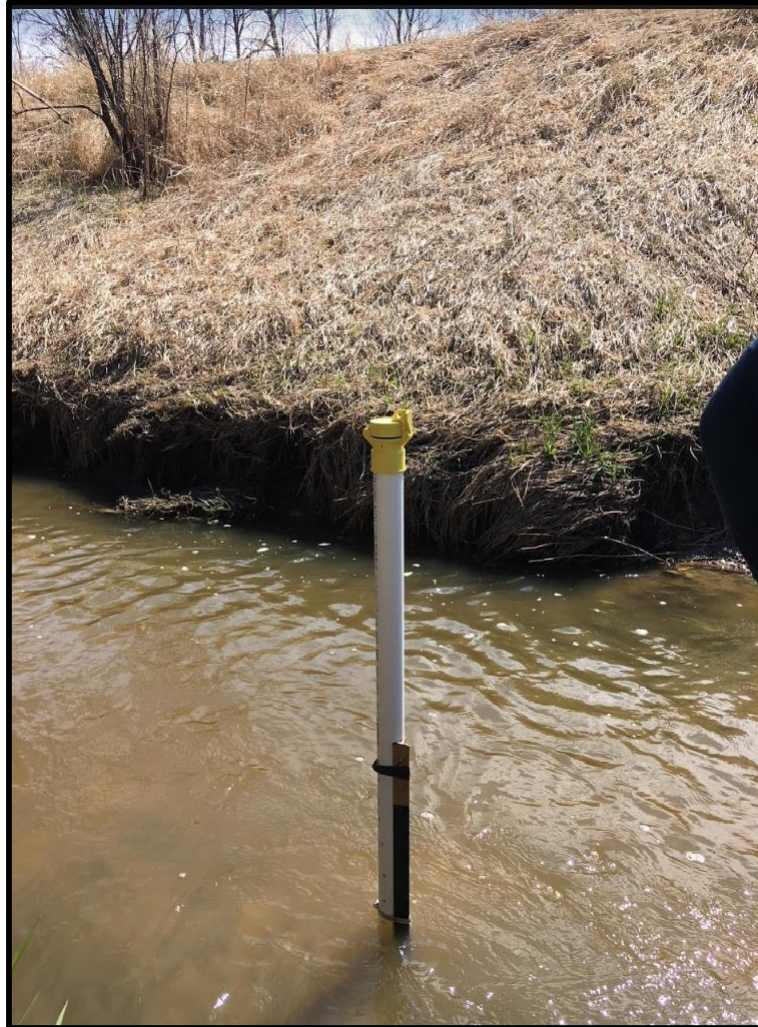
- ▶ Flow Monitors from Hey & Associates
- ▶ Lake level monitoring
- ▶ Flow rate monitoring

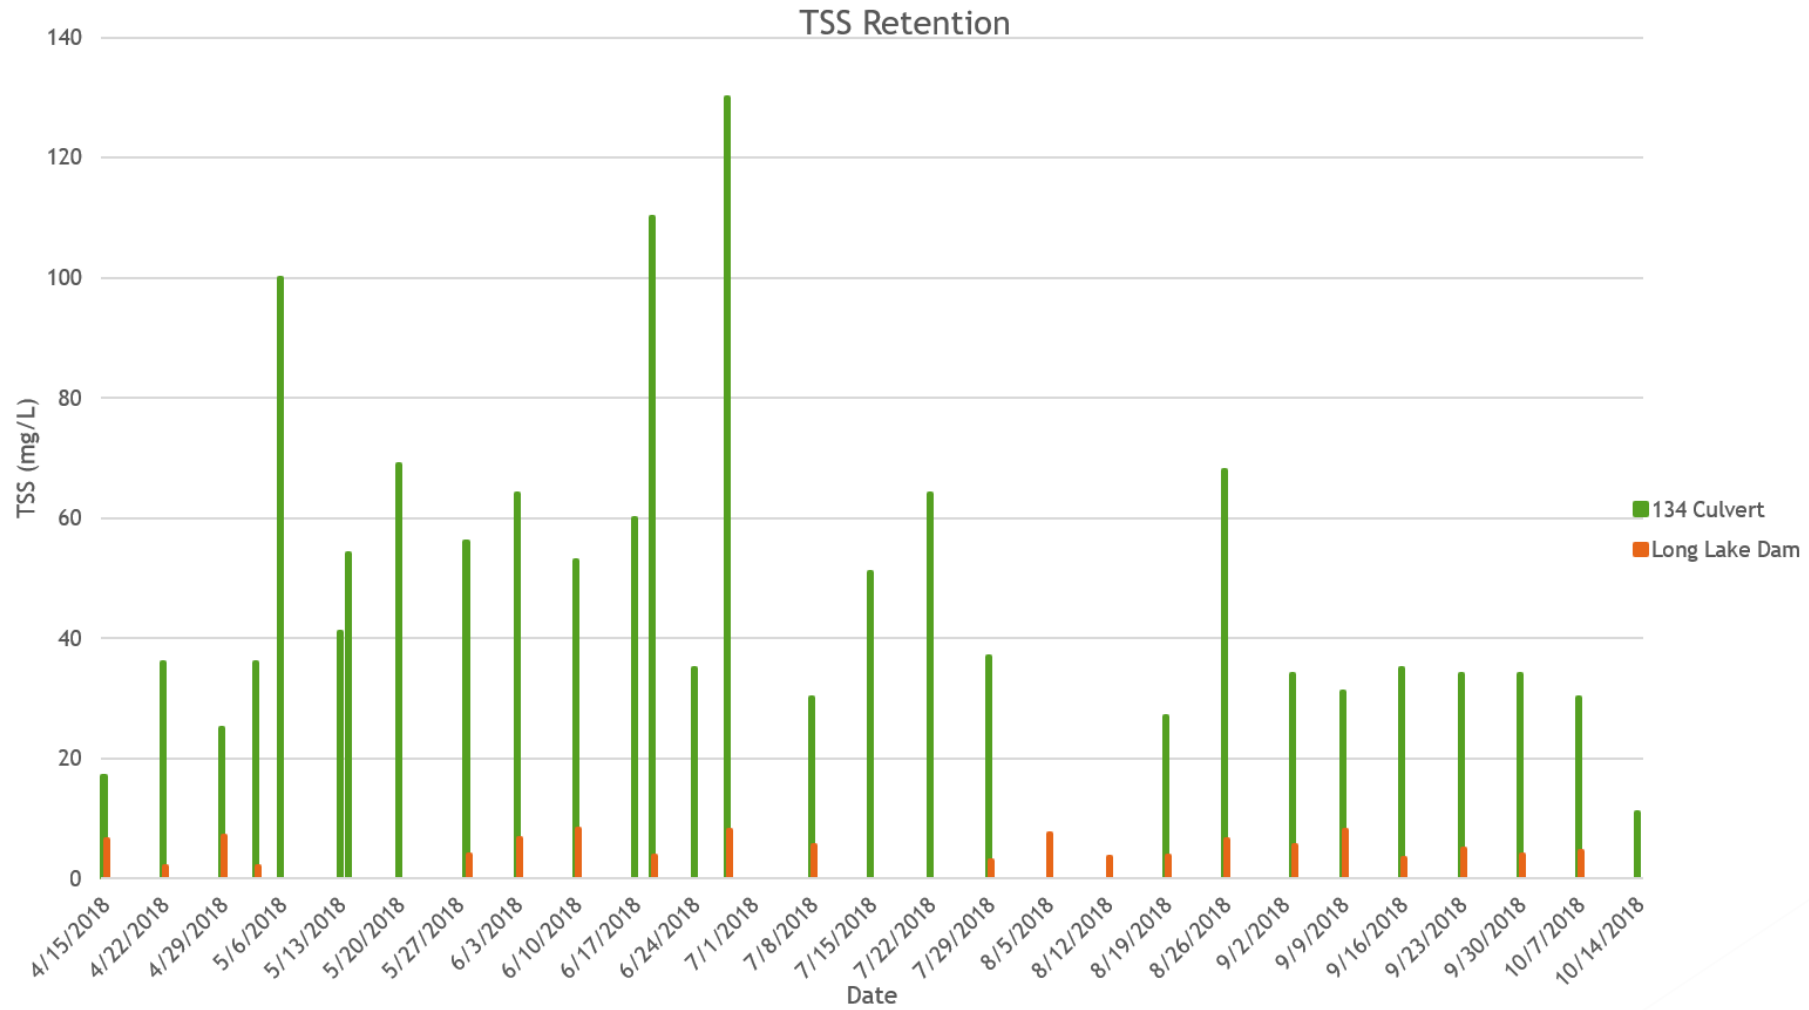
- ▶ 4 Blooms
 - ▶ One bloom >200 ug/L microcystin
- ▶ Overall good water quality
 - ▶ Meeting state standard for Total P
- ▶ High TSS & Total P retention

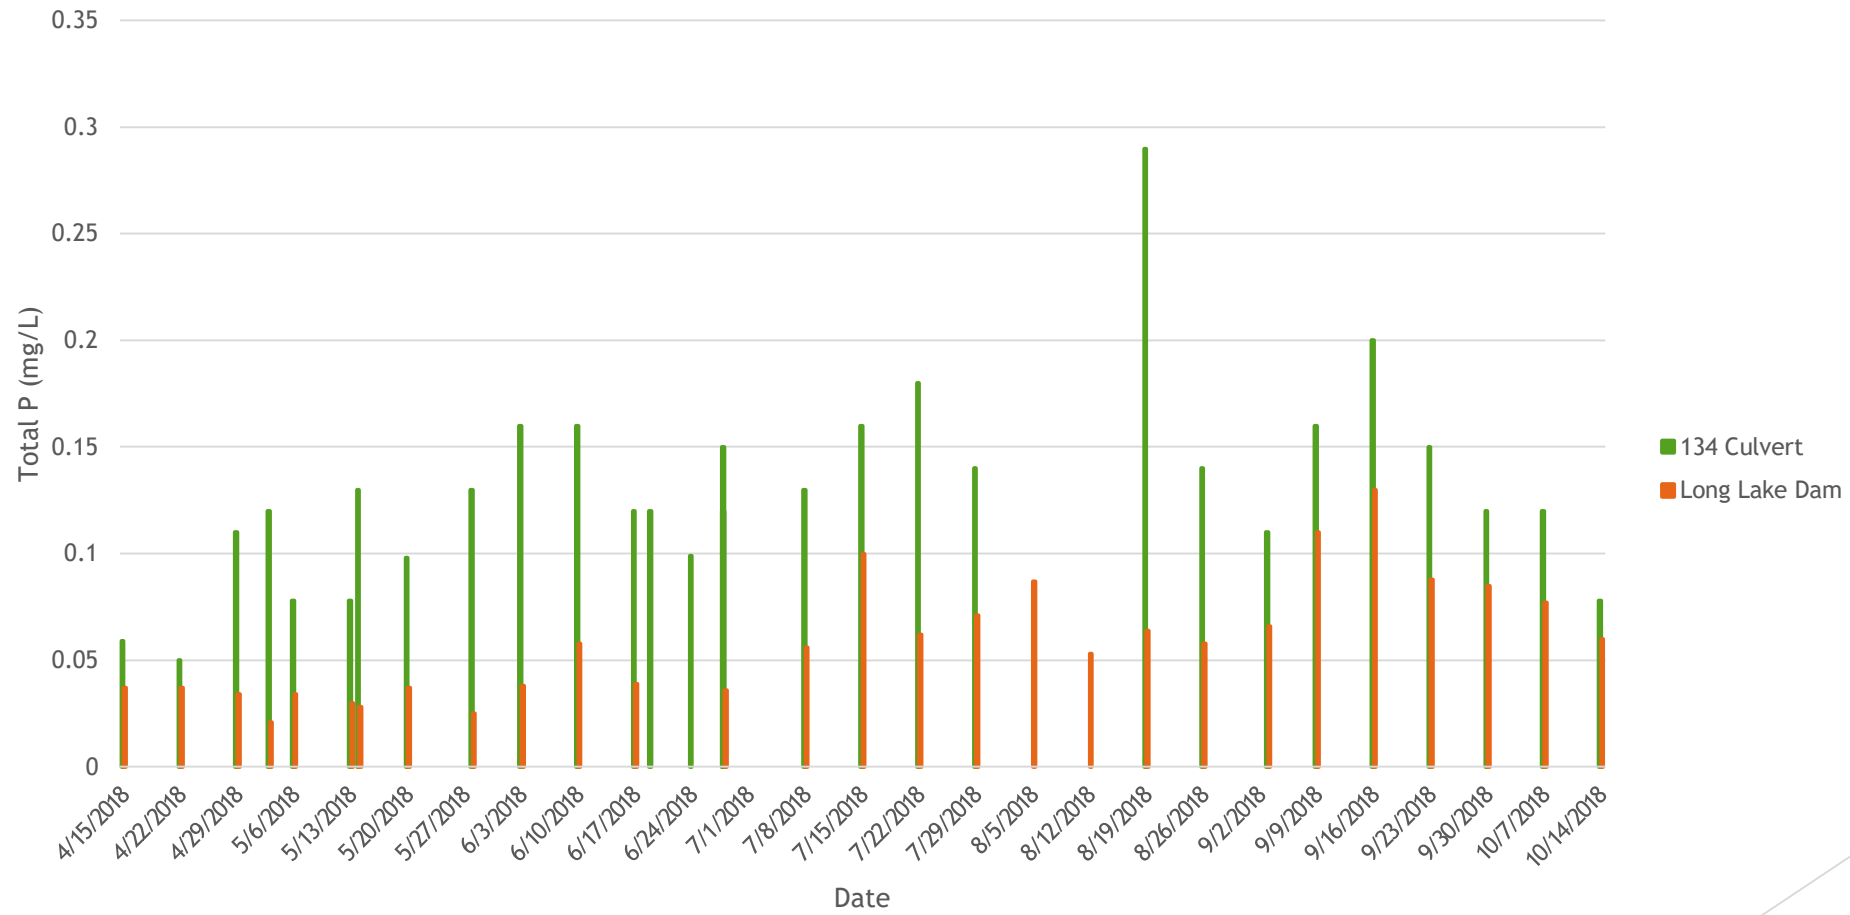
Total P Retention
