In-Lake Phosphorus Mitigation for the Restoration of Impaired Lakes and Streams

Pamela Dugan, PhD

March 17th, 2022

ILMA-AFS Conference

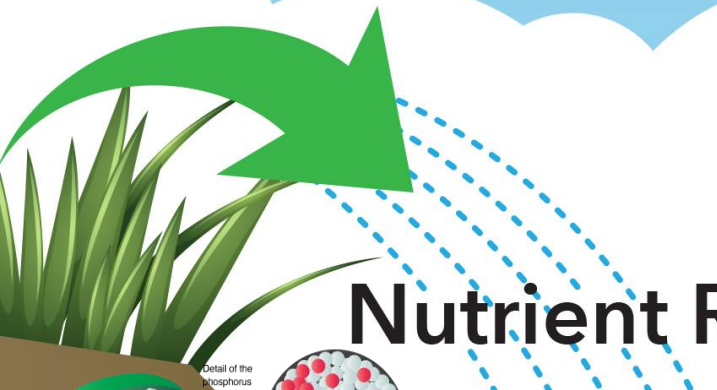
Phosphorus Pollution Inputs

Precipitation

Nutrient Runoff

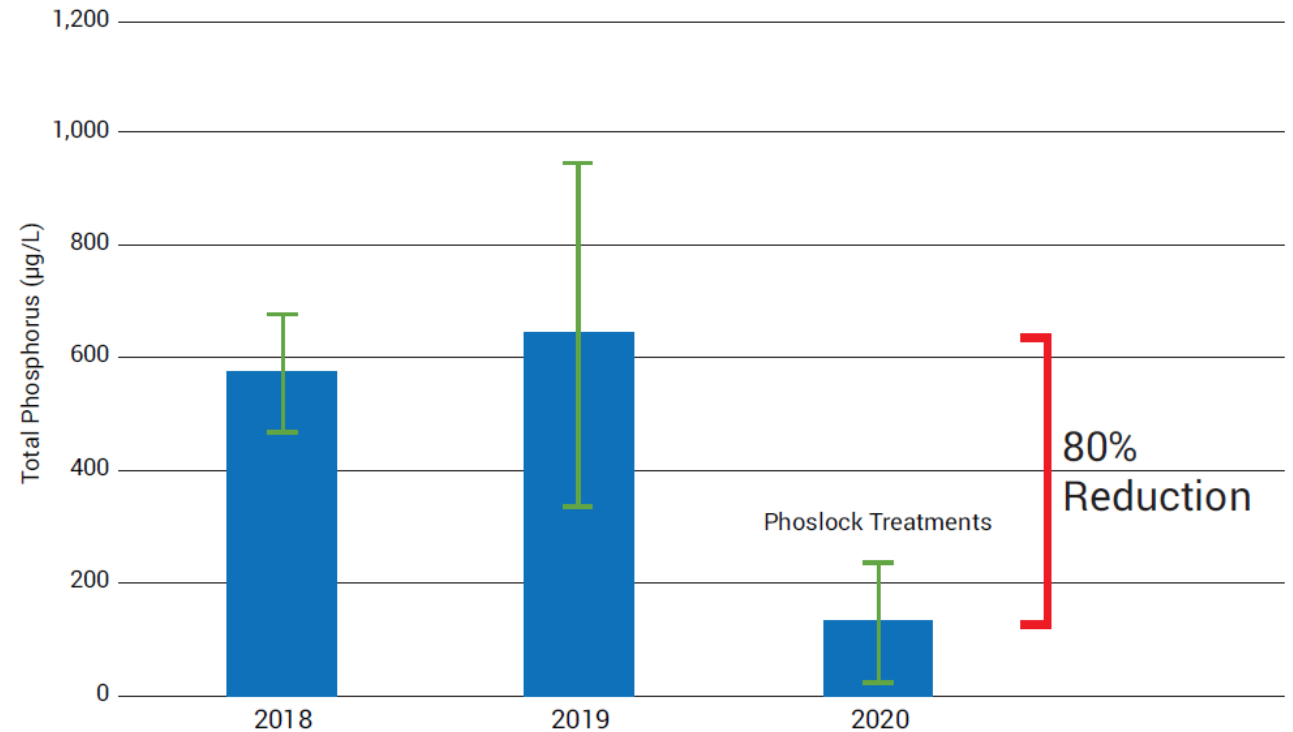
Morrison Lake - Michigan

Average Summer Total Phosphorus (10 meters)
June - September Samples
Error Bars = 1 SD

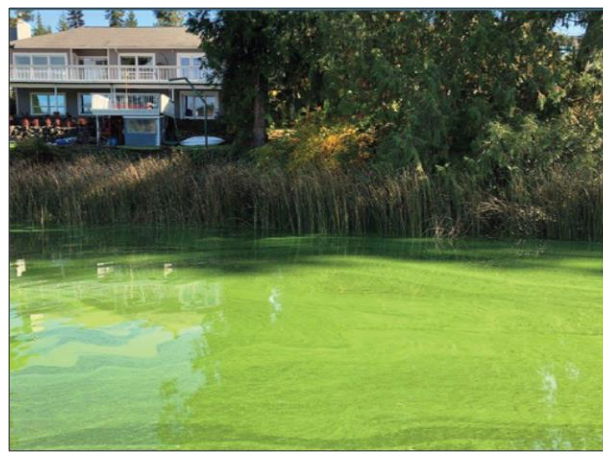
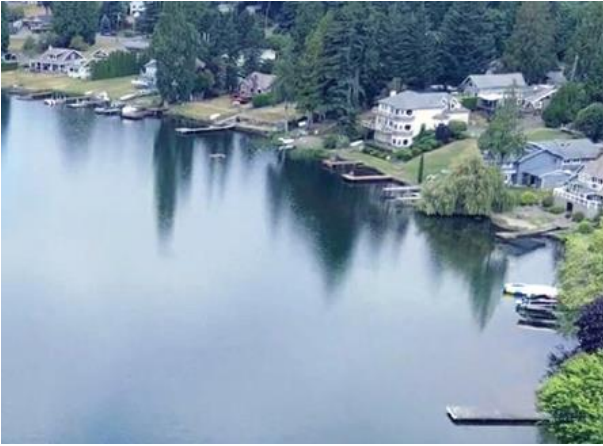
Kitsap Lake - Water Clarity

Average Secchi Disc Depth
 Error Bars = 1 SD (Historical Data: 1996 - 2017 n=36; 2020 n=13; 2021 n=6)

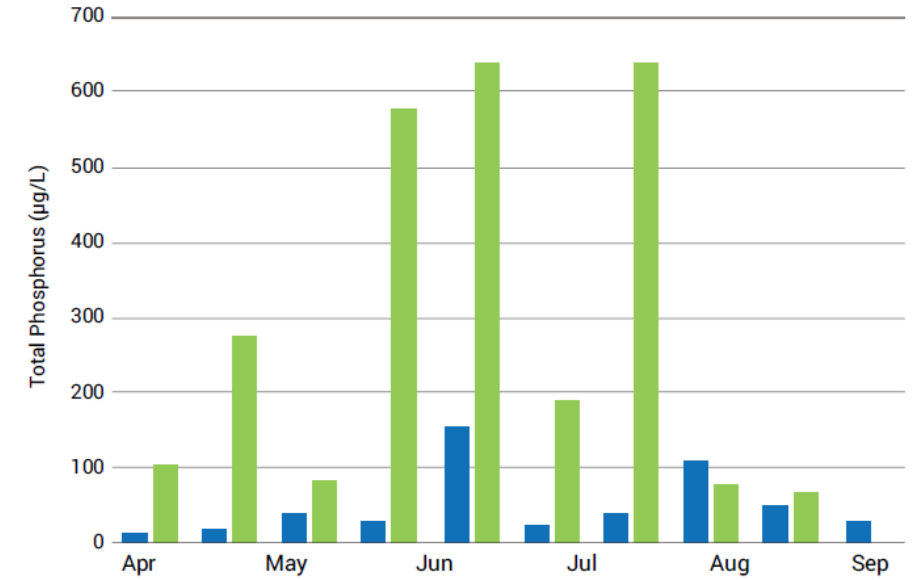
Kitsap Lake - Hypolimnetic (deep water)

Total phosphorus Levels 2020 & 2021

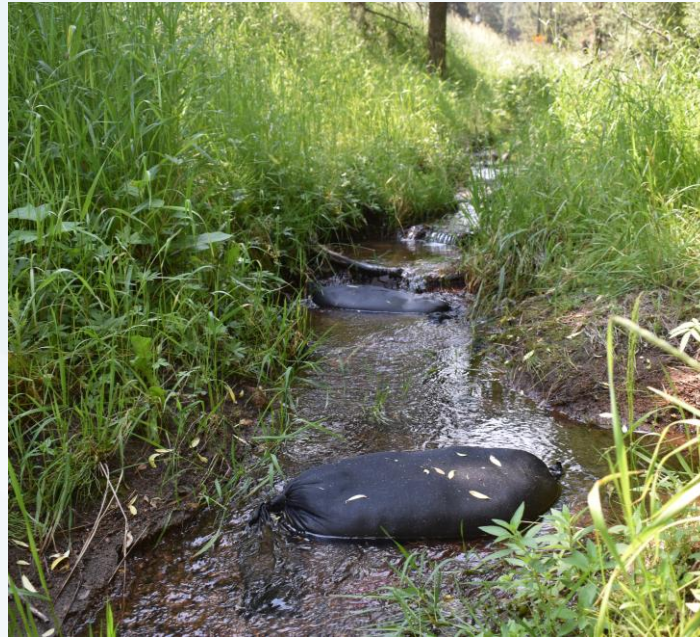
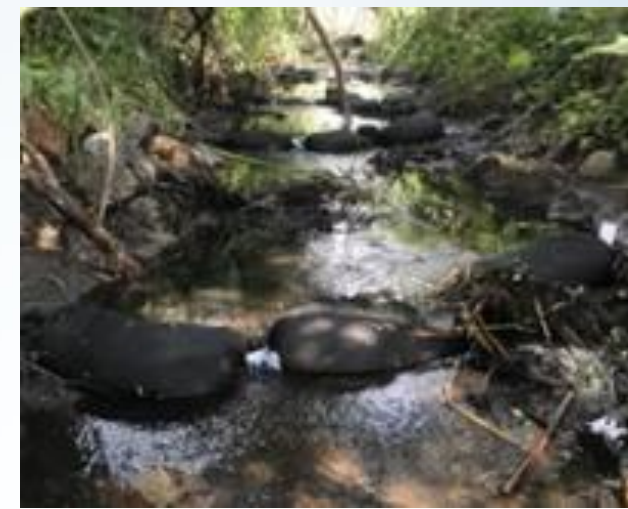
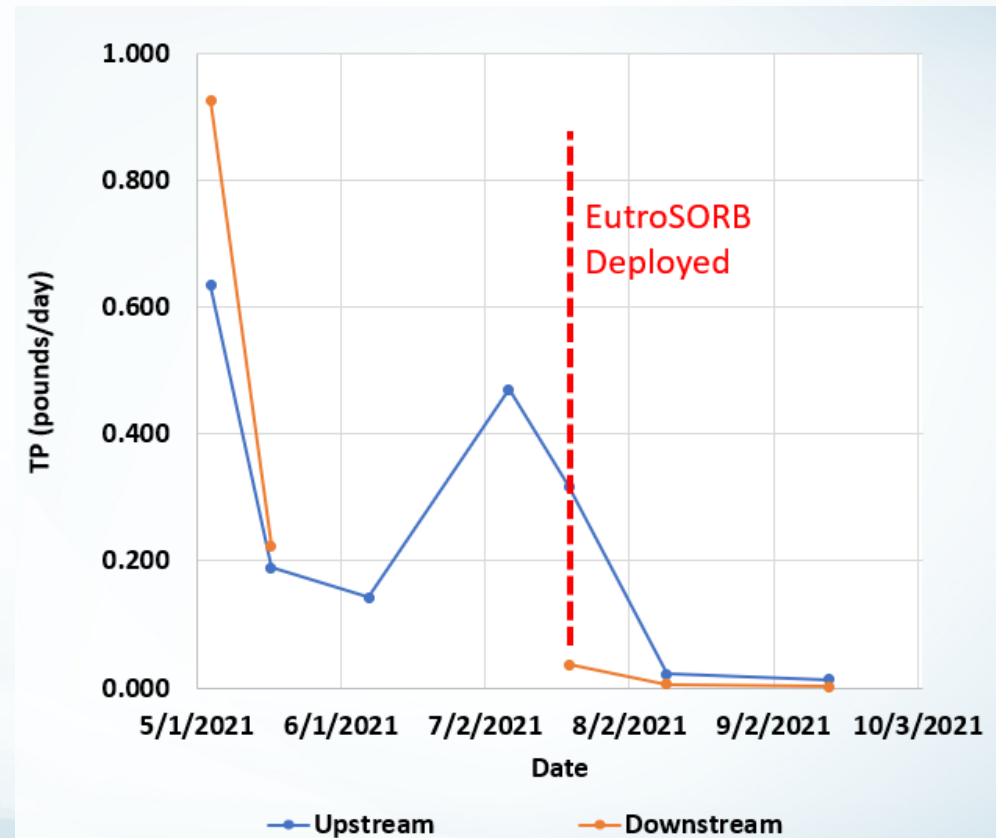
Bear Creek, CO

- Wilmot Creek
- ~0.1 CFS baseflow + stormflow
- 1000 lbs EutroSORB deployed over 900 linear feet (July 2021)
- 53% Removal (SRP)
- 76% Removal (TP)
- ~13 pounds removed
- Target: 20 pounds
 - 65% of target
 - Filters still in service
 - Low P levels (SRP << 25ppb)
